# CAMP MIAKONDA RESTORATION PROJECT

Partners for Clean Streams

# CAMP MIAKONDA & OTTAWA RIVER RESTORATION

OTTAWA RIVER BEND #1 – CAMP MIAKONDA

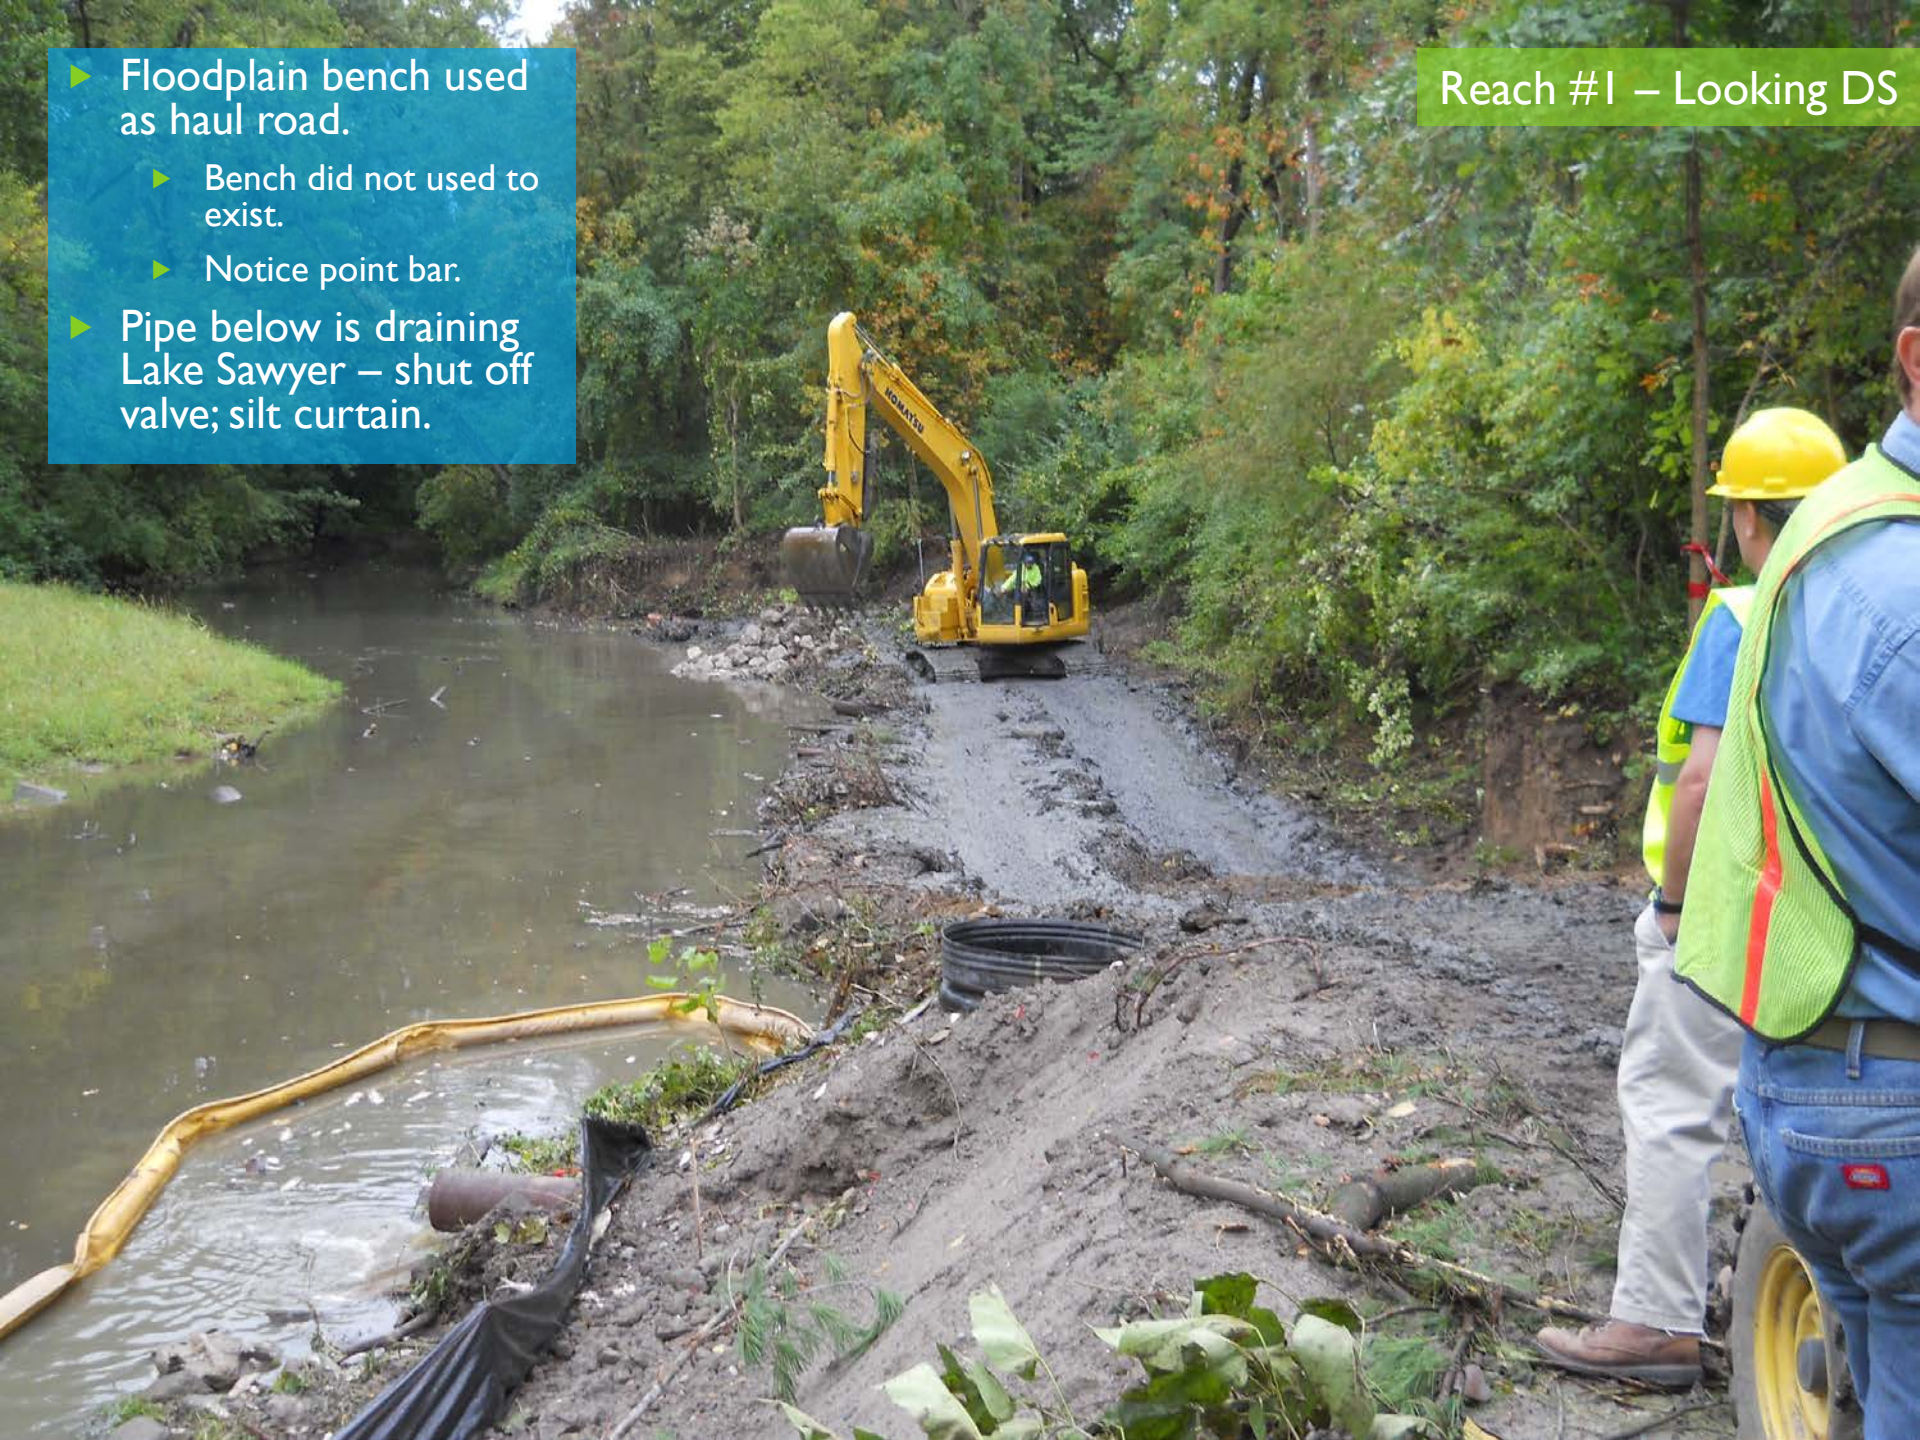
Reach #1 – Looking DS

# Longitudinal Peaked Stone Toe Protection (LPSTP)

As-built

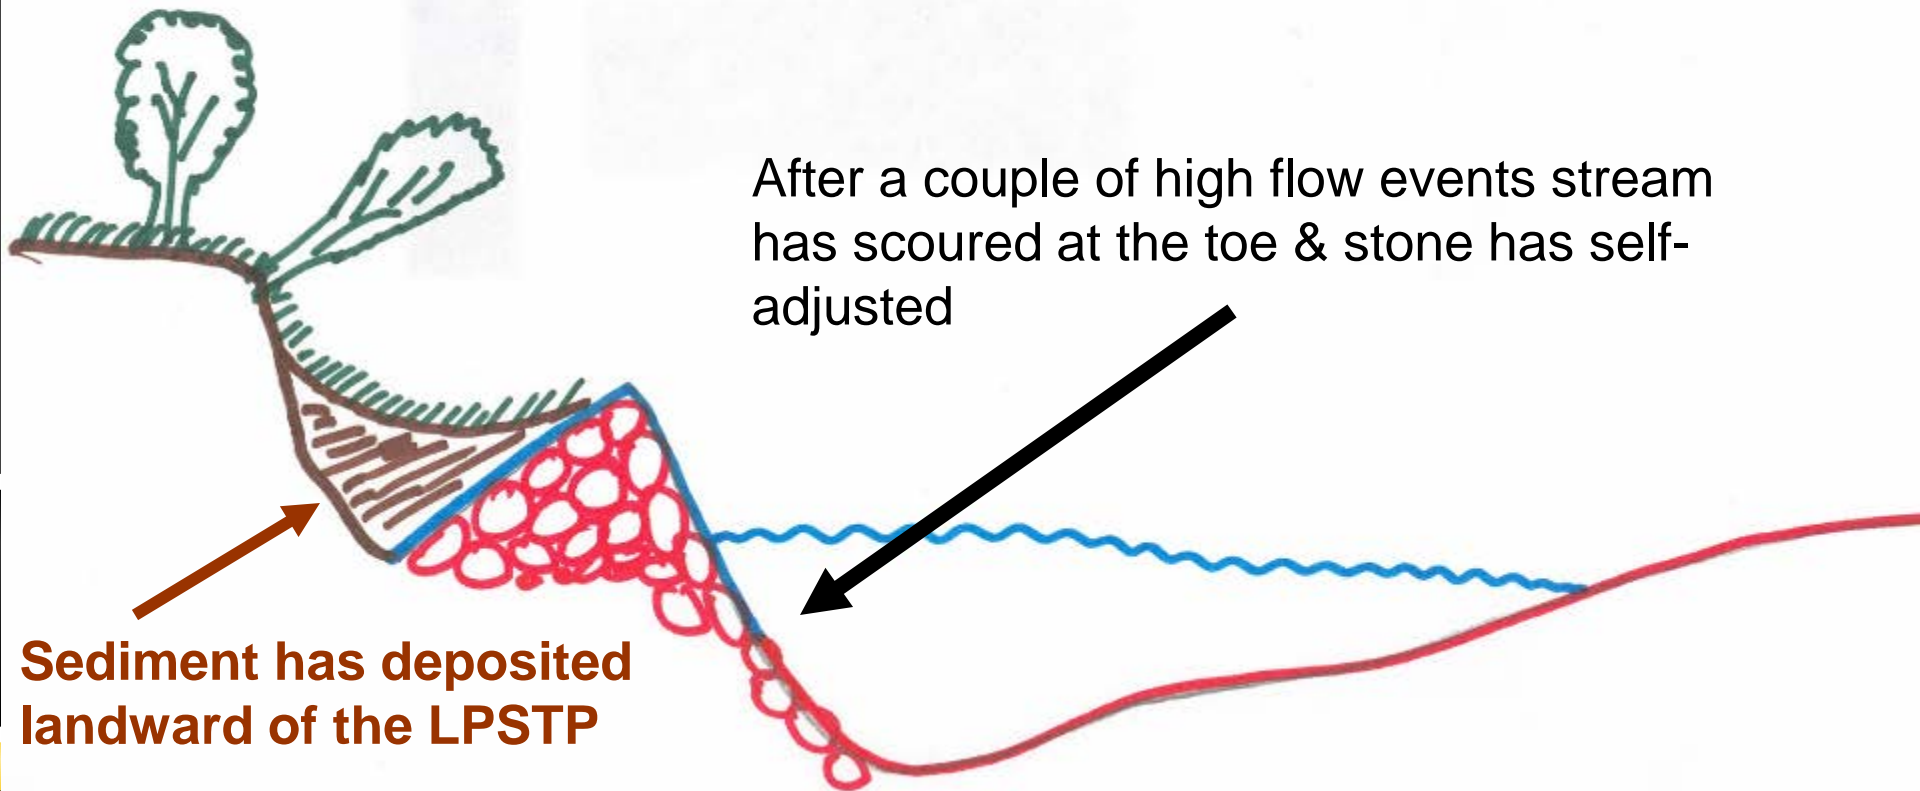
After a couple of high flow events stream  
has scoured at the toe & stone has self-  
adjusted

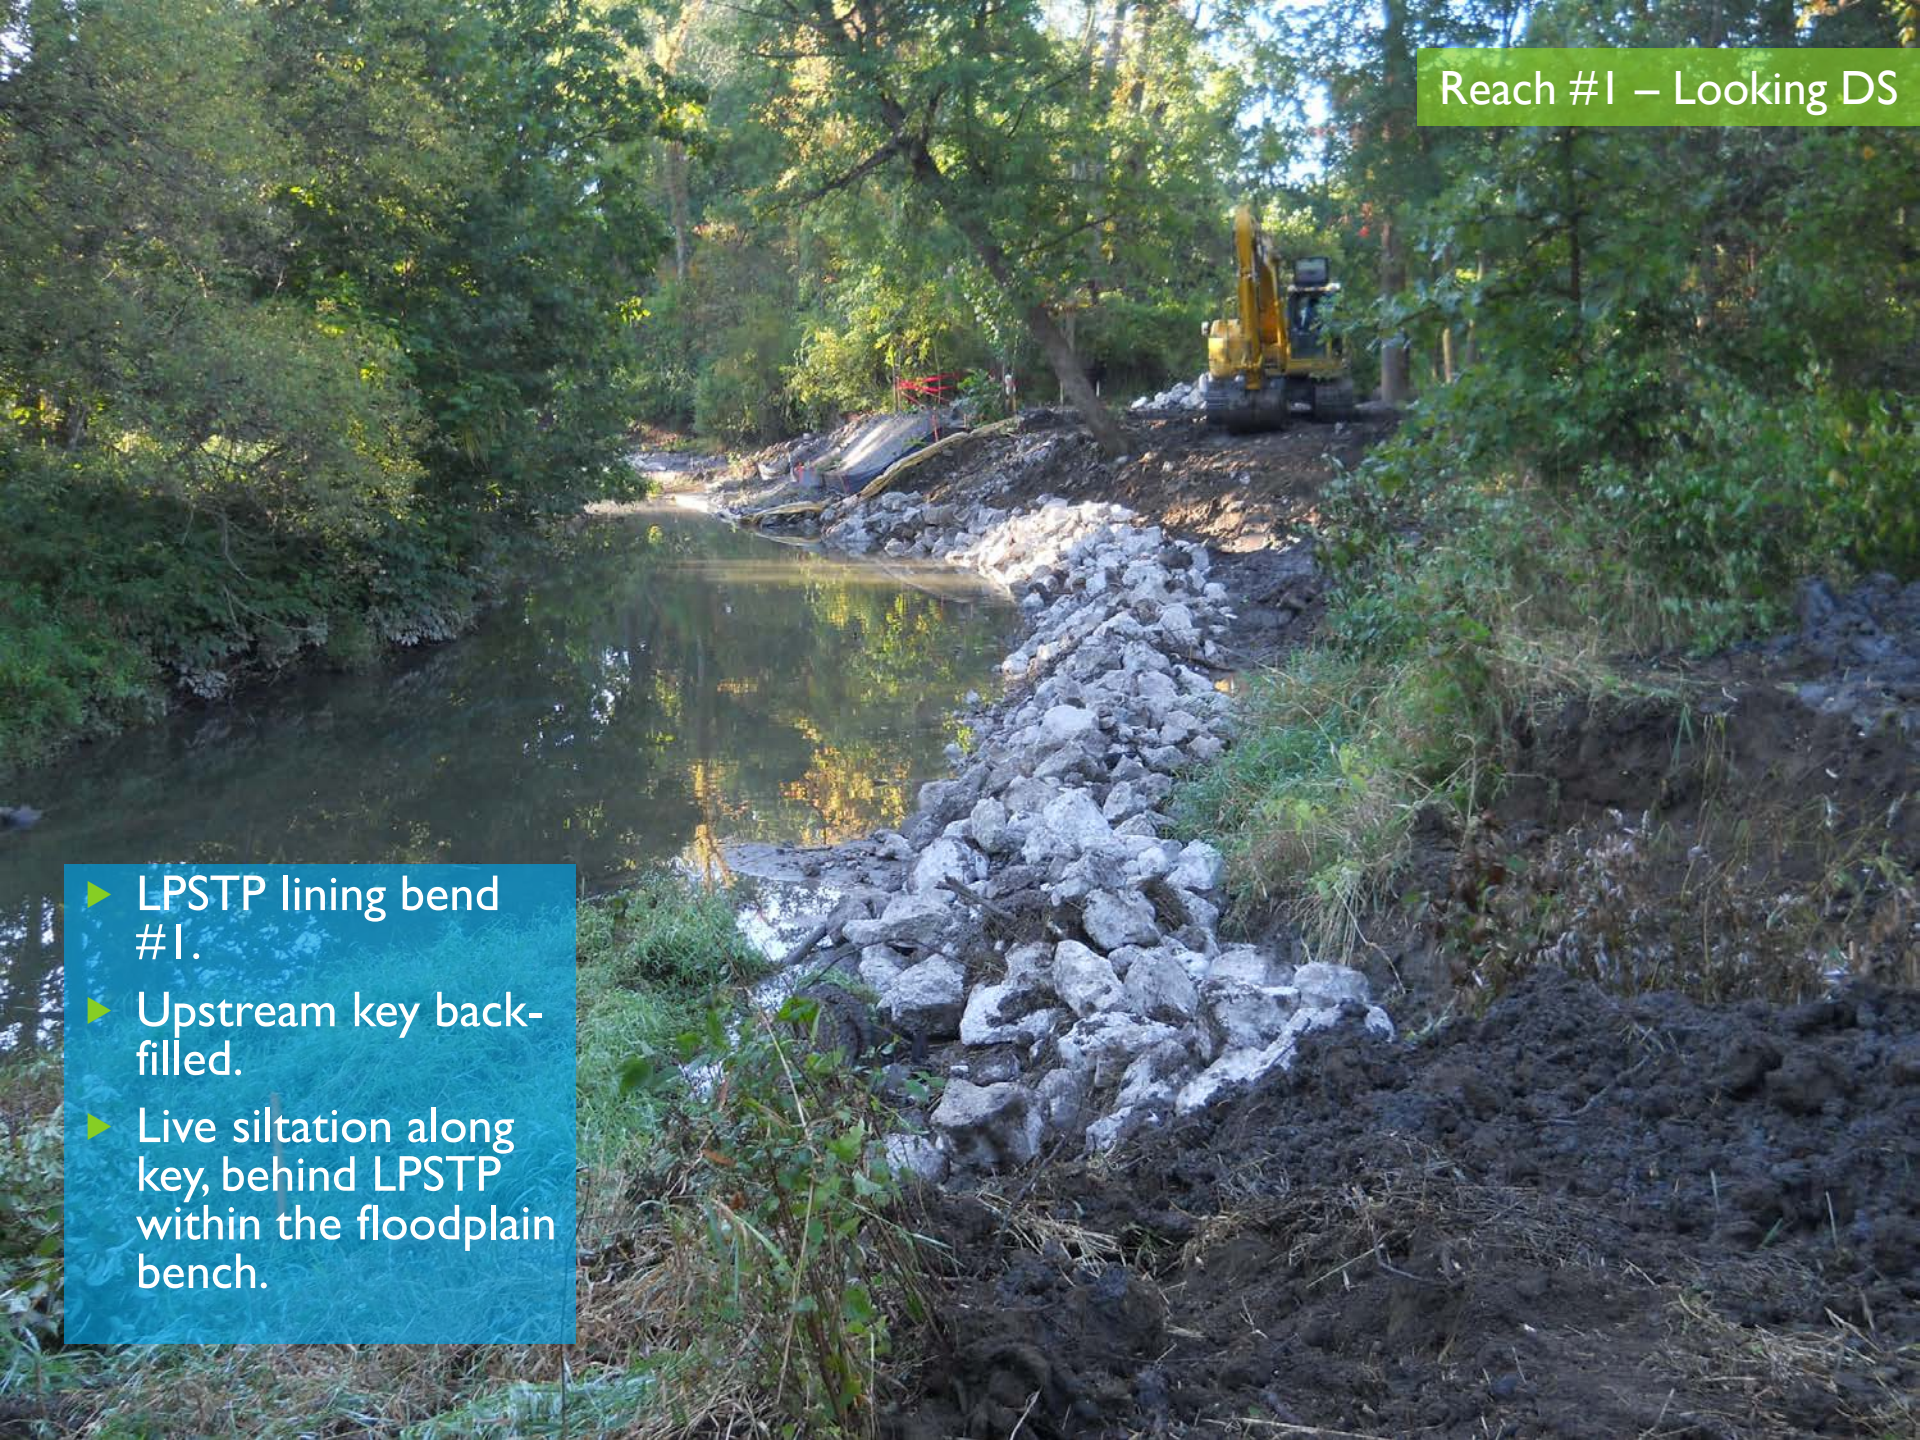
**Sediment has deposited  
landward of the LPSTP**

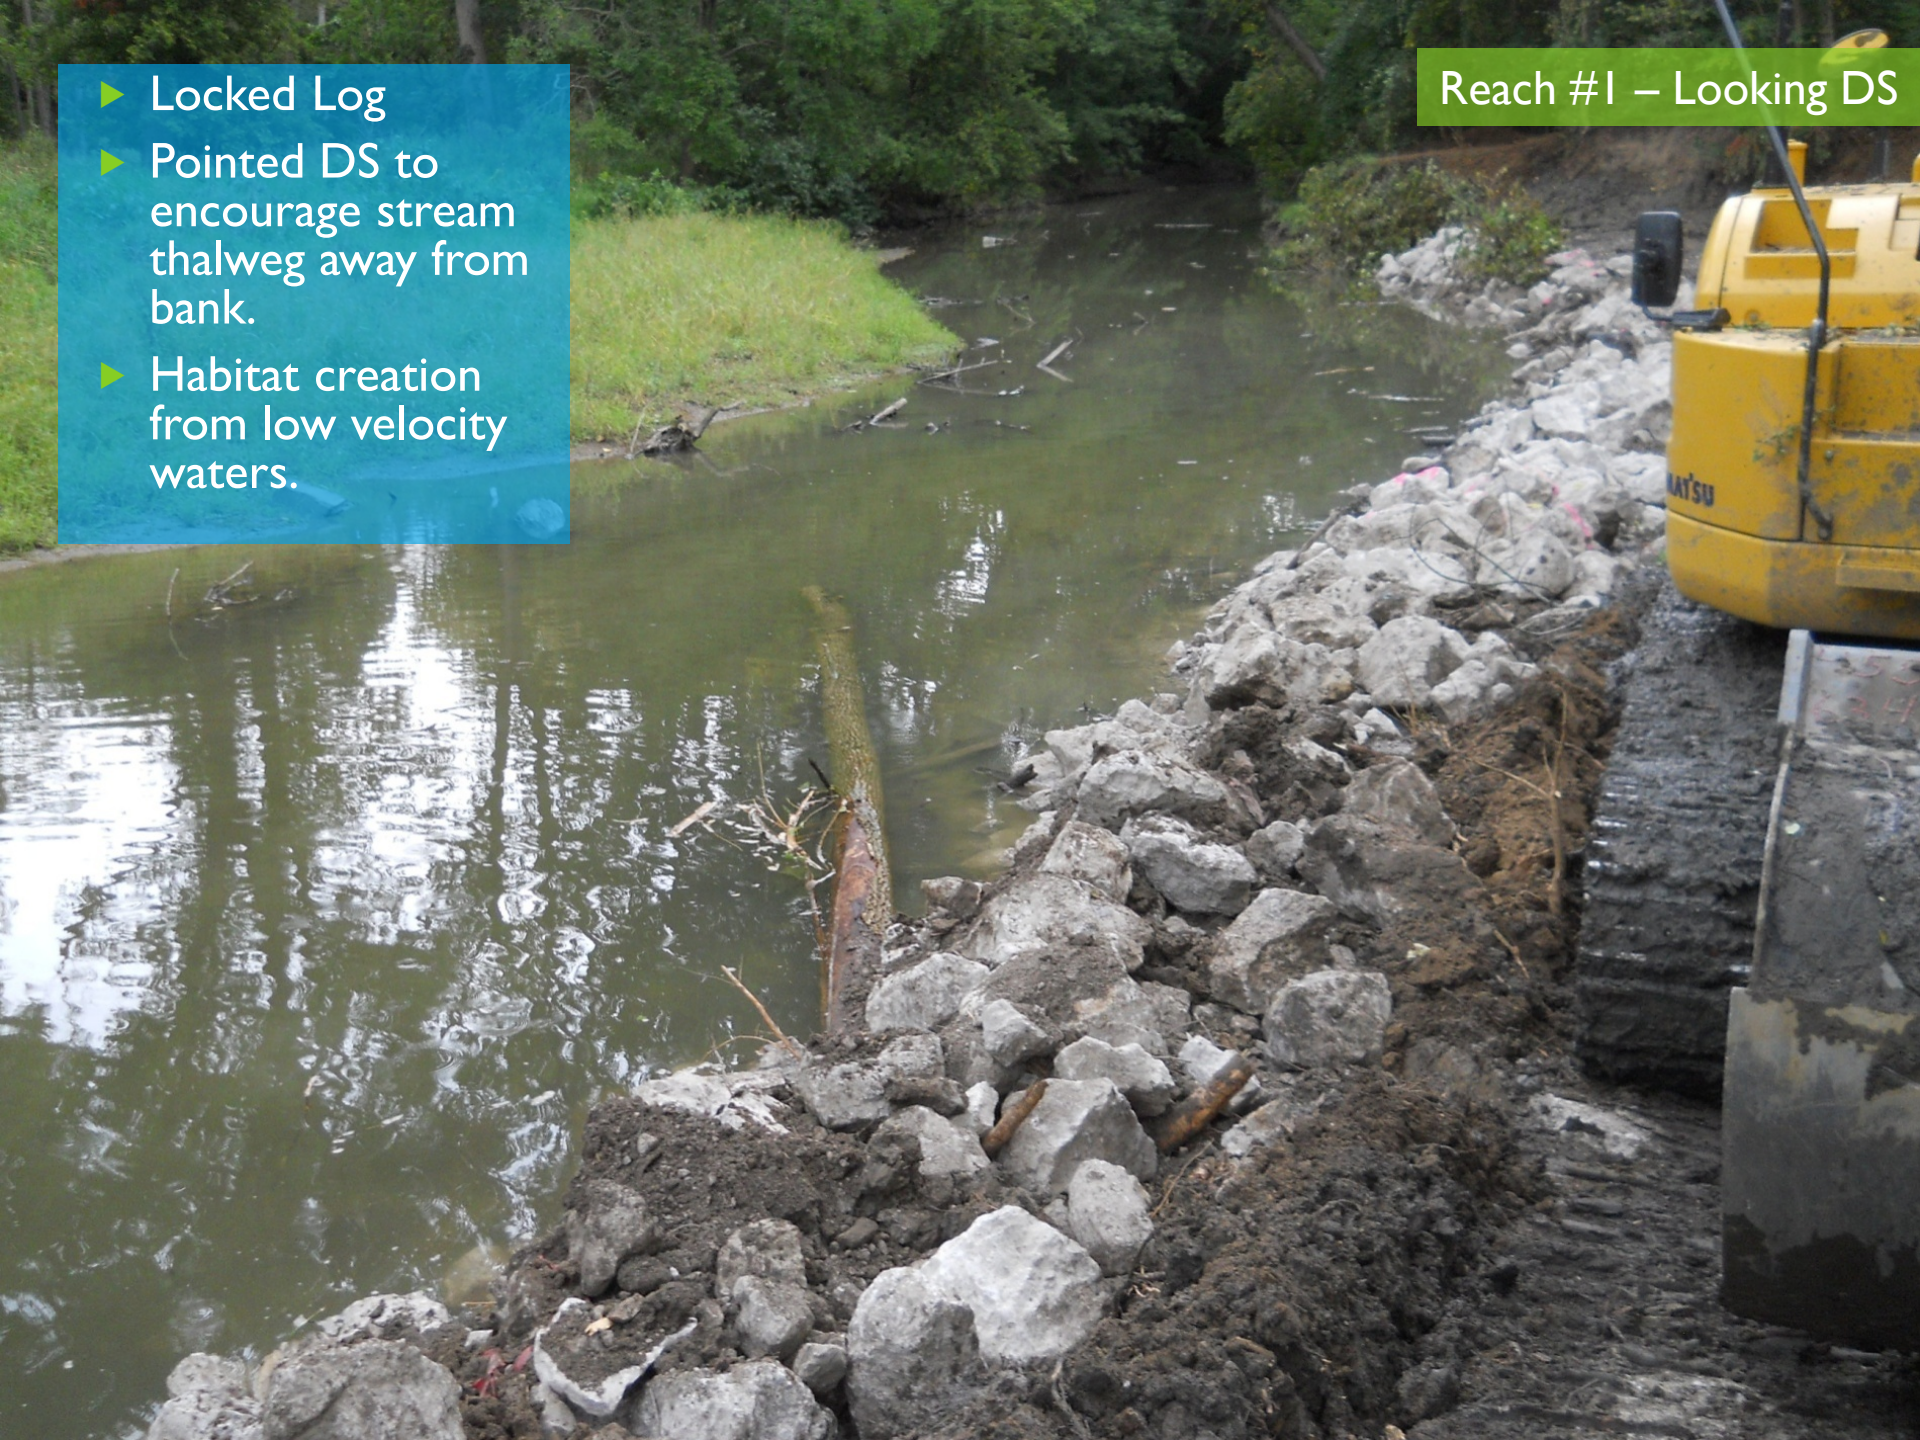
Reach #1 – Looking DS

- A photograph showing a river bend with a stone-lined bank. A yellow excavator is visible in the background on a dirt bank. The water is calm, reflecting the surrounding trees. The foreground shows a dark, muddy area with some vegetation.
- ▶ LPSTP lining bend #1.
  - ▶ Upstream key back-filled.
  - ▶ Live siltation along key, behind LPSTP within the floodplain bench.

- ▶ Locked Log
- ▶ Pointed DS to encourage stream thalweg away from bank.
- ▶ Habitat creation from low velocity waters.

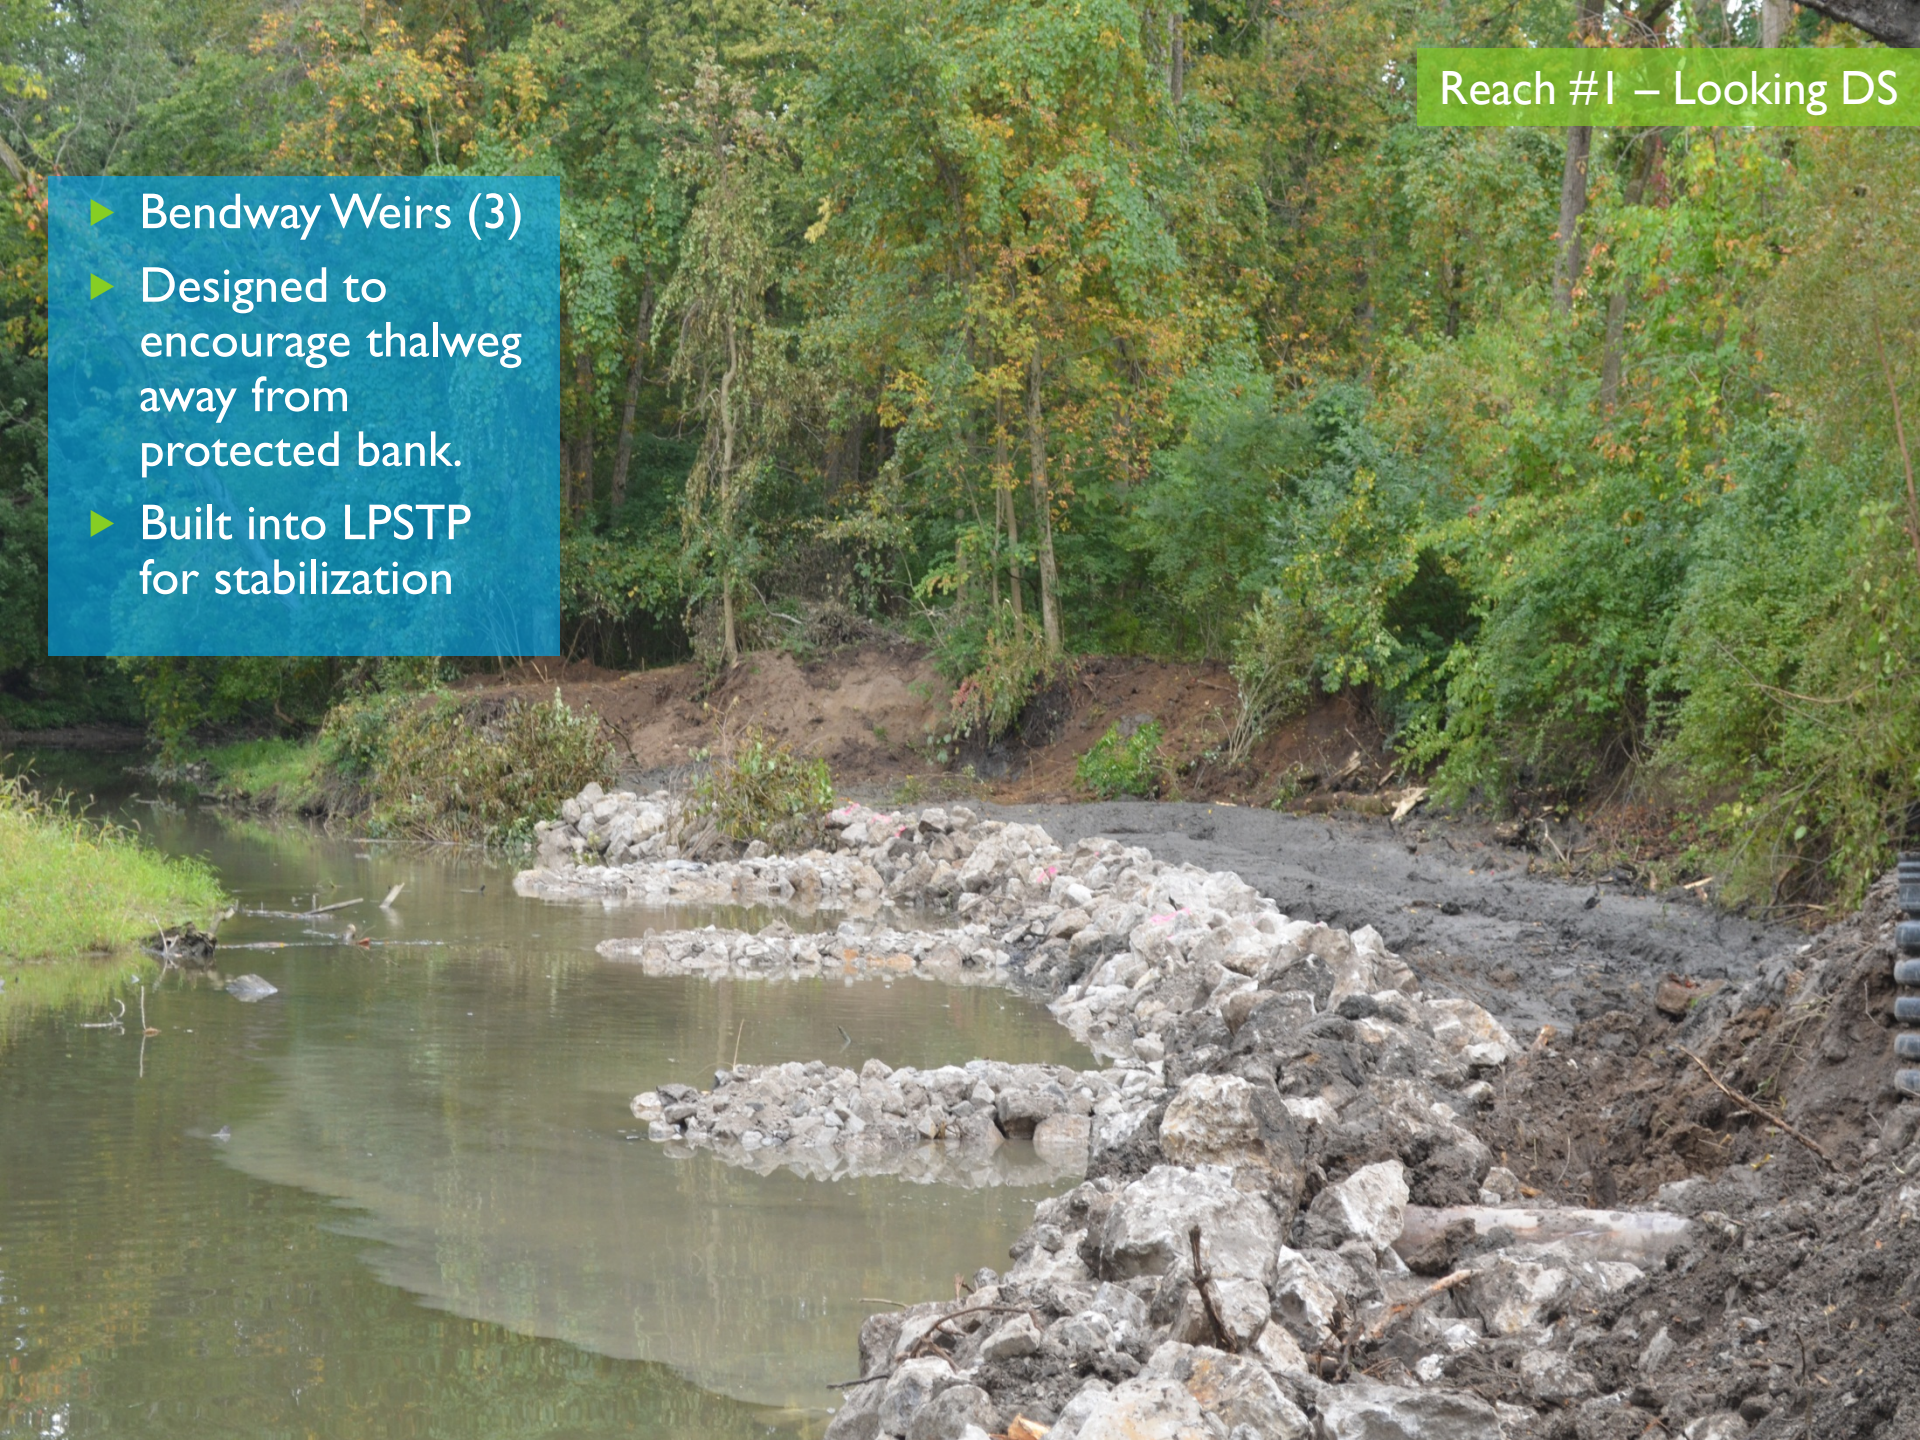
- ▶ Bendway Weirs (3)
- ▶ Designed to encourage thalweg away from protected bank.
- ▶ Built into LPSTP for stabilization

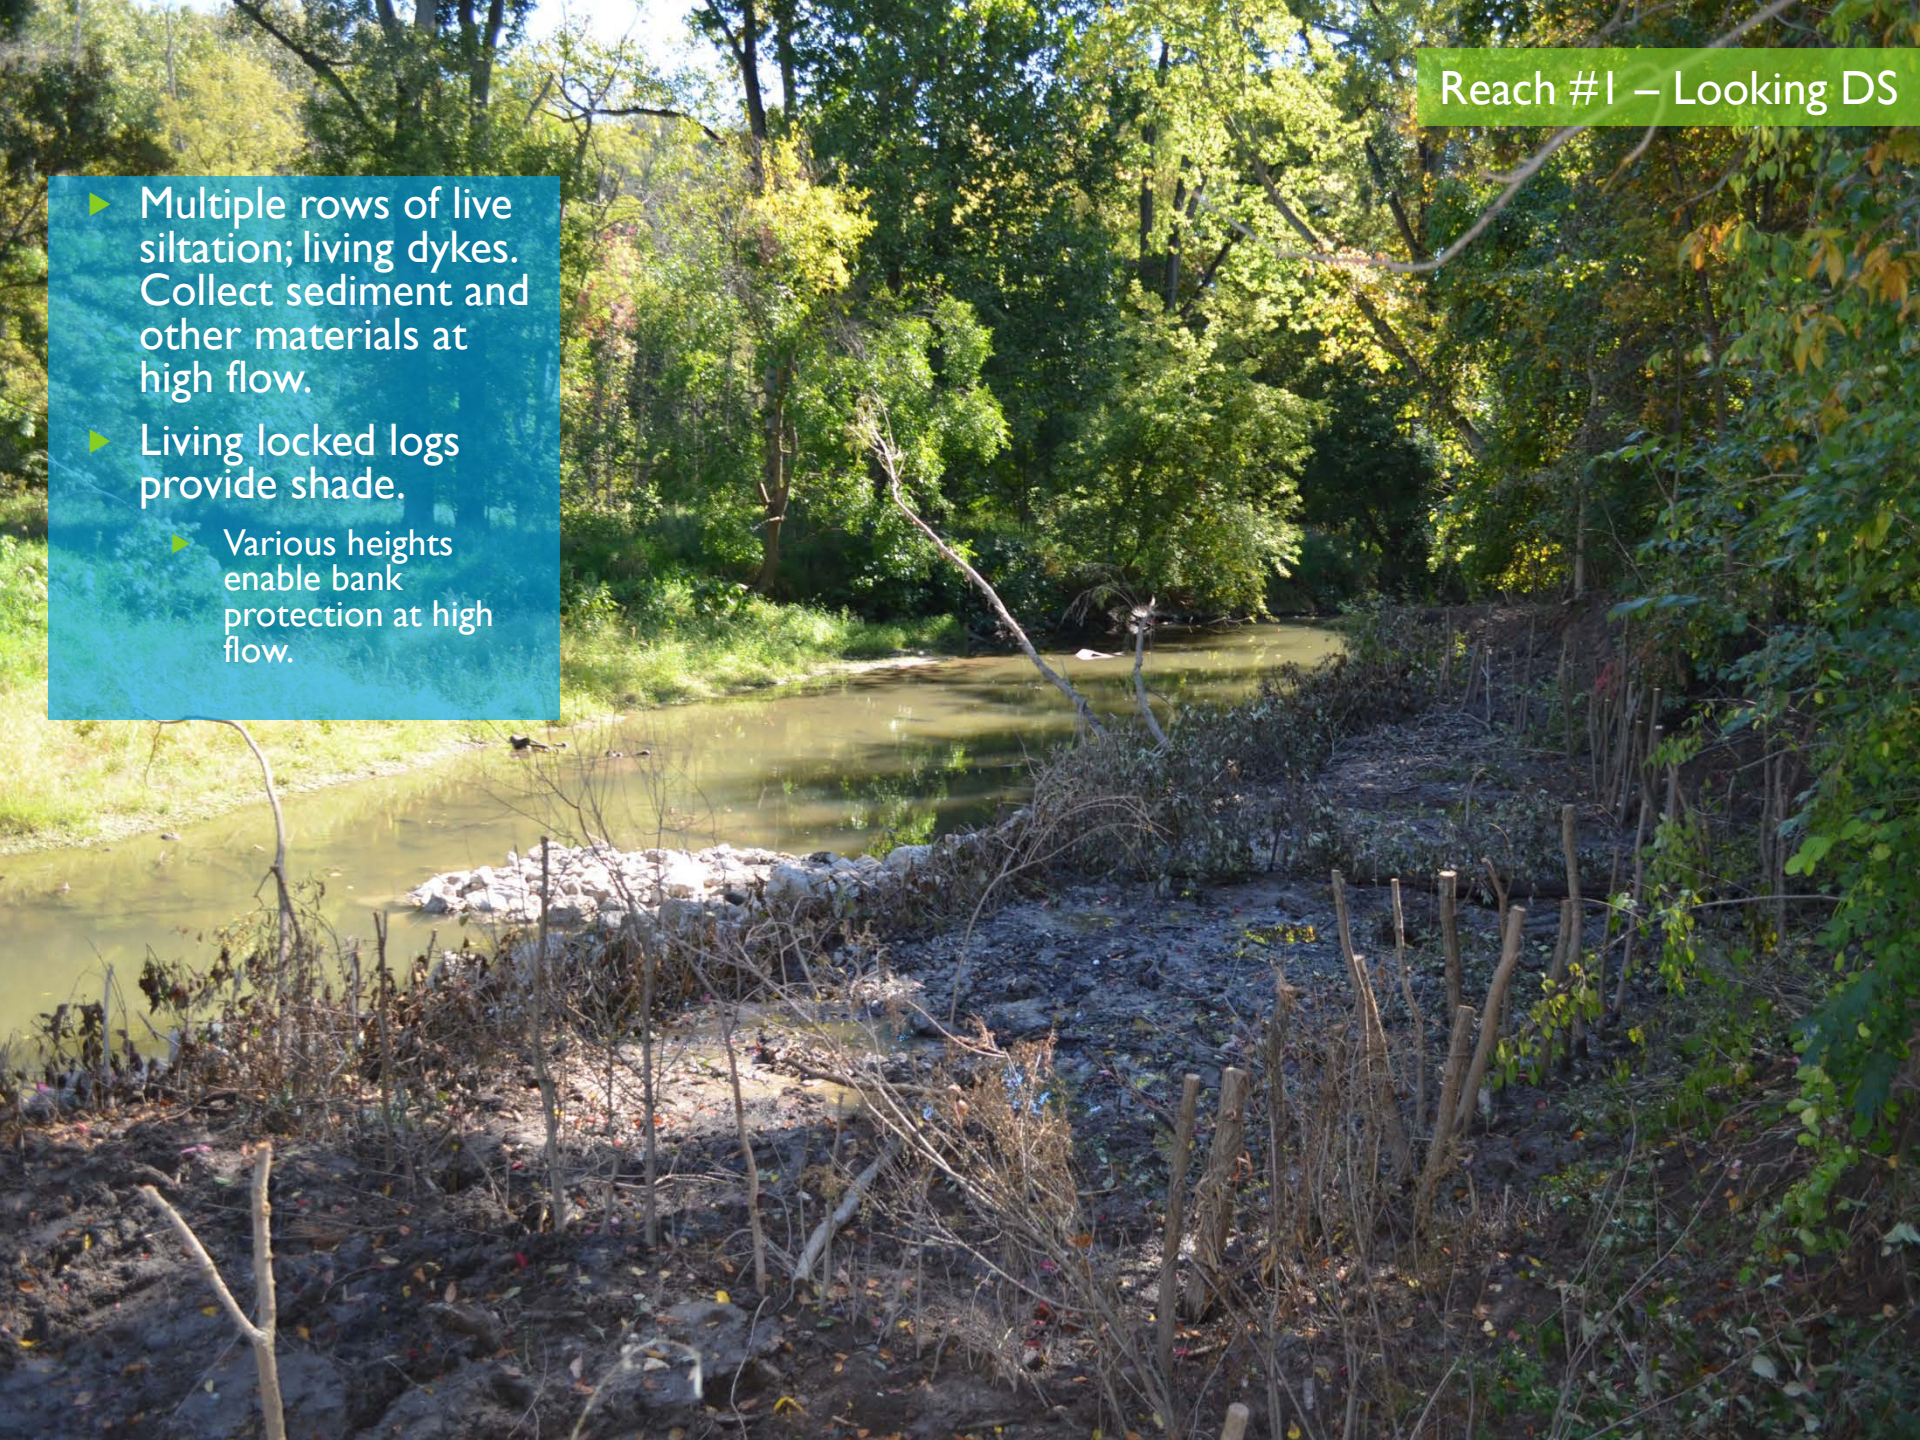
- ▶ Multiple rows of live siltation; living dykes. Collect sediment and other materials at high flow.
- ▶ Living locked logs provide shade.
  - ▶ Various heights enable bank protection at high flow.

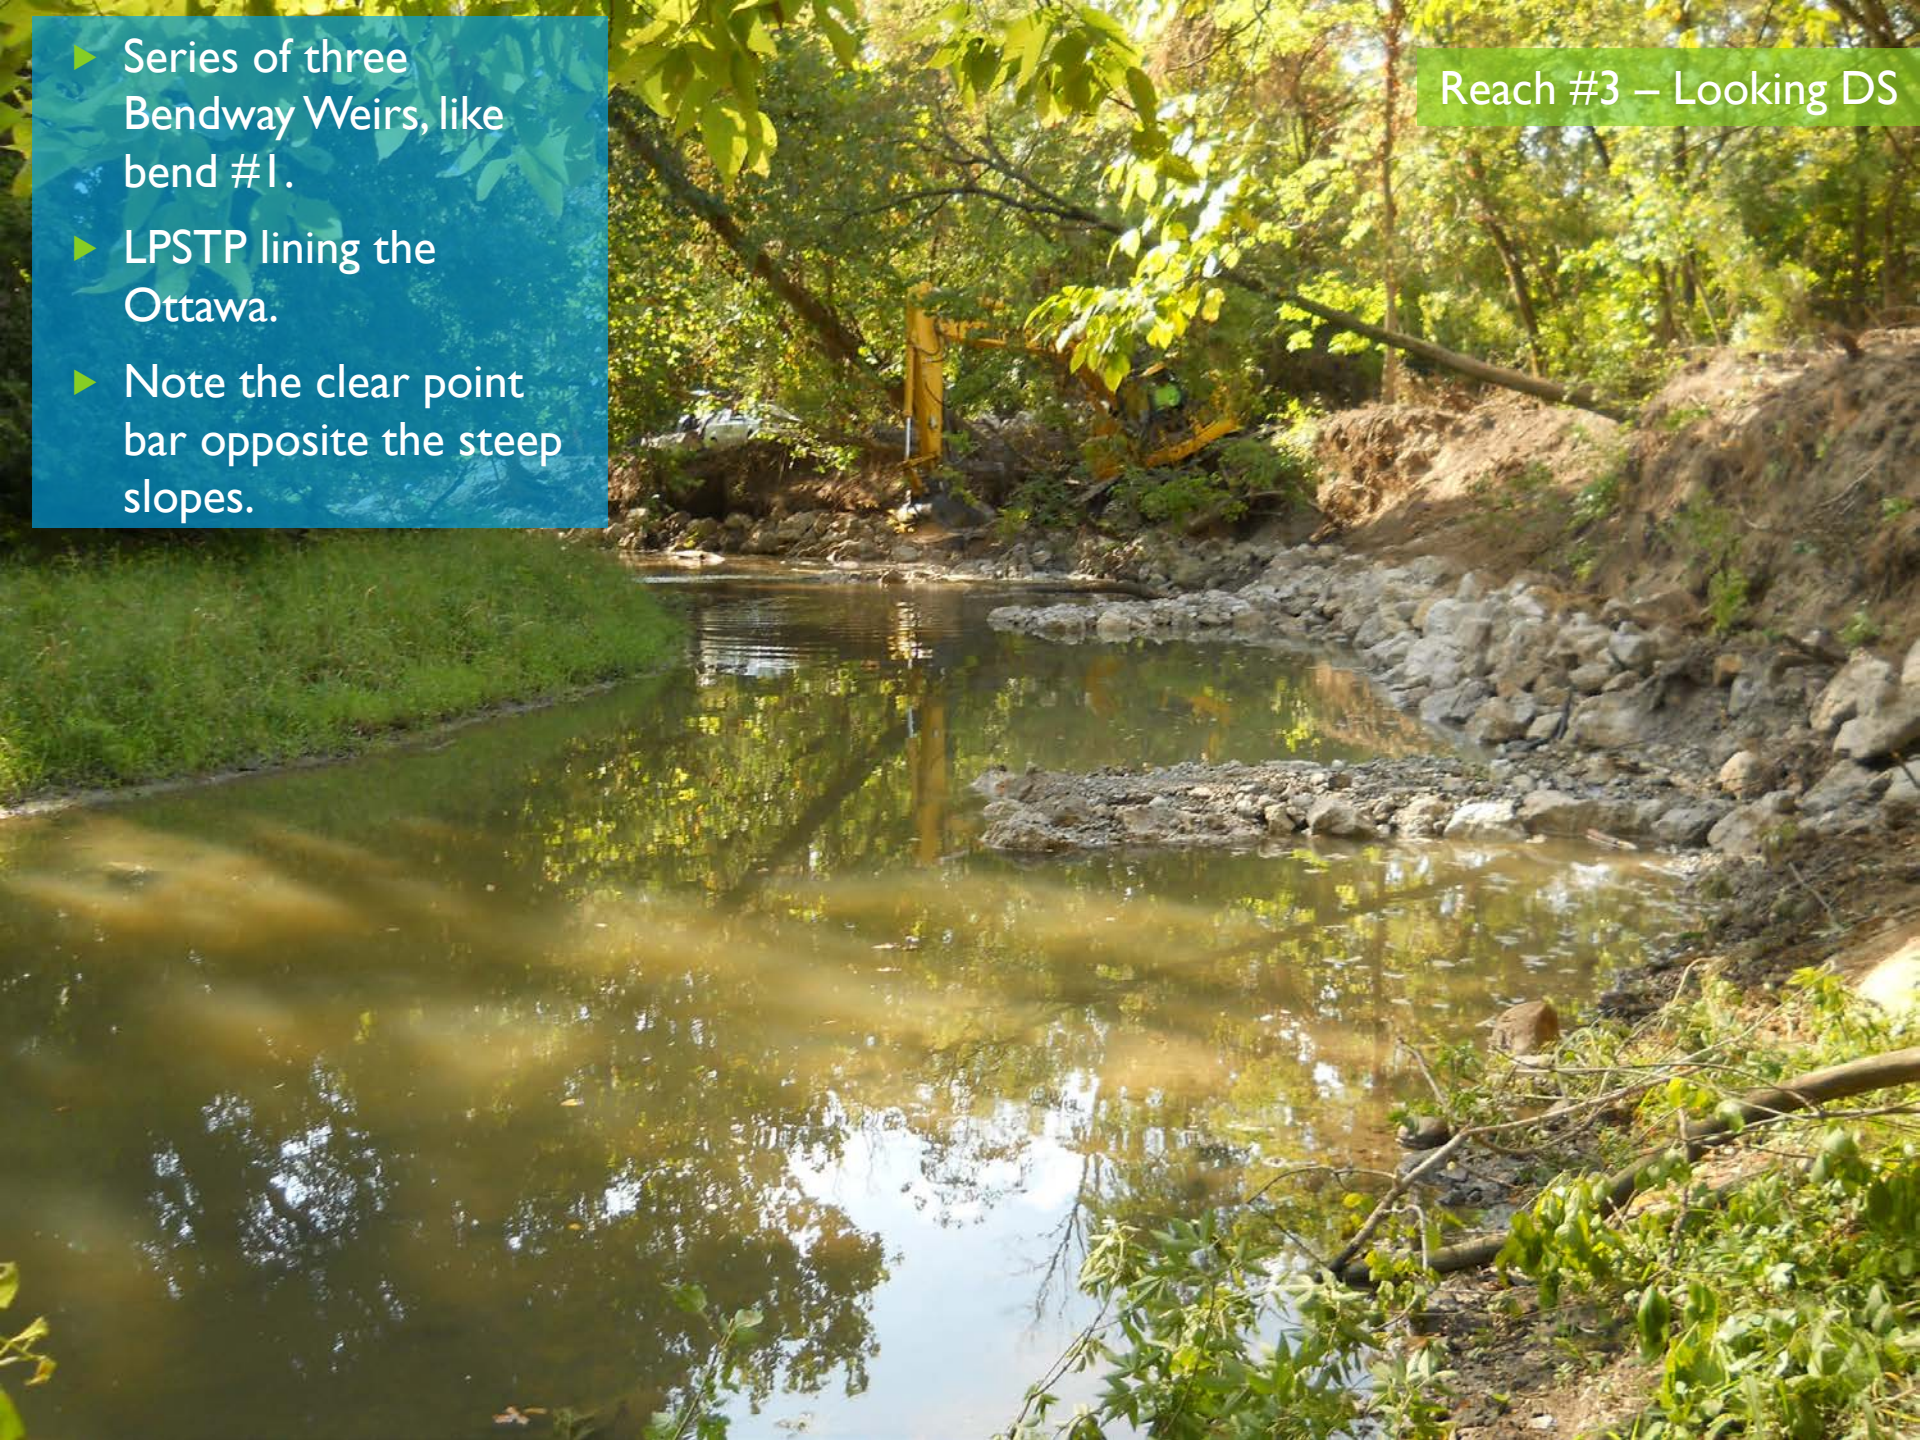
Reach #3 – Looking DS

- ▶ Series of three Bendway Weirs, like bend #1.
- ▶ LPSTP lining the Ottawa.
- ▶ Note the clear point bar opposite the steep slopes.

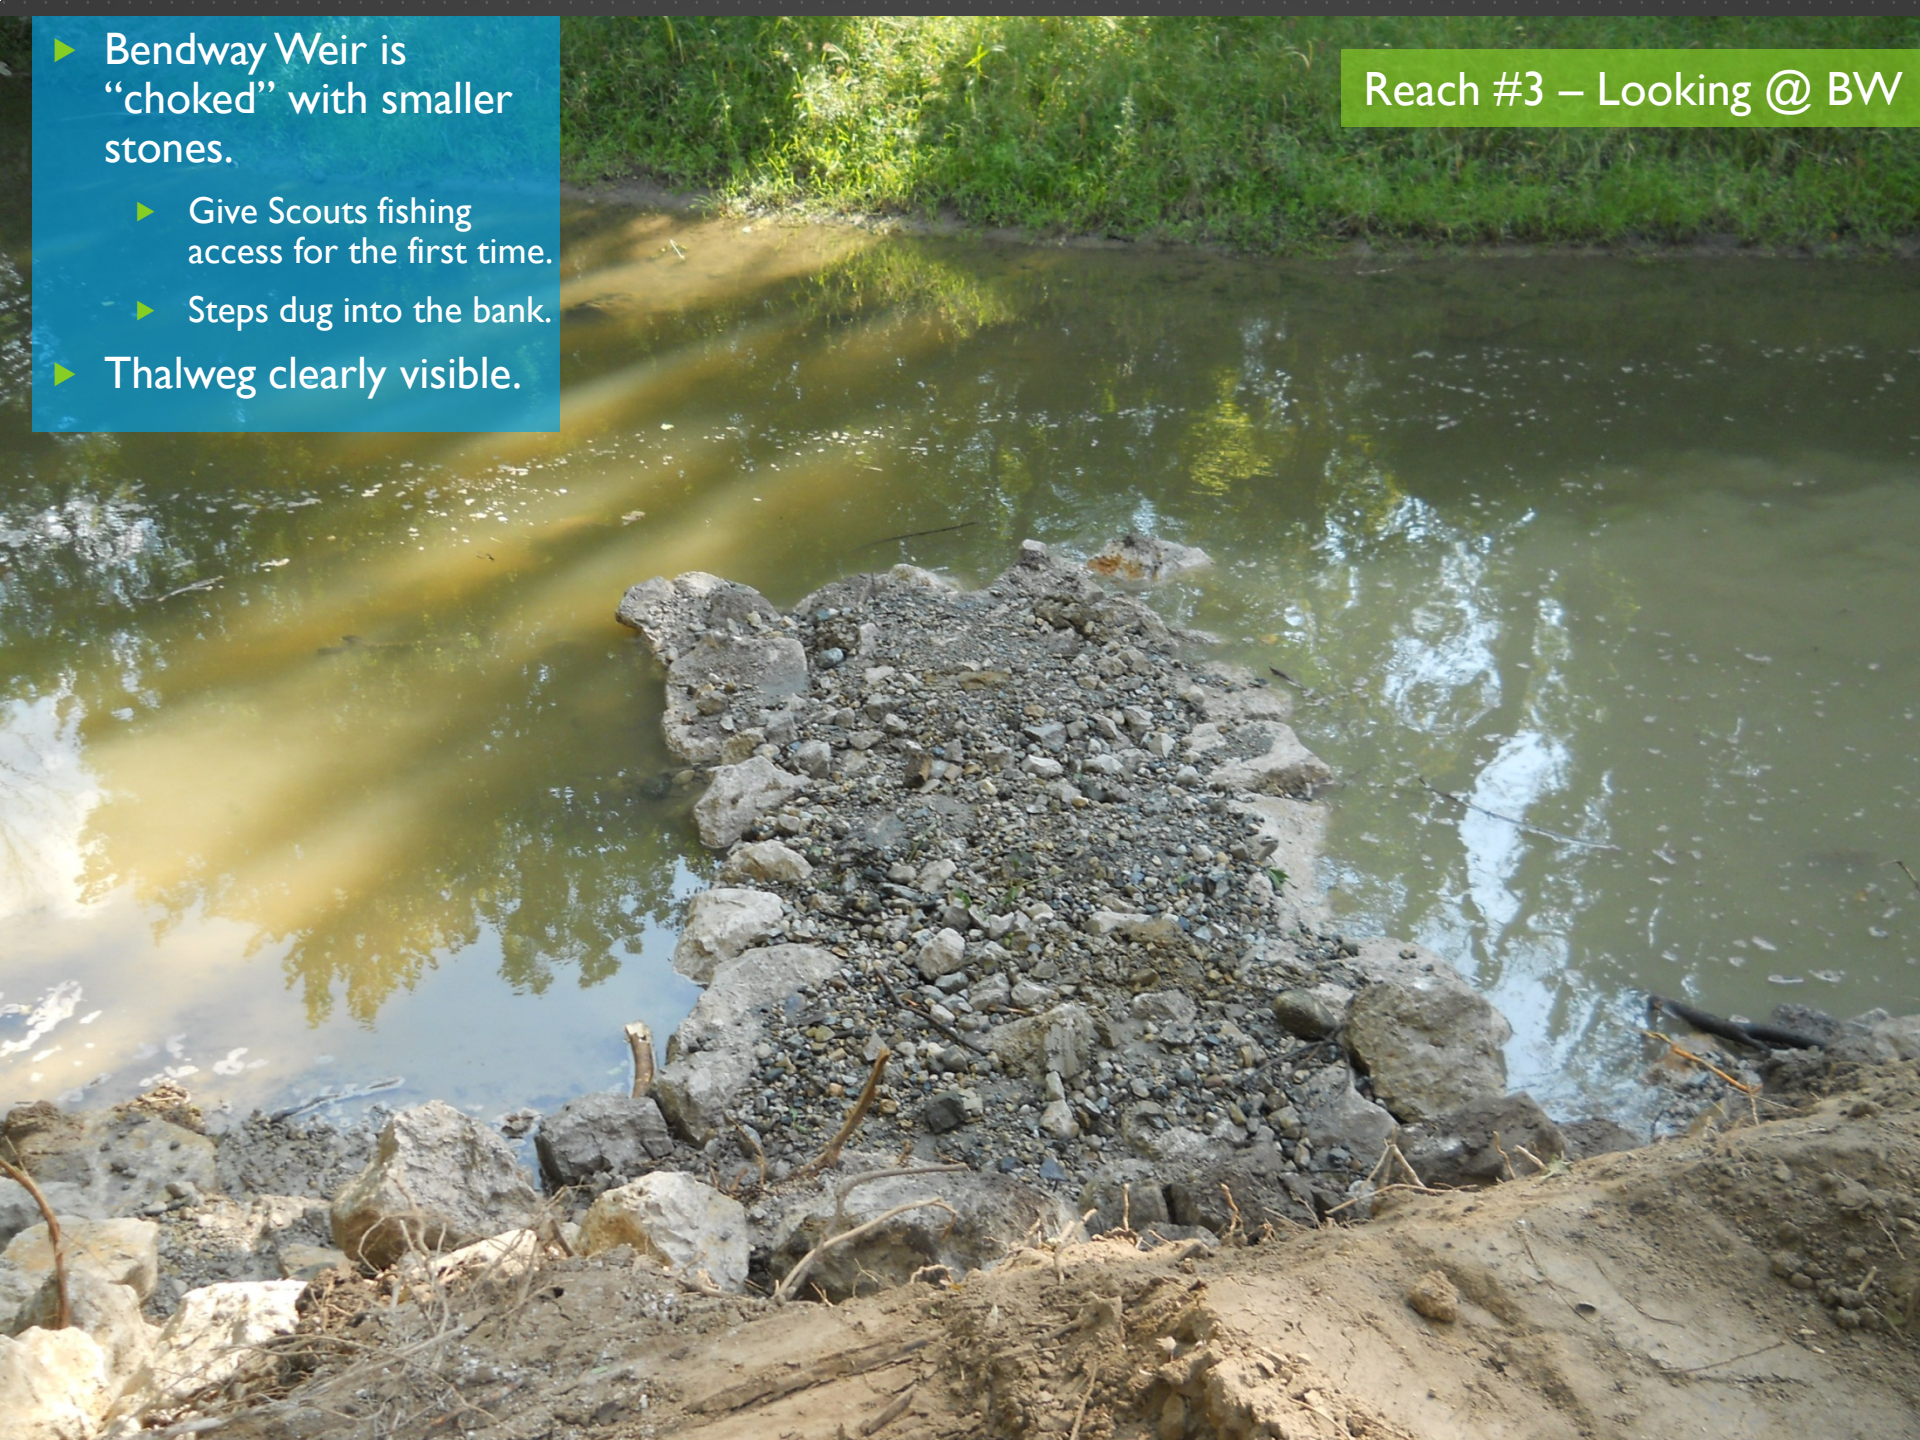
Reach #3 – Looking @ BW

► Bendway Weir is “choked” with smaller stones.

- Give Scouts fishing access for the first time.
- Steps dug into the bank.

► Thalweg clearly visible.
