# CAMP MIAKONDA RESTORATION PROJECT

Partners for Clean Streams

# CAMP MIAKONDA & OTTAWA RIVER RESTORATION

OTTAWA RIVER BEND #1 – CAMP MIAKONDA

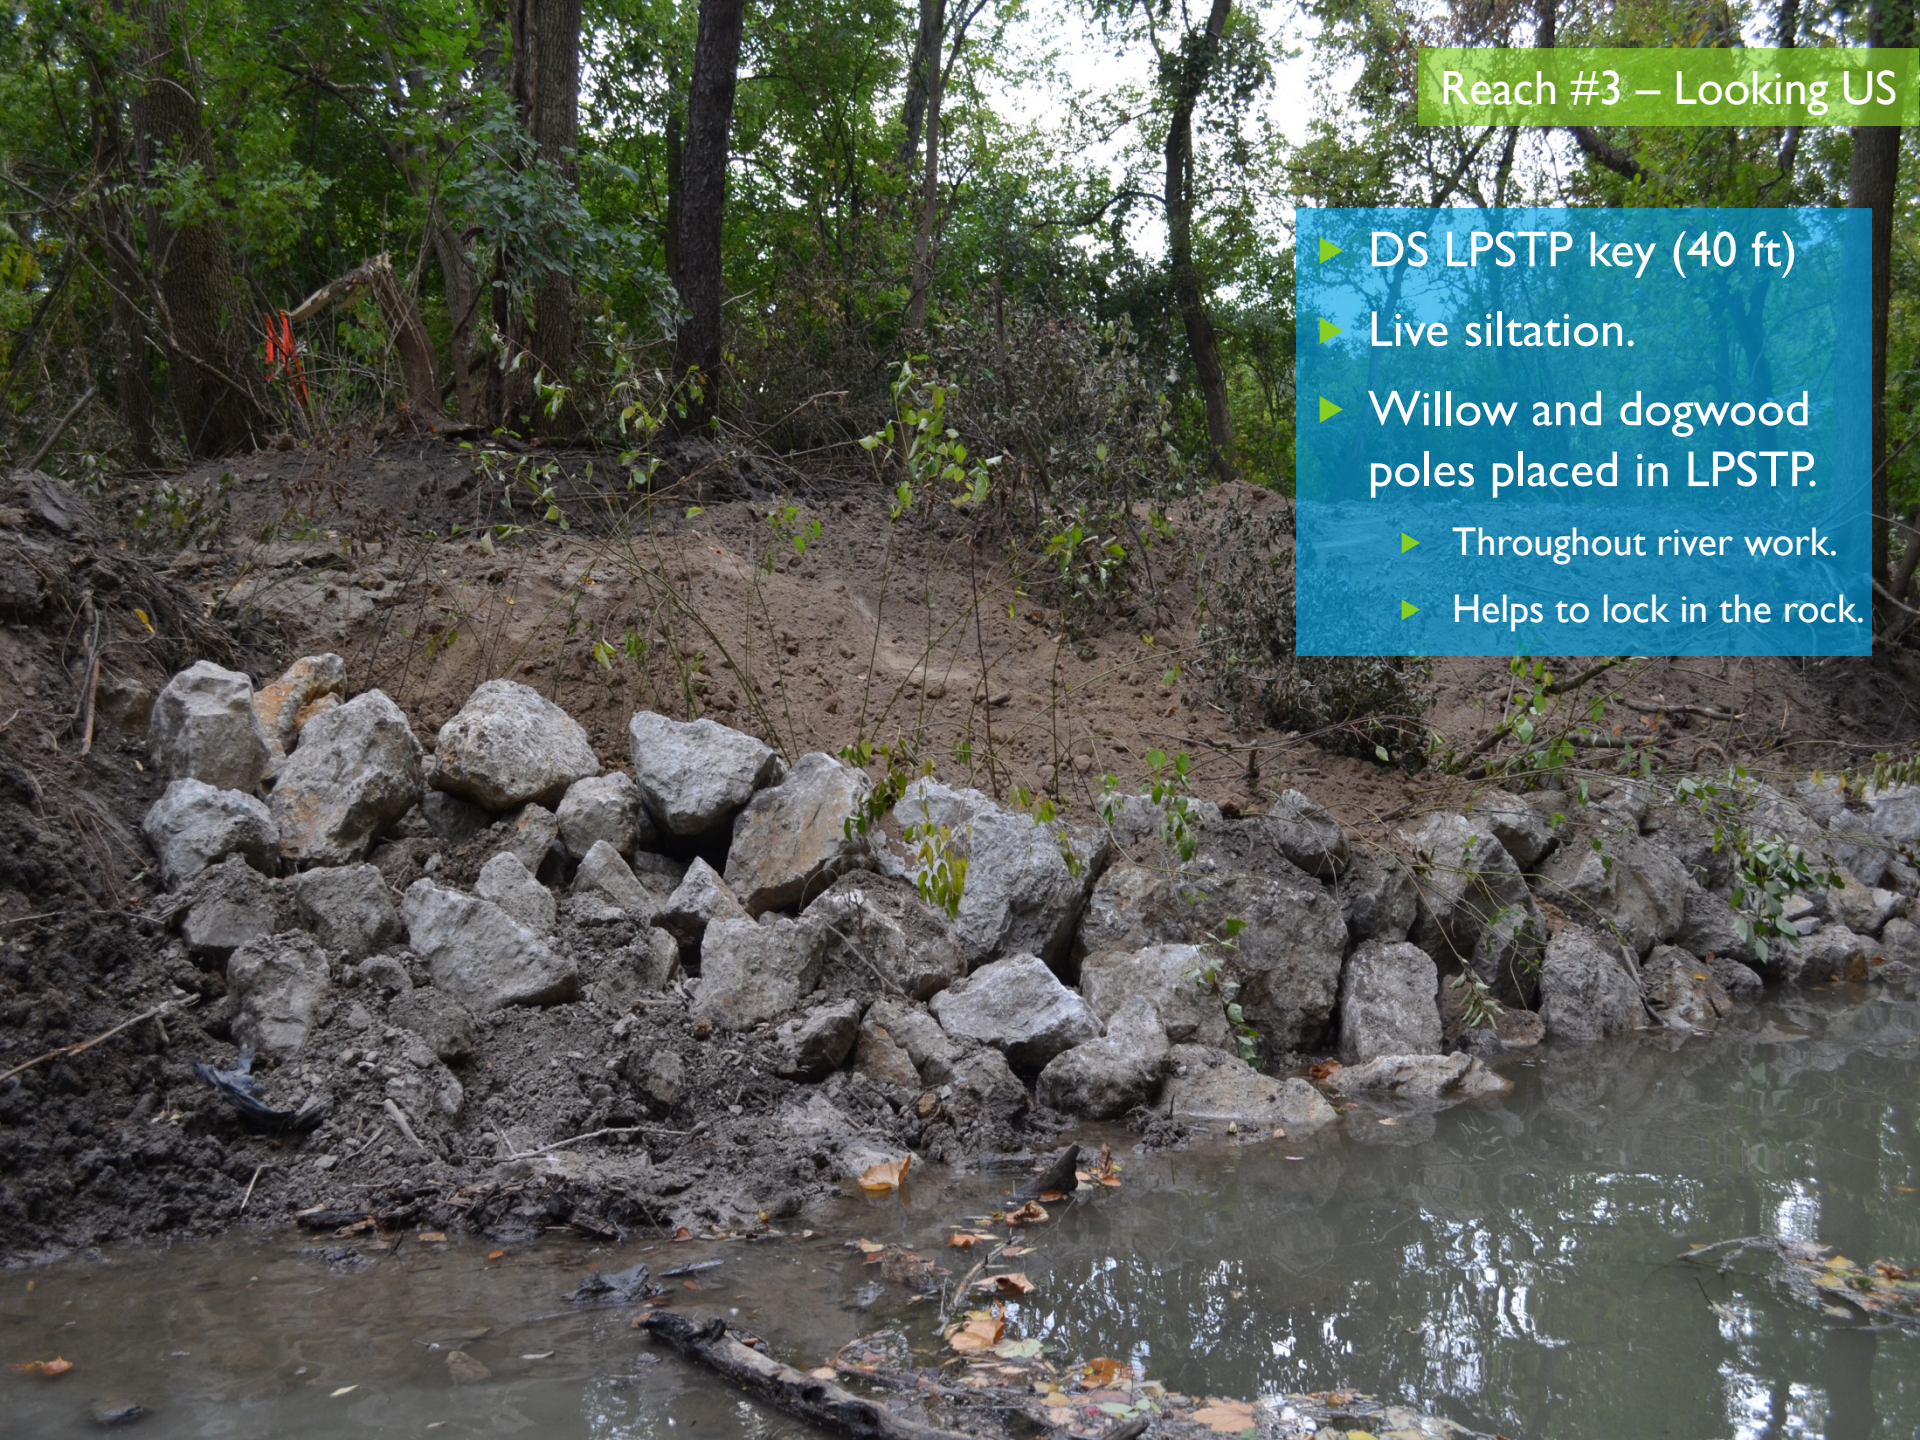
## Reach #3 – Looking US

- ▶ DS LPSTP key (40 ft)
- ▶ Live siltation.
- ▶ Willow and dogwood poles placed in LPSTP.
  - ▶ Throughout river work.
  - ▶ Helps to lock in the rock.

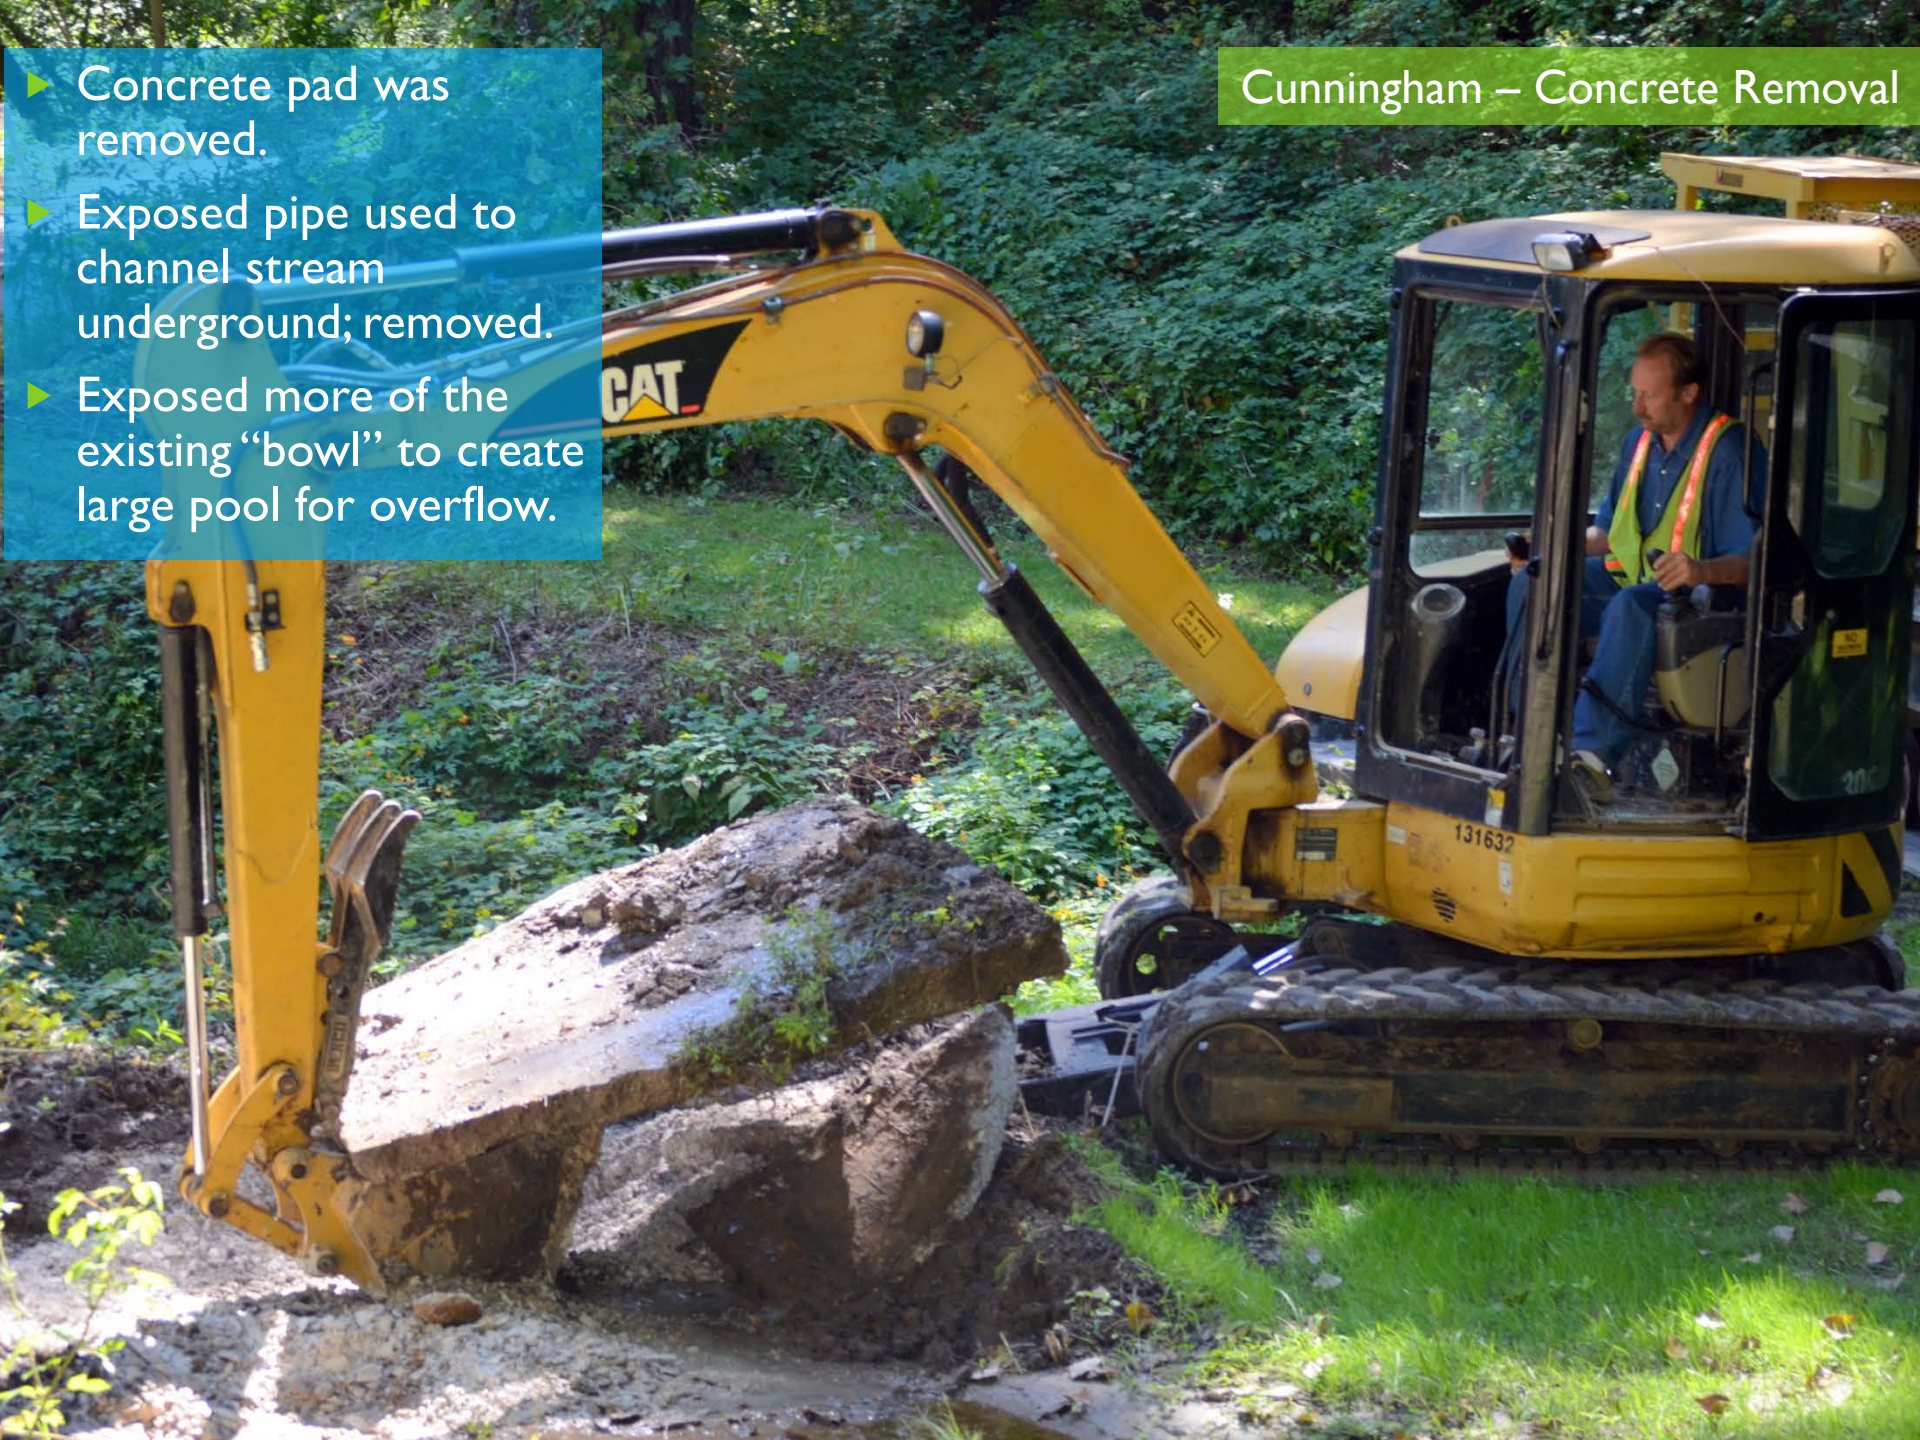
Cunningham – Looking US

- ▶ Concrete pad was removed.
- ▶ Exposed pipe used to channel stream underground; removed.
- ▶ Exposed more of the existing “bowl” to create large pool for overflow.

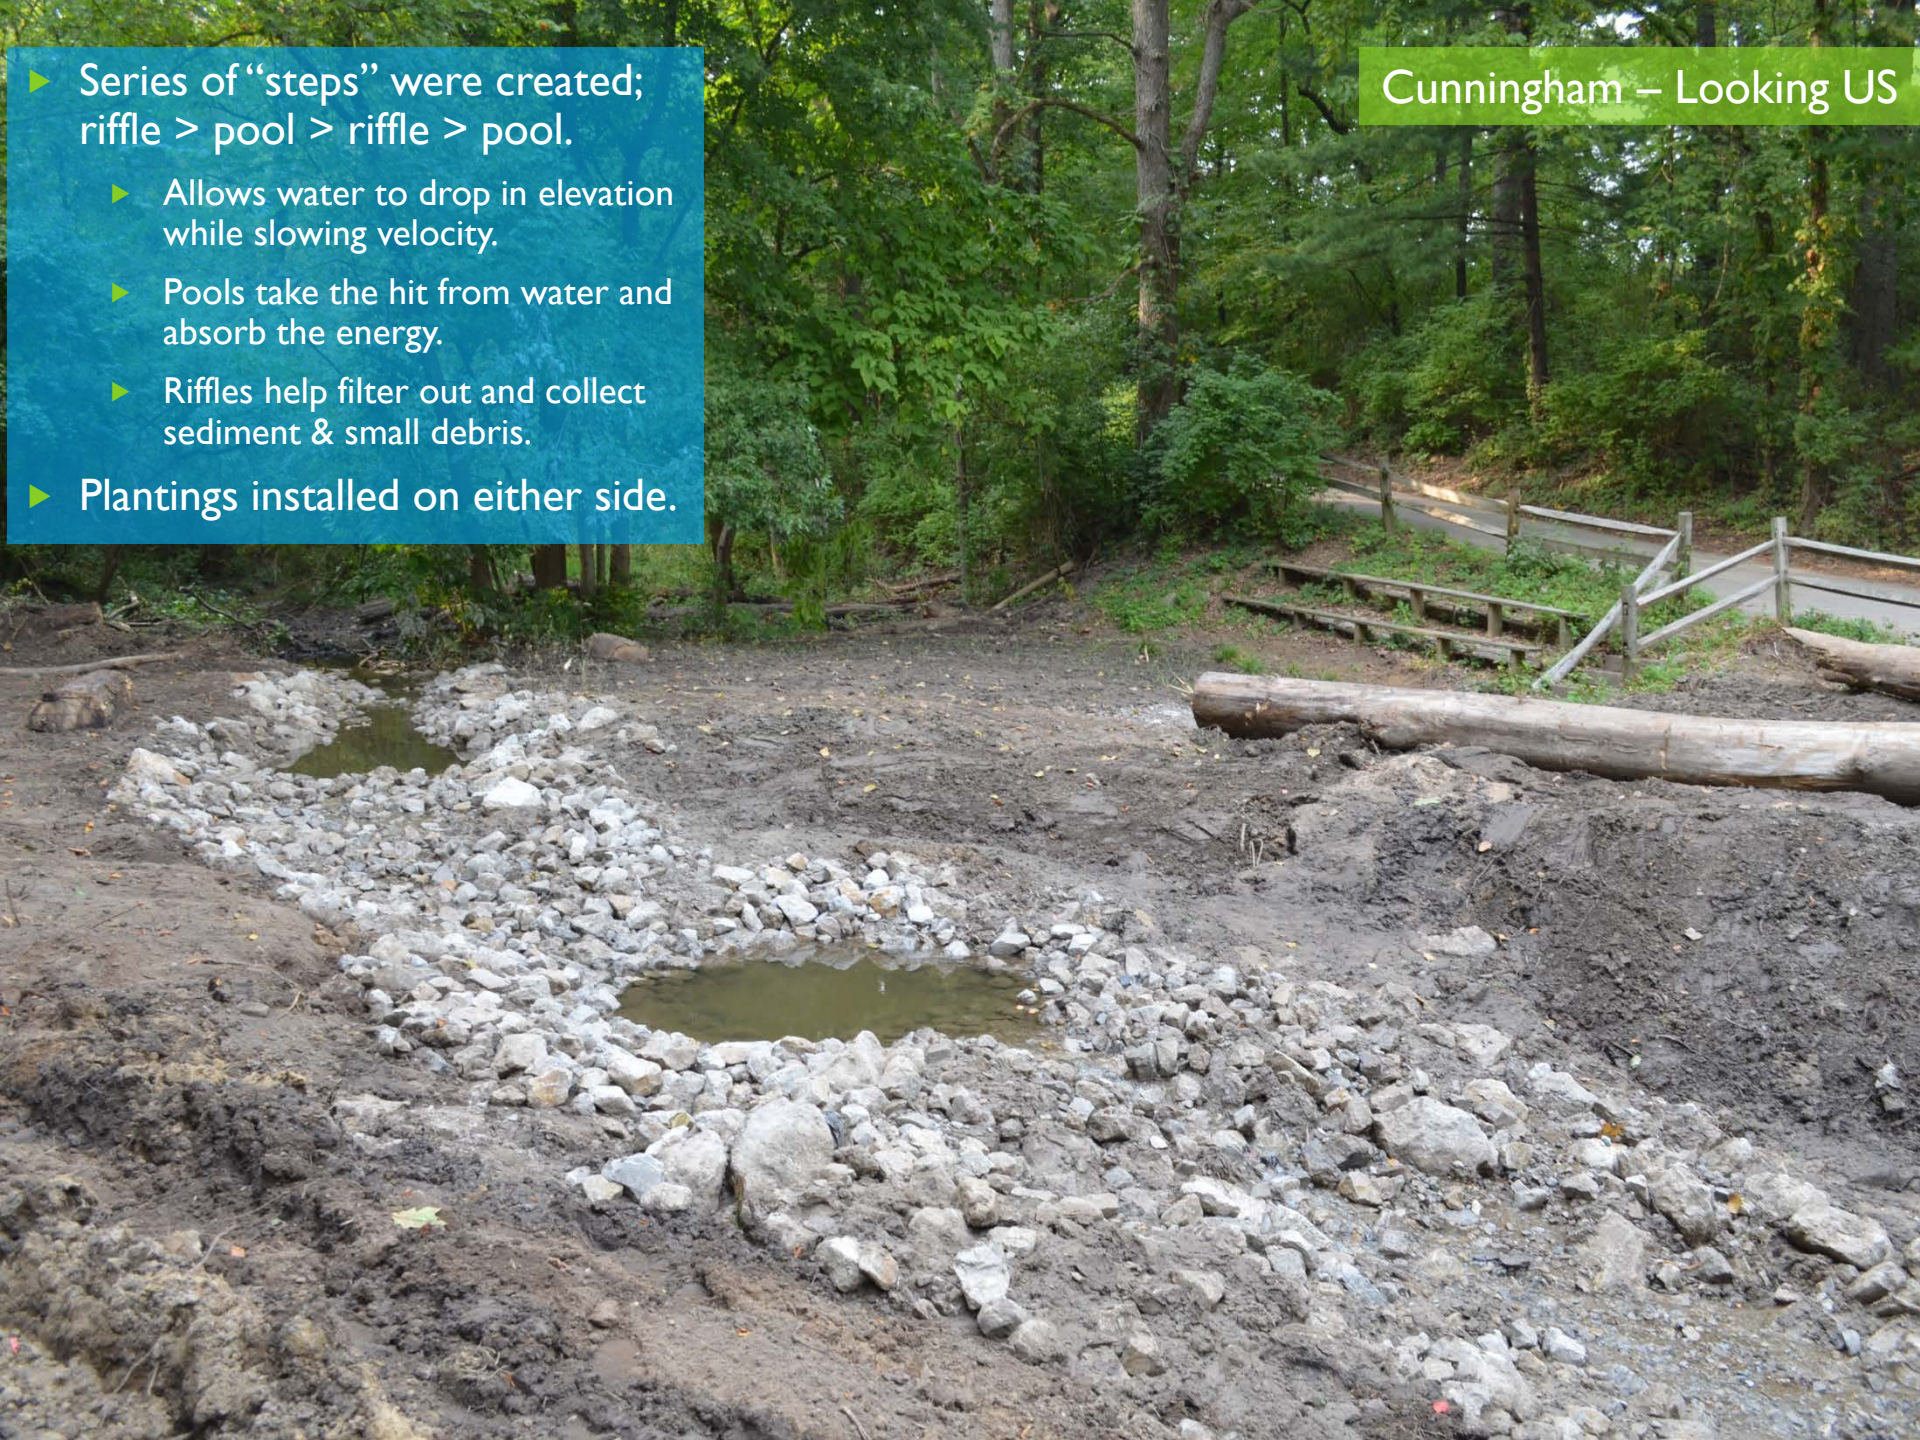
- ▶ Series of “steps” were created; riffle > pool > riffle > pool.
  - ▶ Allows water to drop in elevation while slowing velocity.
  - ▶ Pools take the hit from water and absorb the energy.
  - ▶ Riffles help filter out and collect sediment & small debris.
- ▶ Plantings installed on either side.

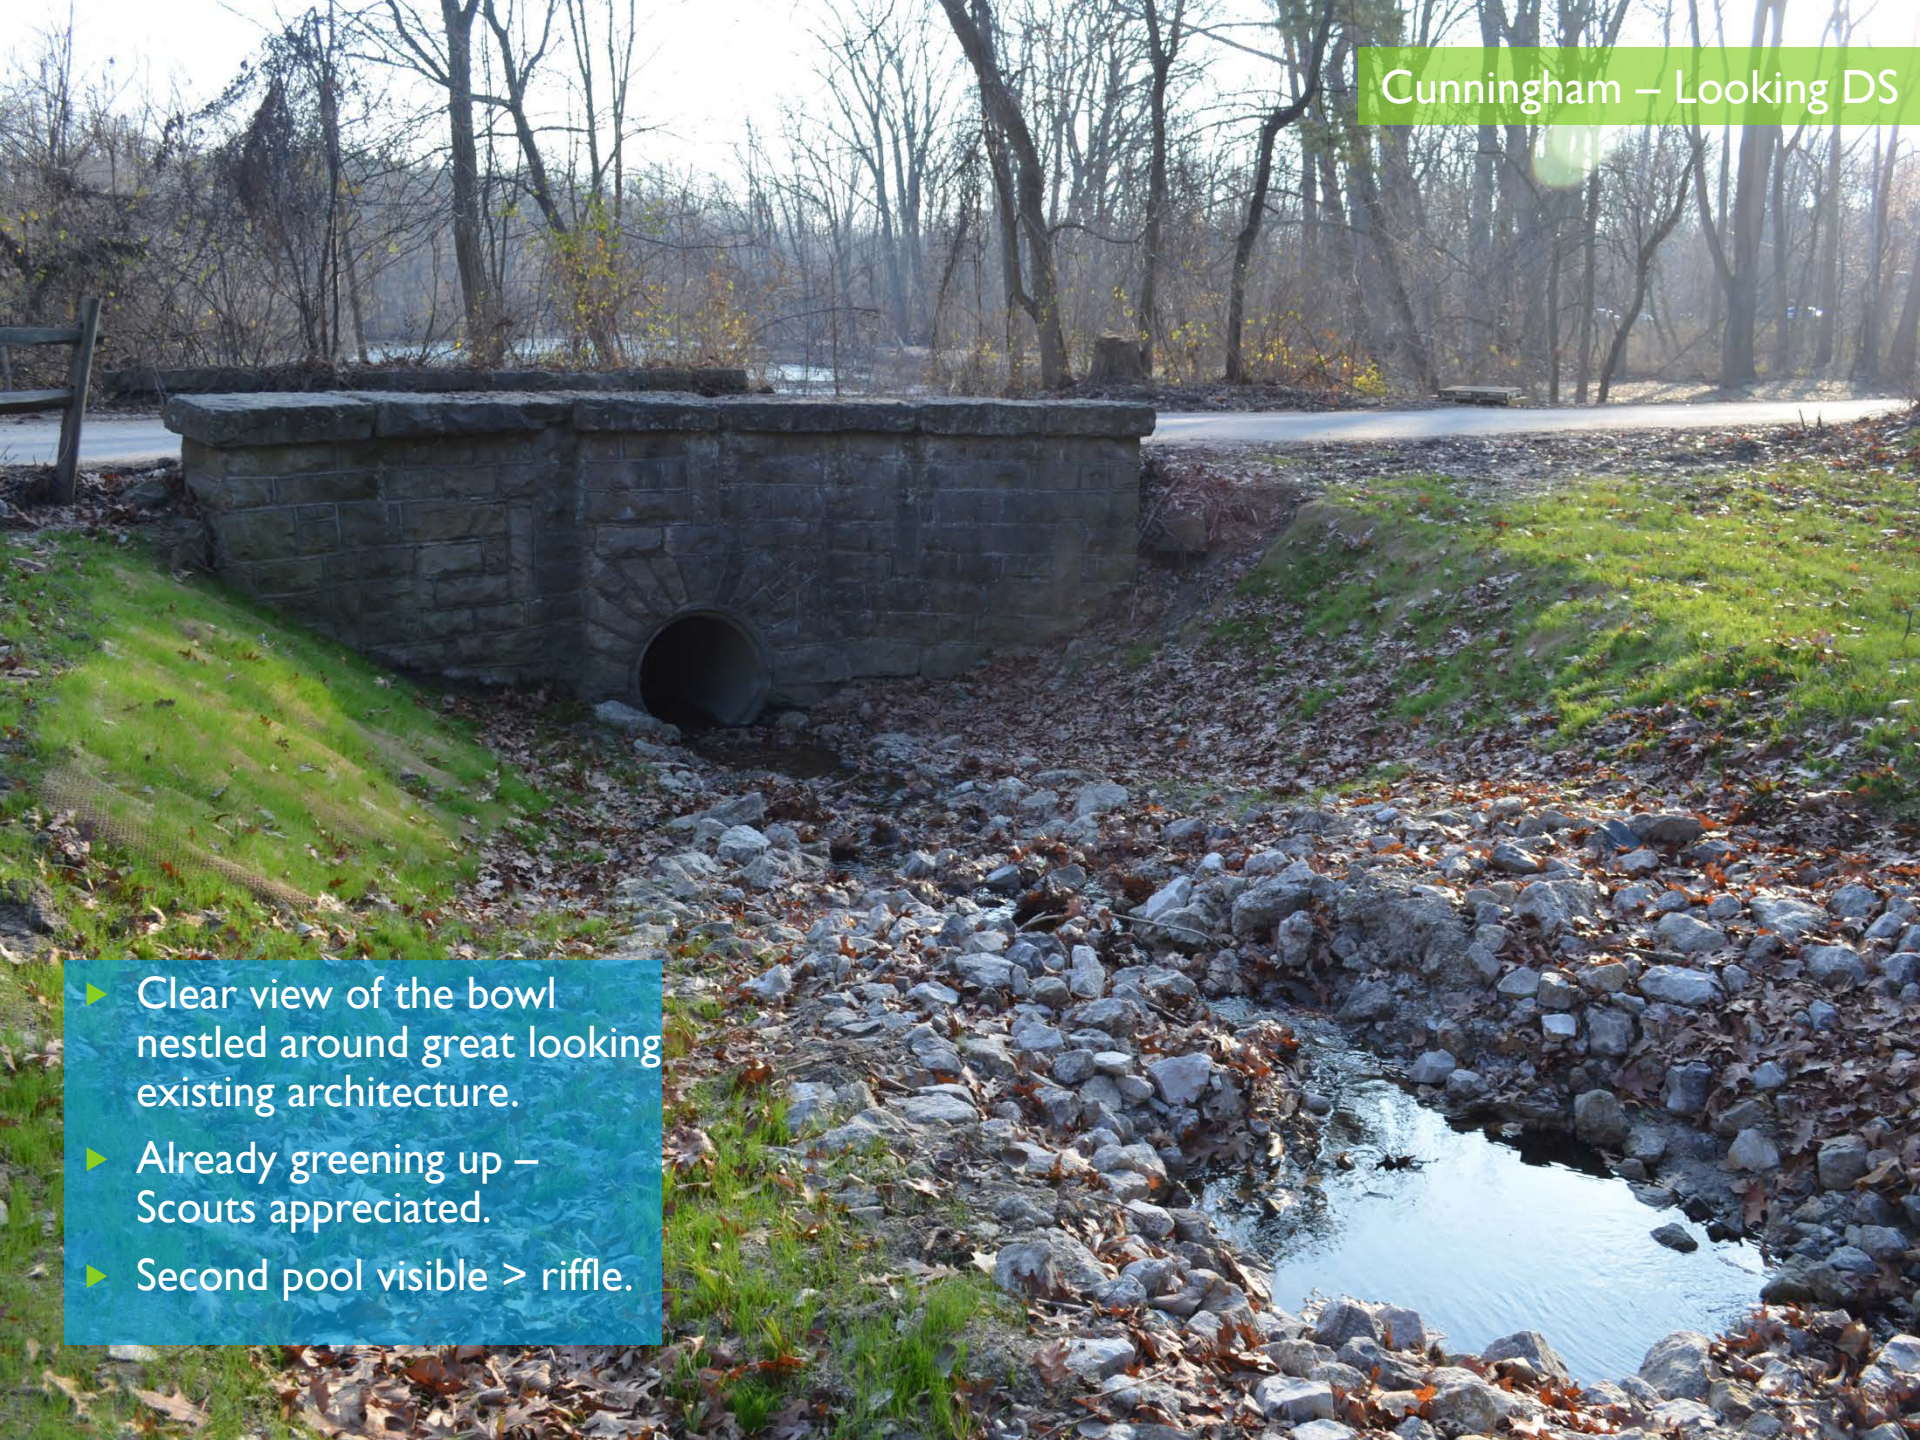
- ▶ Clear view of the bowl nestled around great looking existing architecture.
  - ▶ Already greening up – Scouts appreciated.
  - ▶ Second pool visible > riffle.

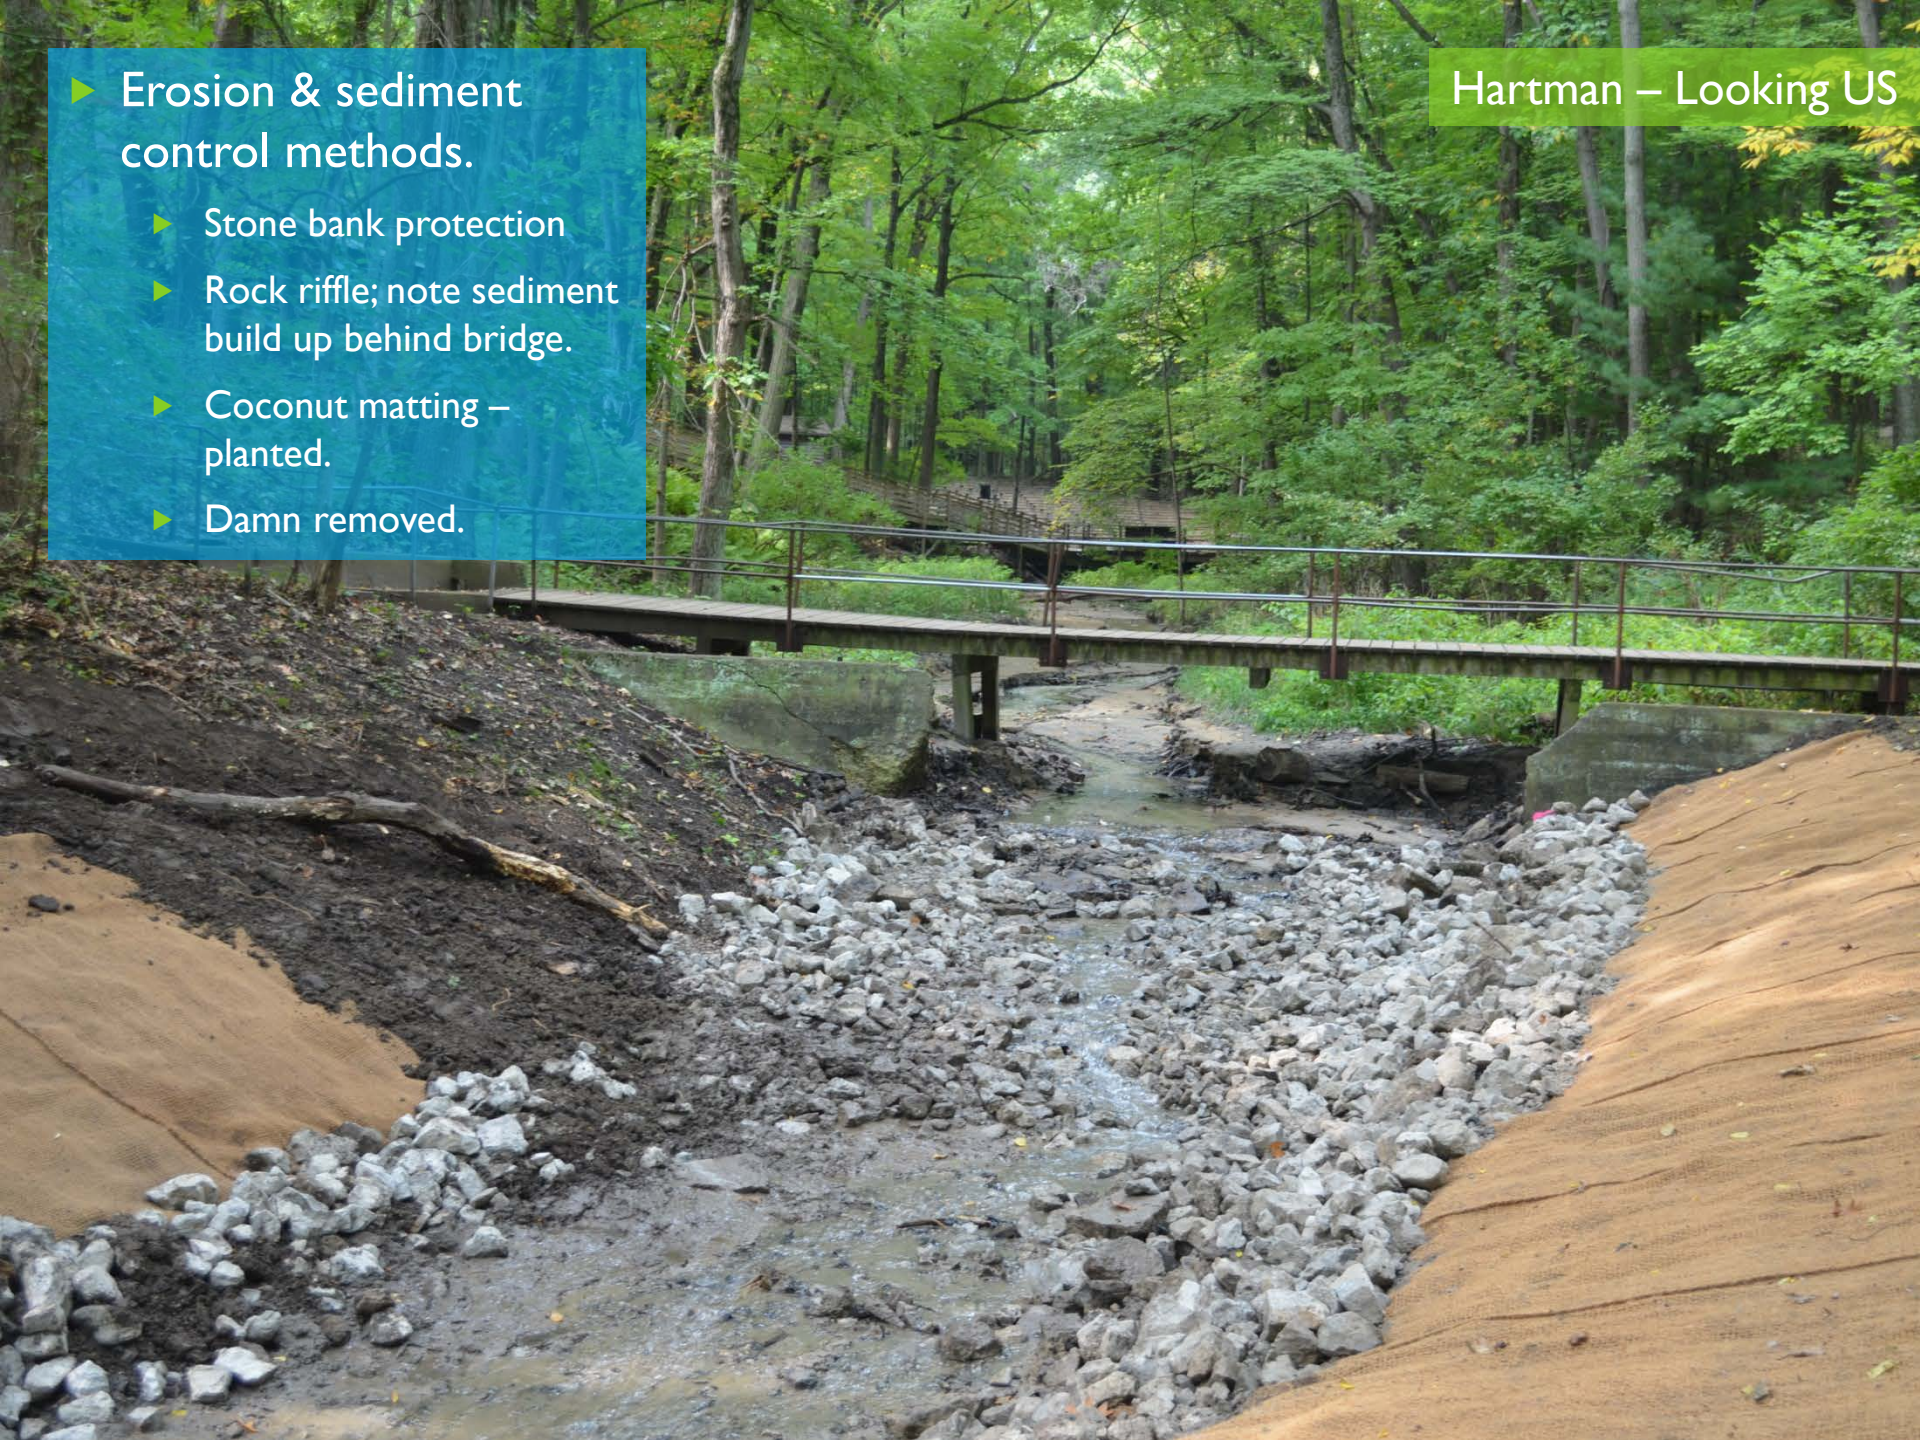
Hartman – Looking US

## ► Erosion & sediment control methods.

- Stone bank protection
- Rock riffle; note sediment build up behind bridge.
- Coconut matting – planted.
- Damn removed.

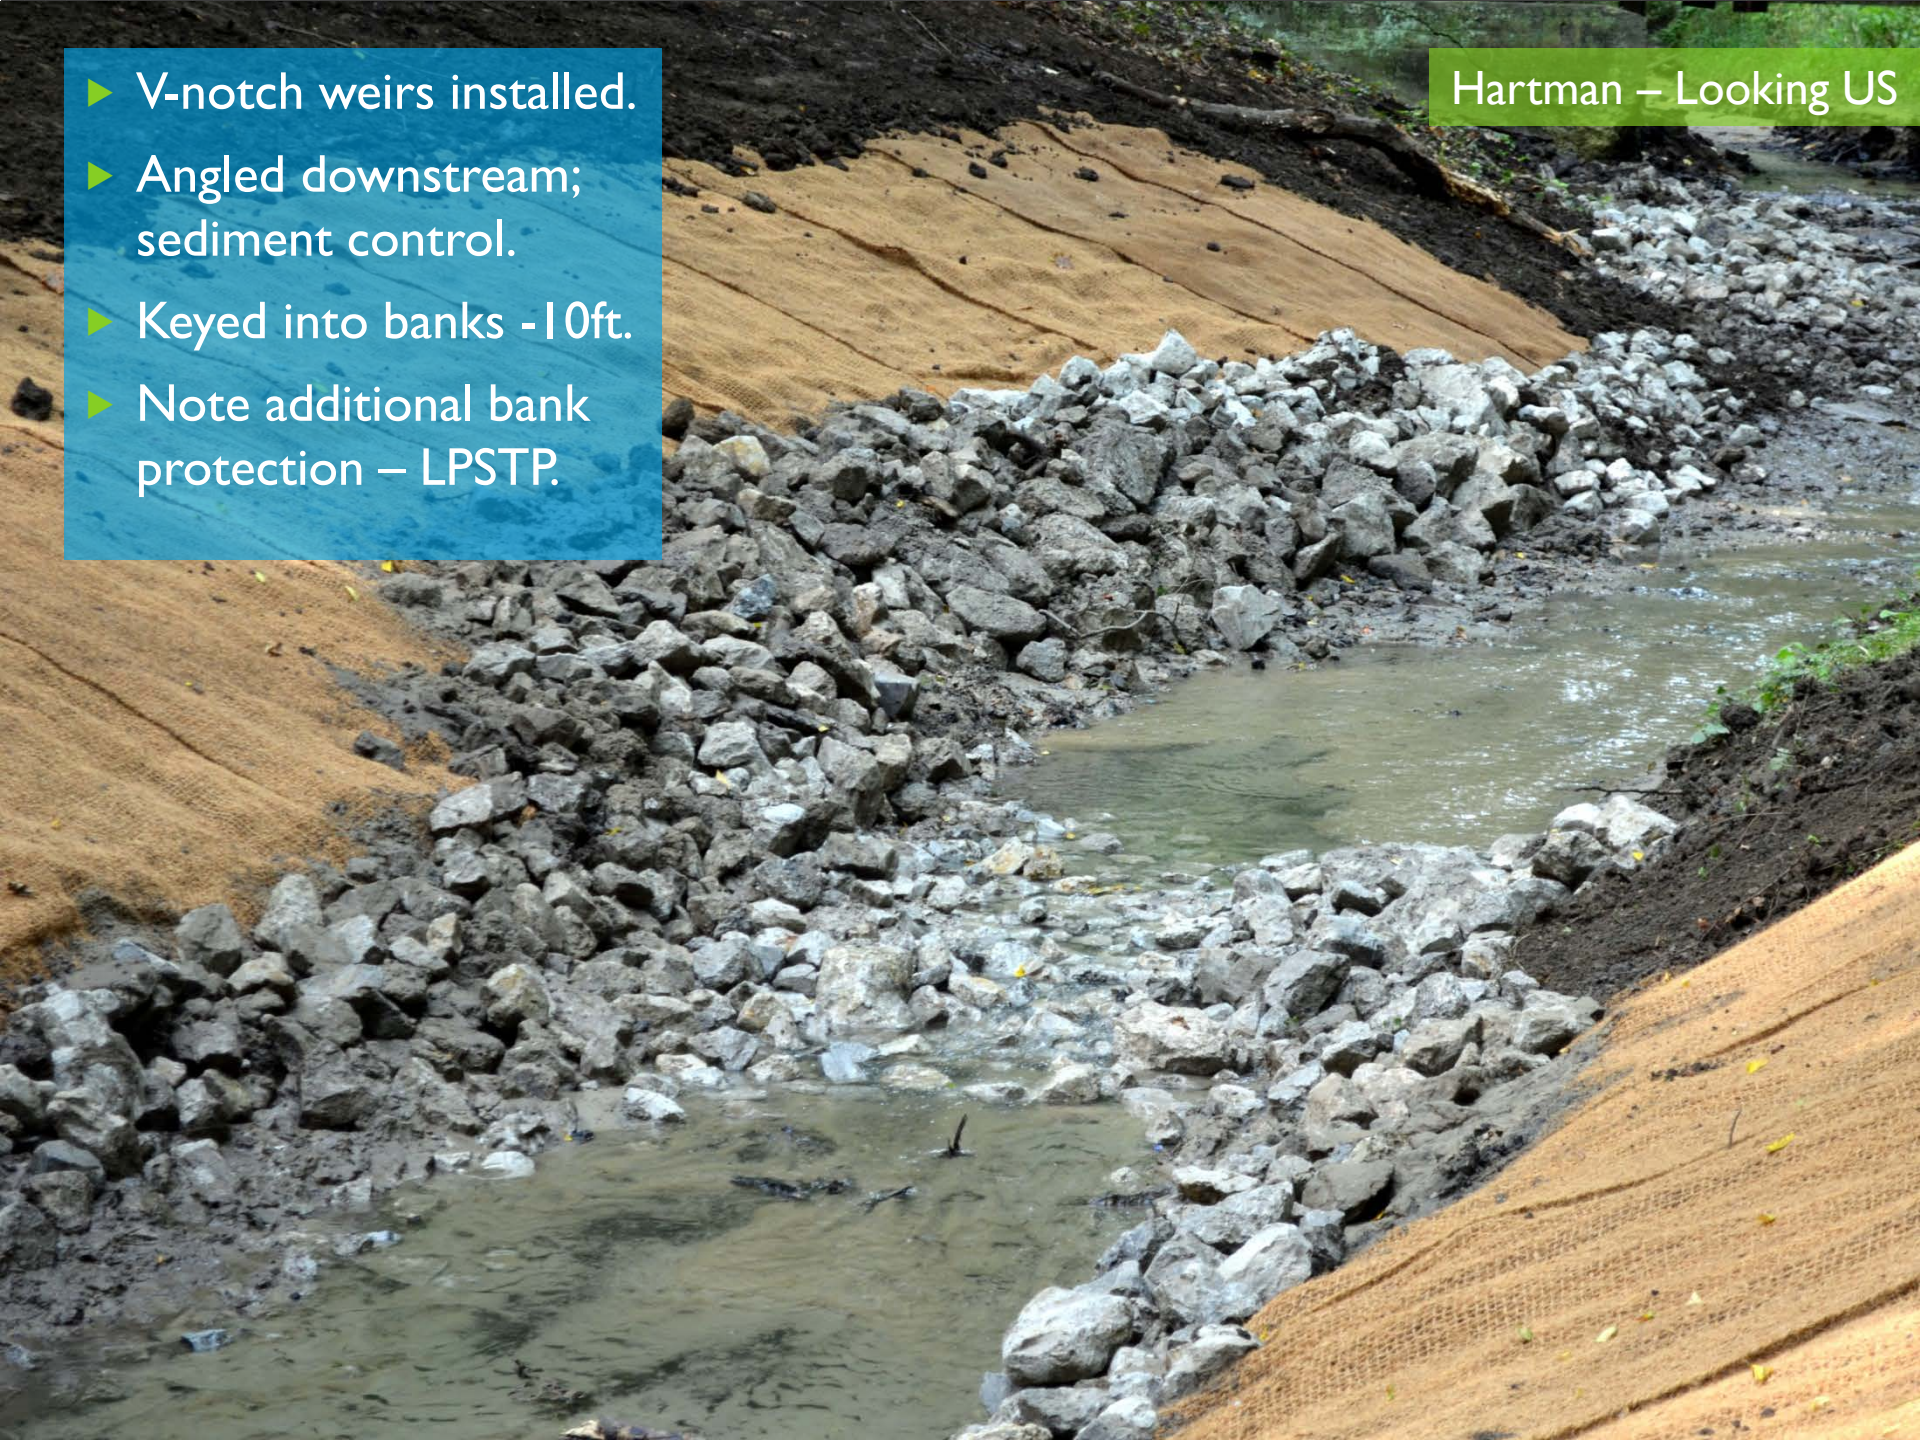
- ▶ V-notch weirs installed.
- ▶ Angled downstream; sediment control.
- ▶ Keyed into banks - 10ft.
- ▶ Note additional bank protection – LPSTP.

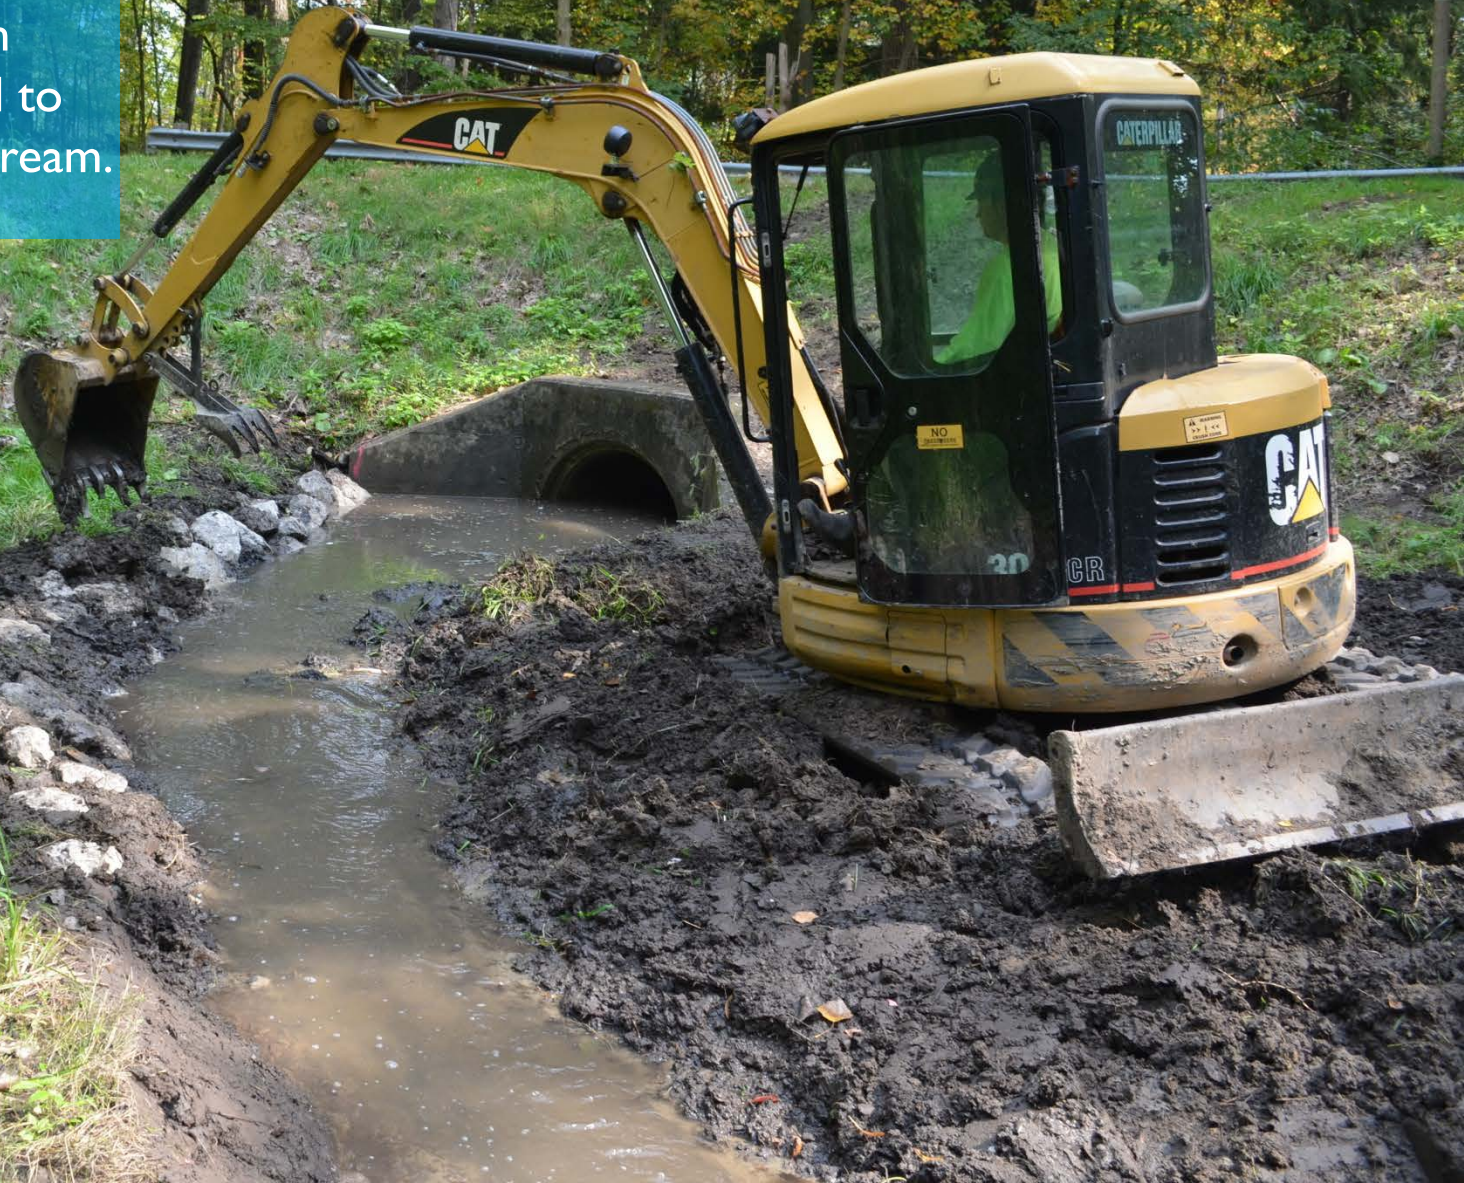
Hartman – Looking DS

- ▶ Hartman made an “awkward” turn into the existing culvert.
- ▶ Bank protection added, and used to help turn the stream.

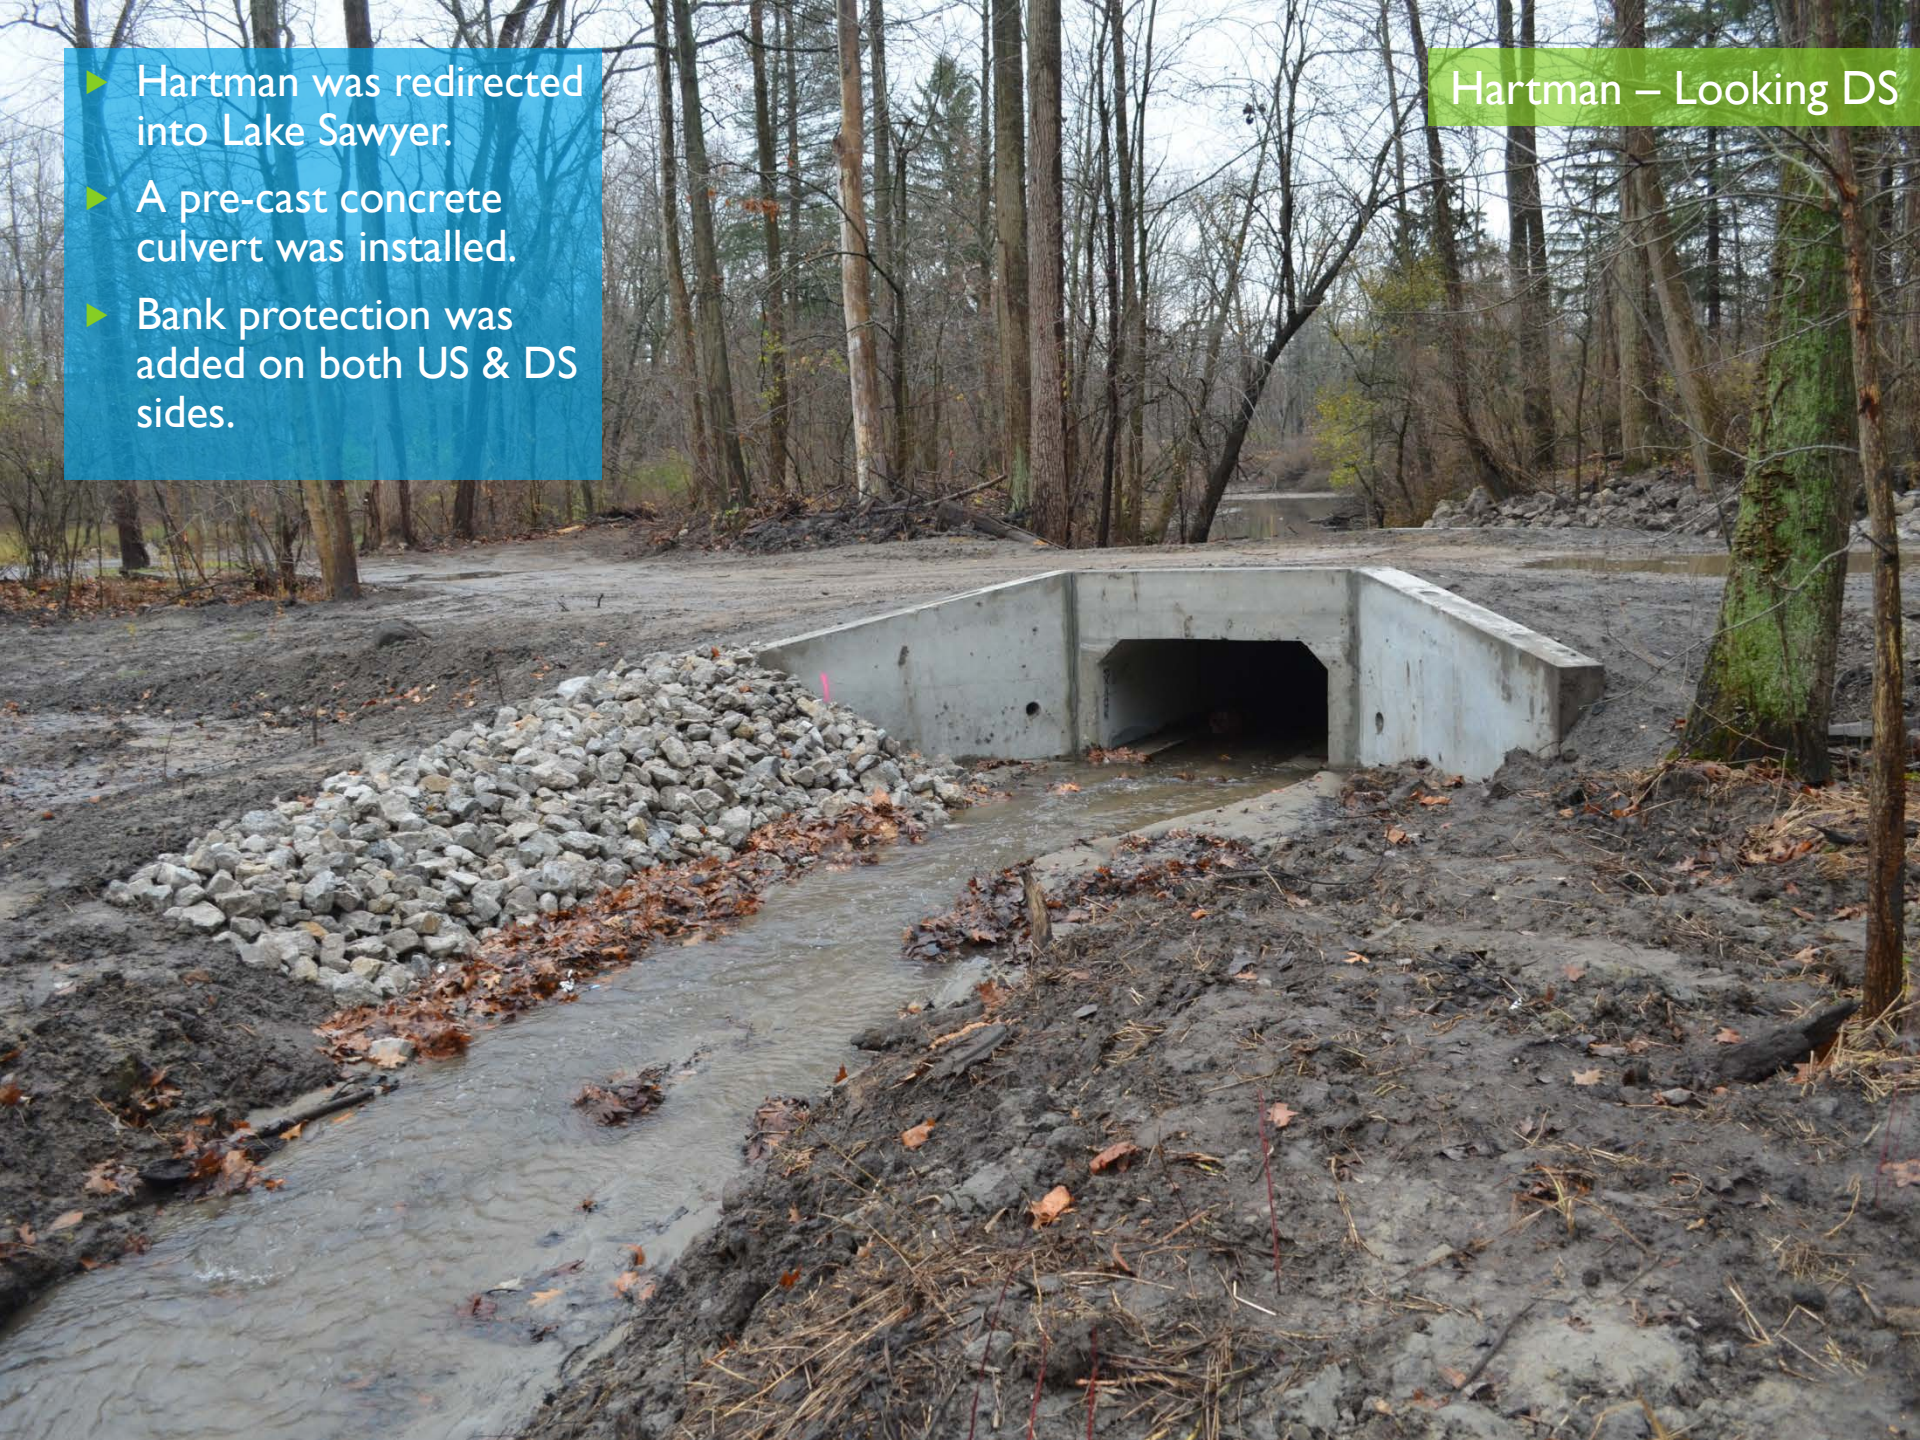
Hartman – Looking DS

- ▶ Hartman was redirected into Lake Sawyer.
- ▶ A pre-cast concrete culvert was installed.
- ▶ Bank protection was added on both US & DS sides.
