# CAMP MIAKONDA RESTORATION PROJECT

Partners for Clean Streams

# CAMP MIAKONDA & OTTAWA RIVER RESTORATION

OTTAWA RIVER BEND #1 – CAMP MIAKONDA

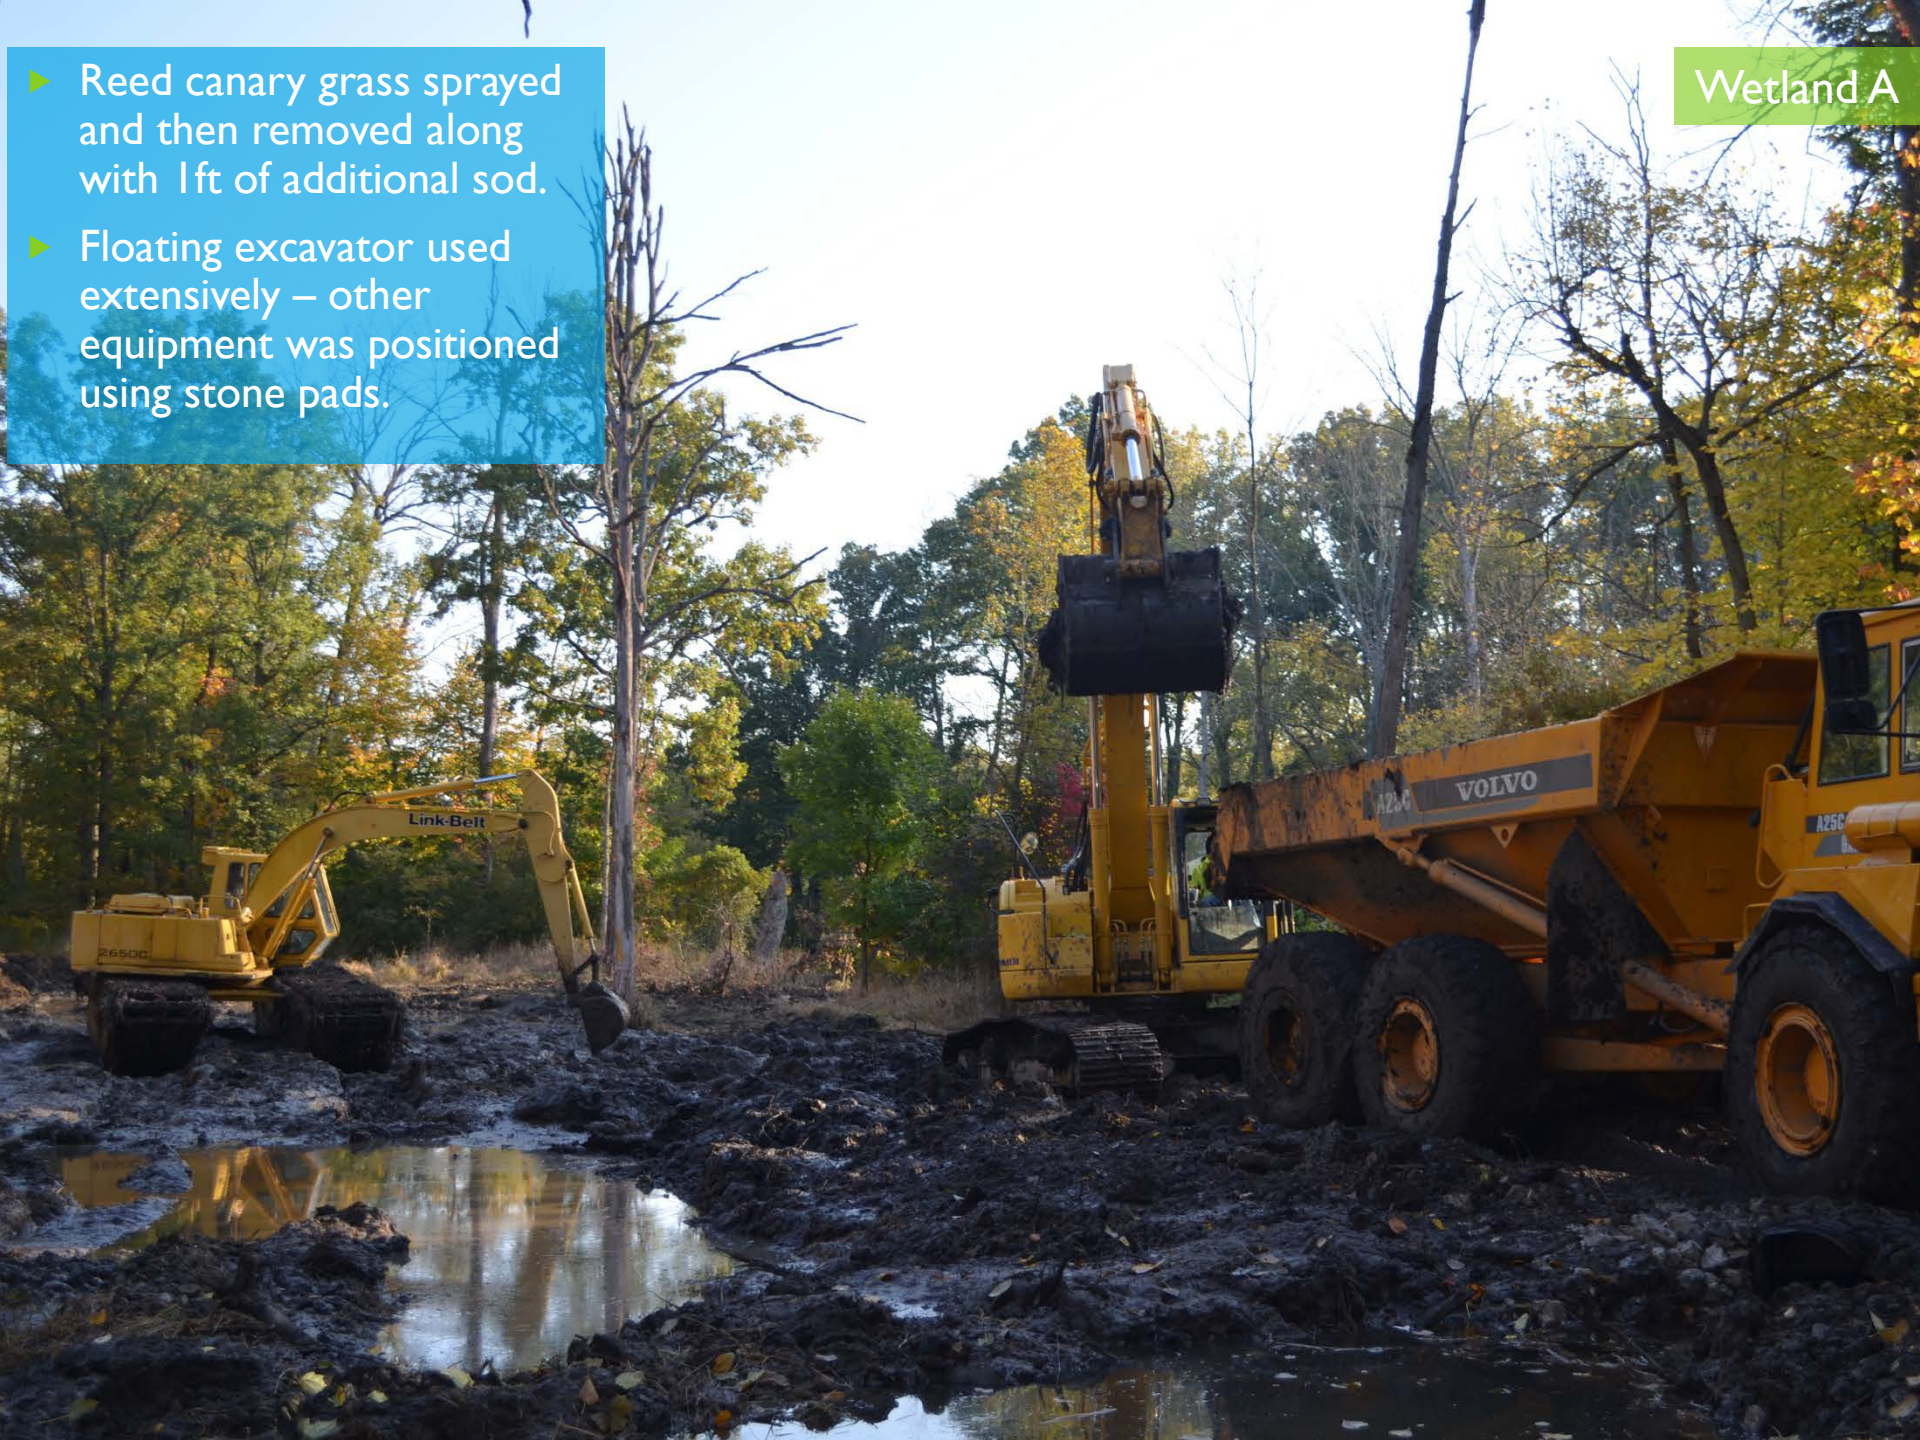
- ▶ Reed canary grass sprayed and then removed along with 1ft of additional sod.
- ▶ Floating excavator used extensively – other equipment was positioned using stone pads.

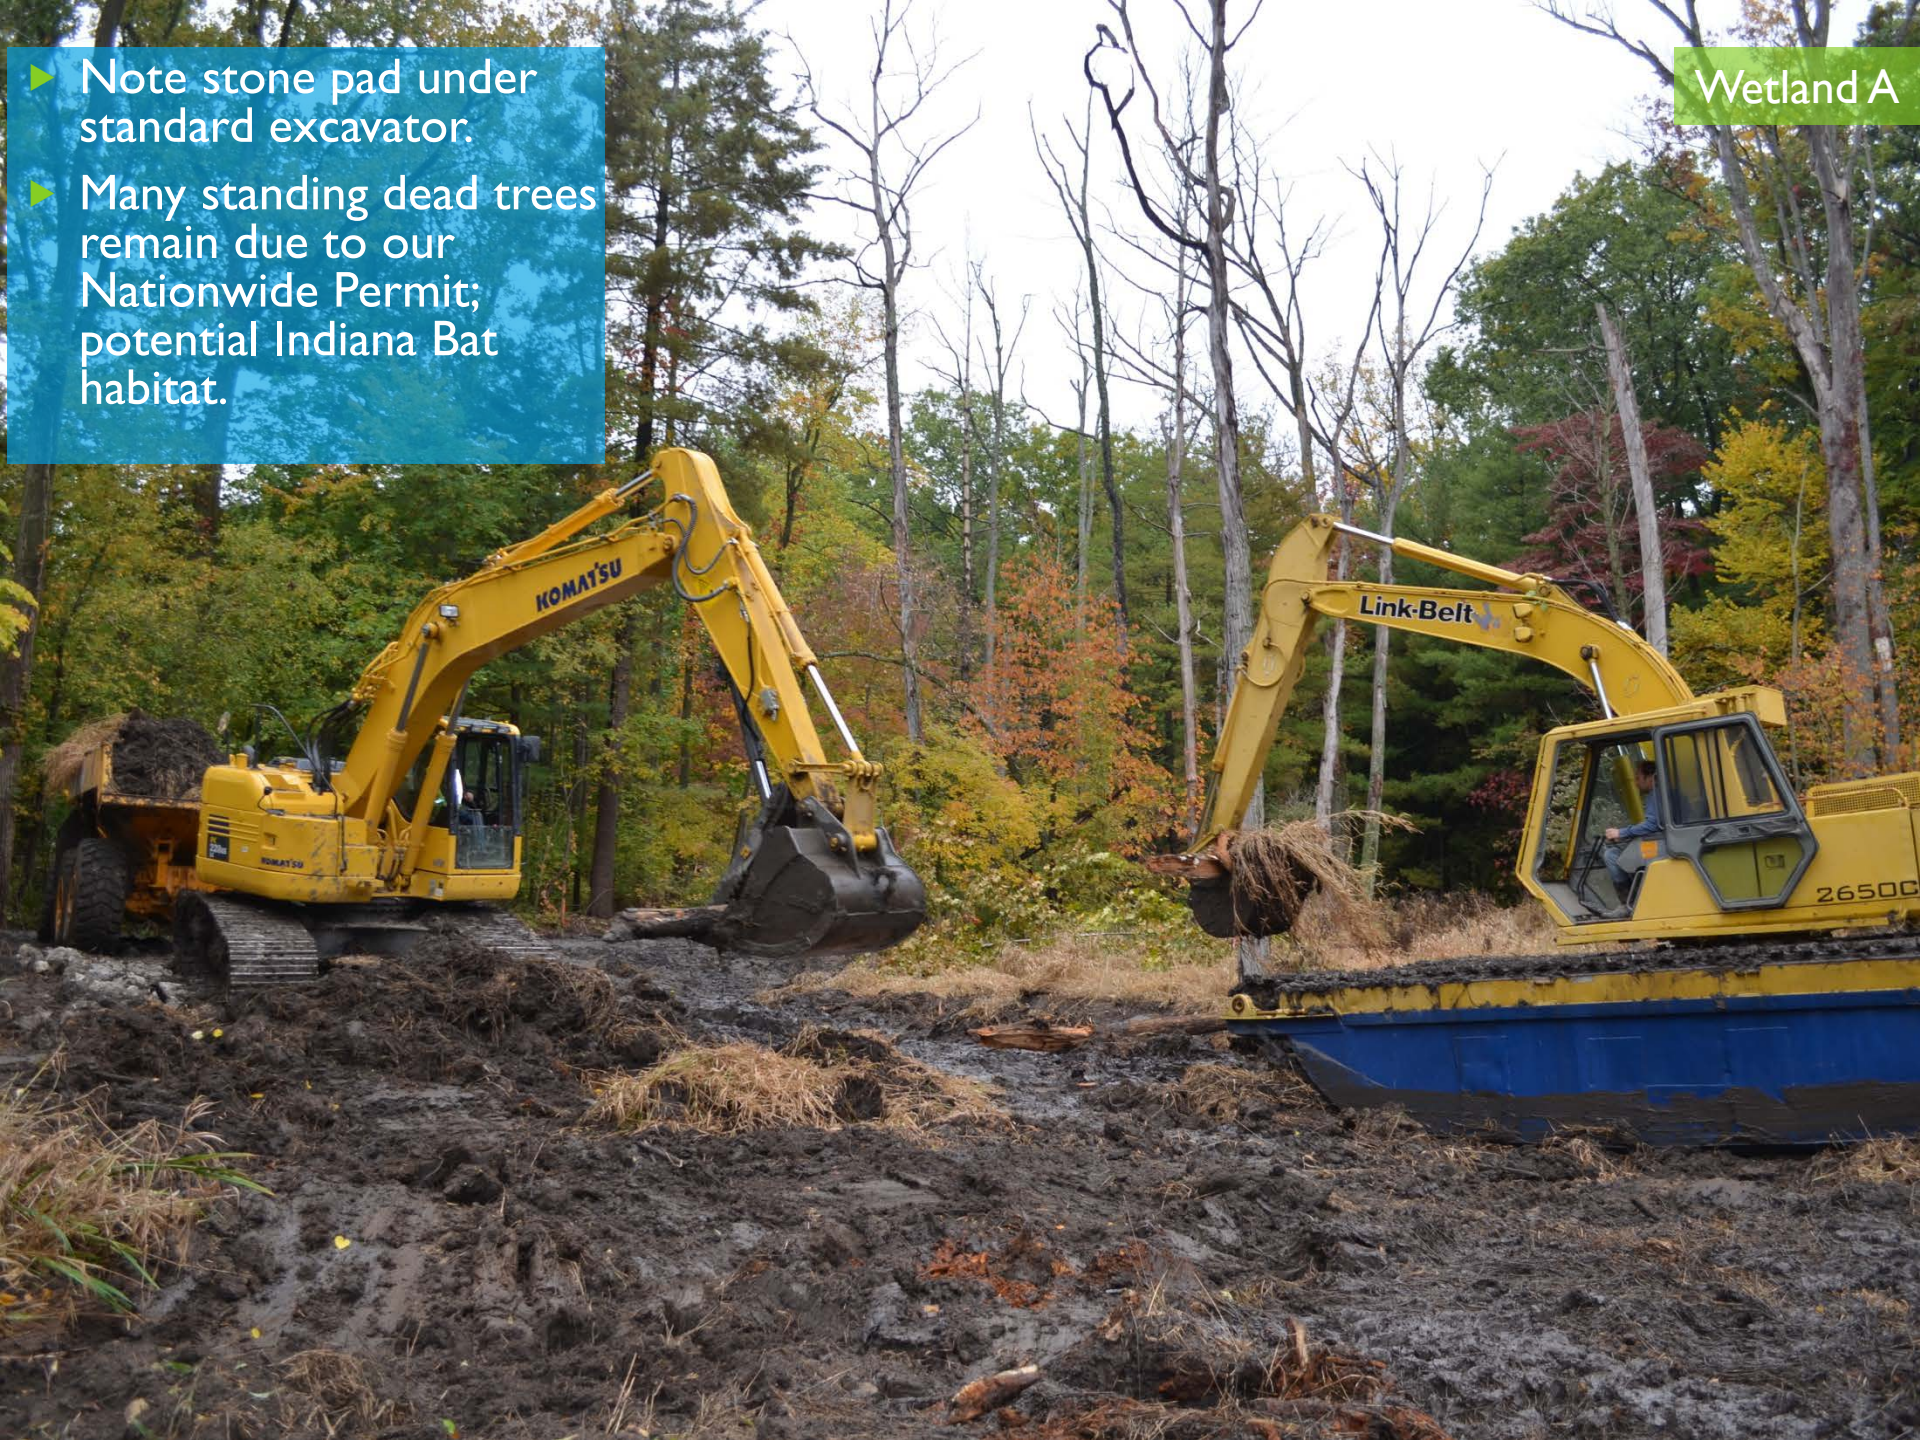
- ▶ Note stone pad under standard excavator.
- ▶ Many standing dead trees remain due to our Nationwide Permit; potential Indiana Bat habitat.

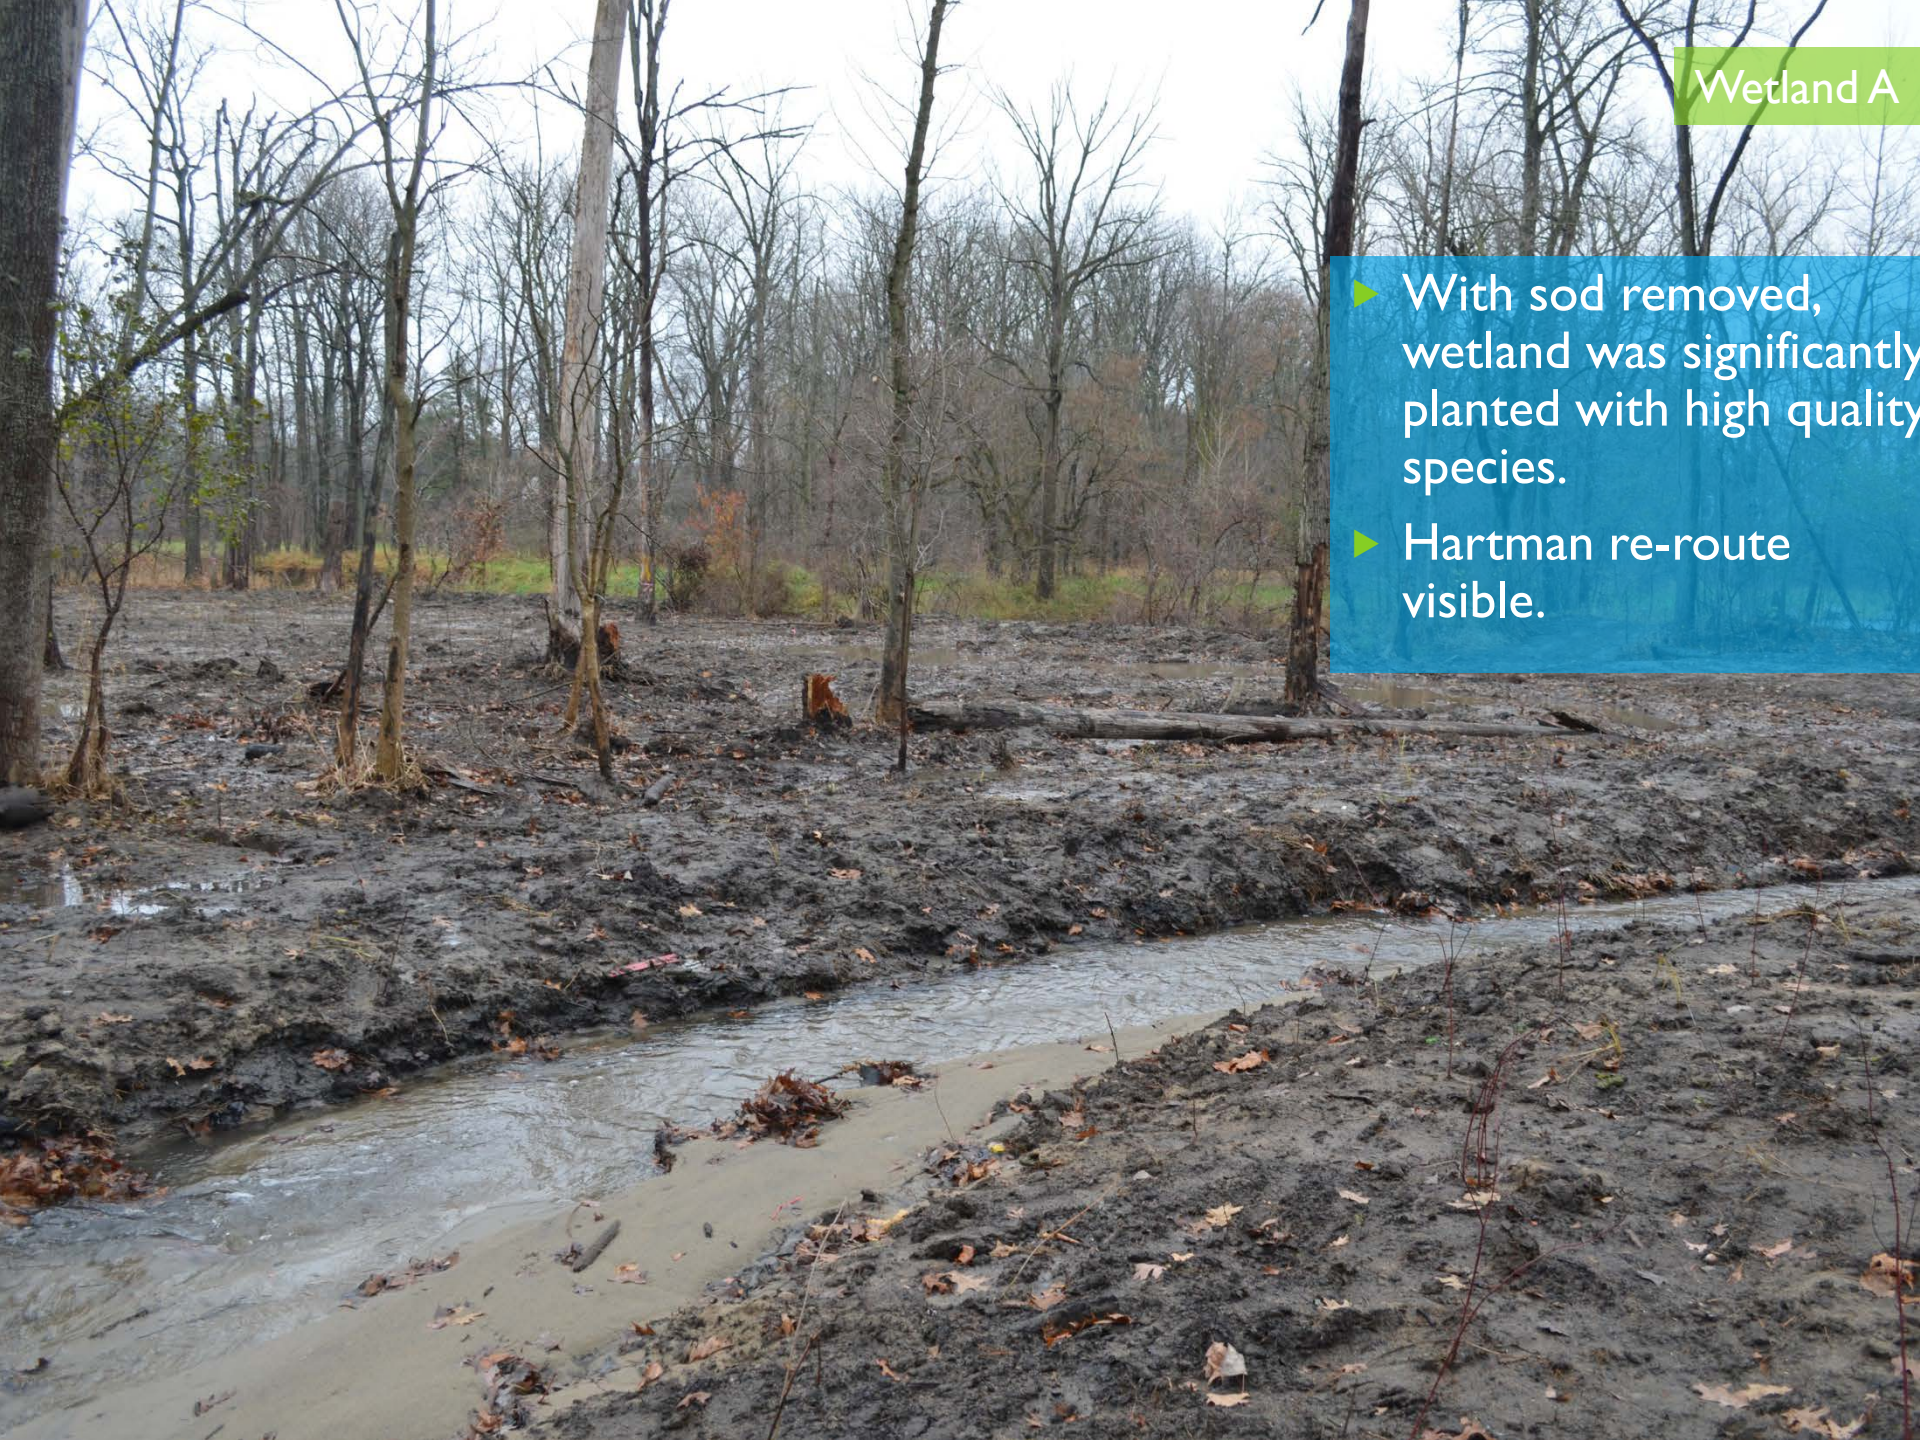
- ▶ With sod removed, wetland was significantly planted with high quality species.
- ▶ Hartman re-route visible.

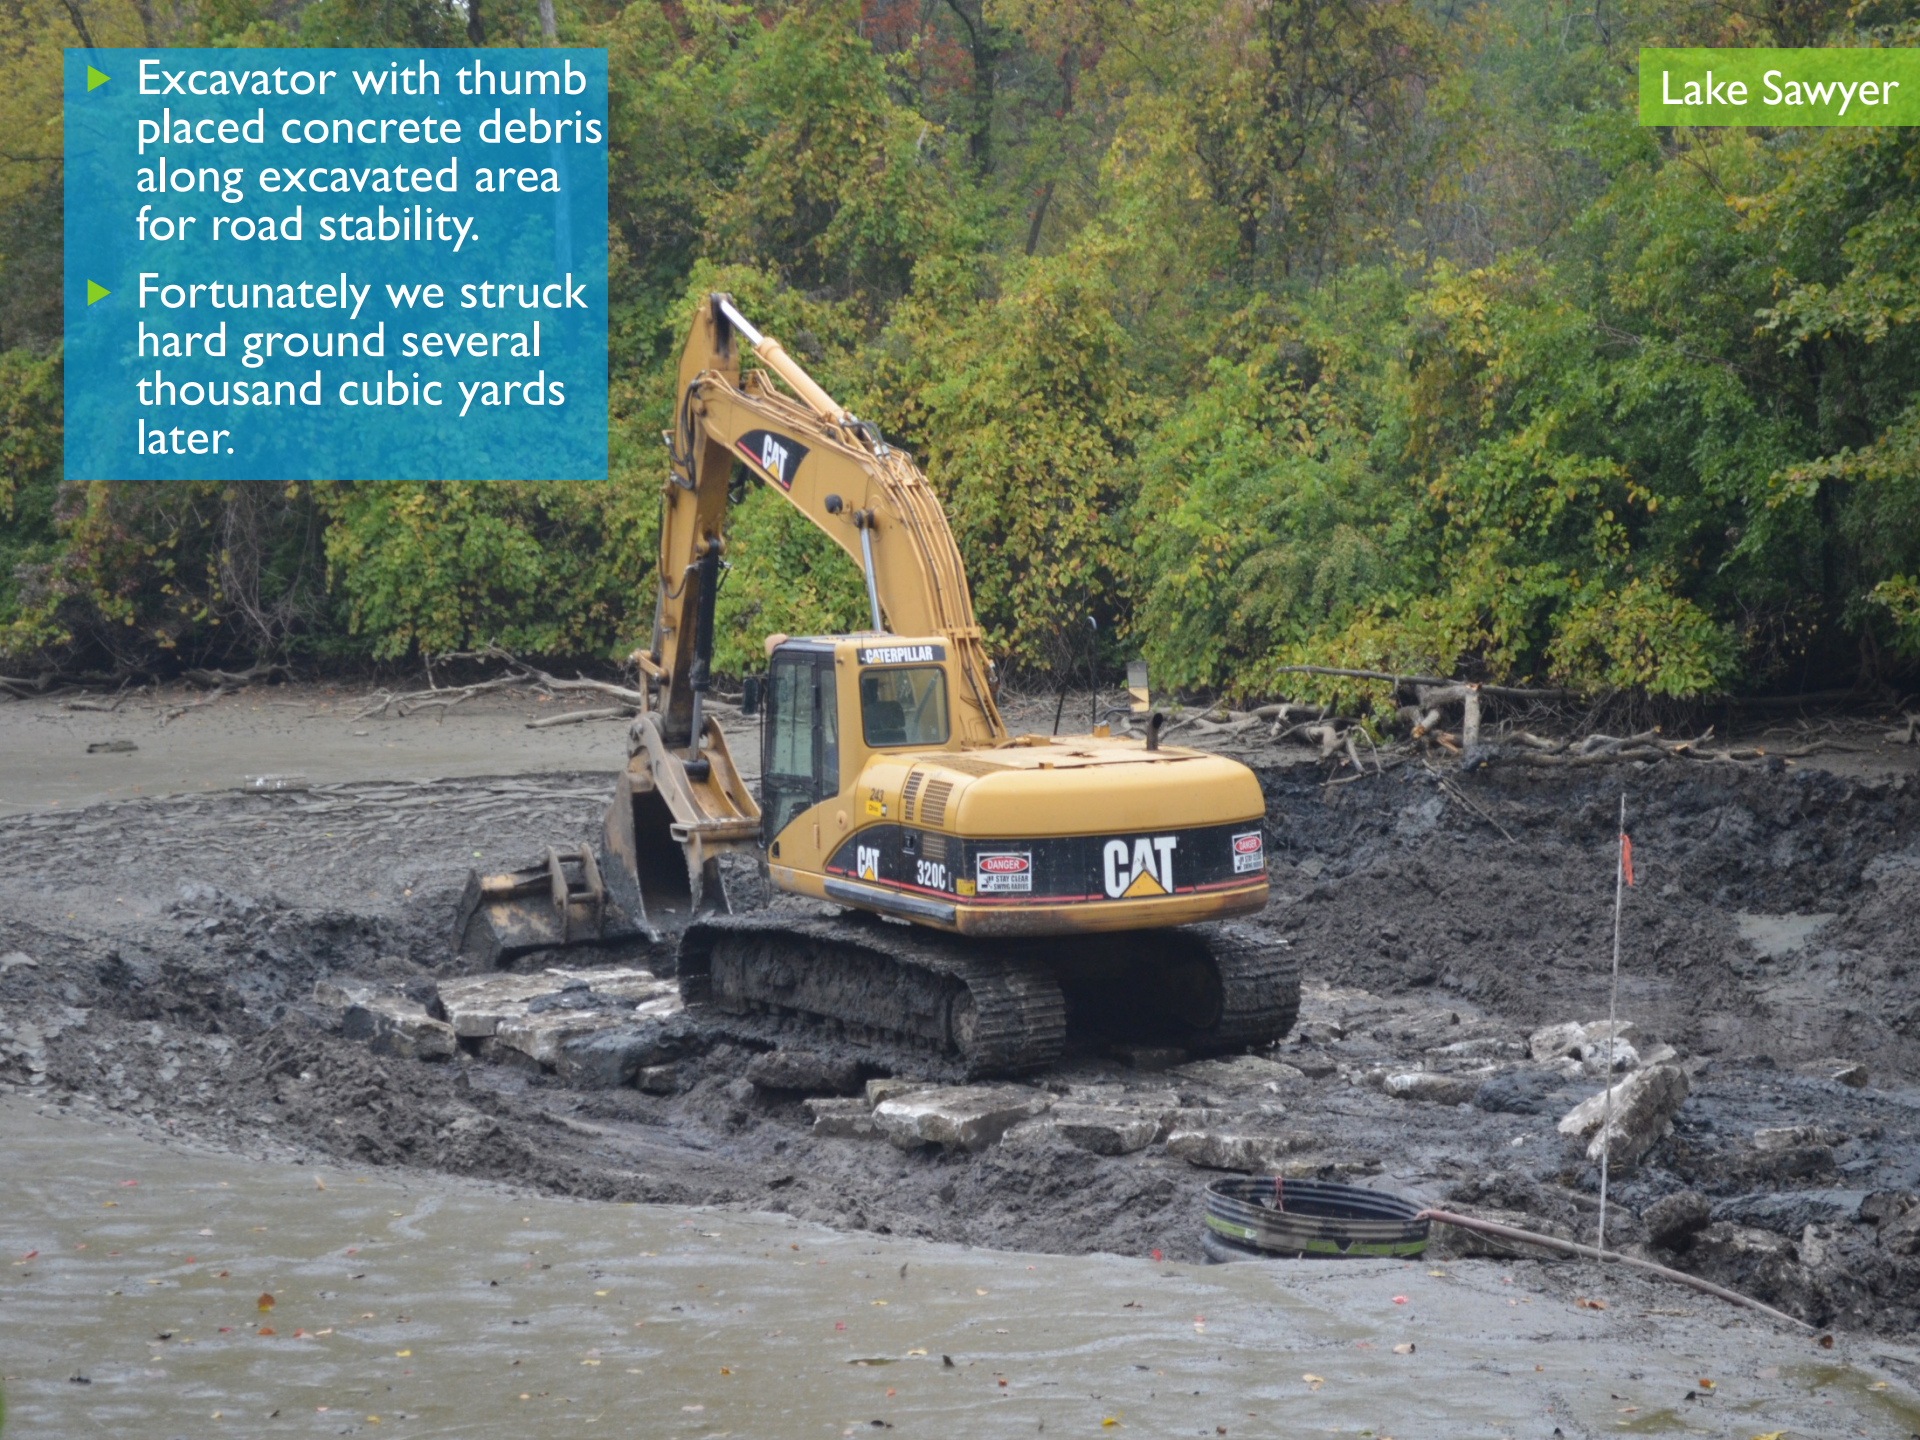
- ▶ Excavator with thumb placed concrete debris along excavated area for road stability.
- ▶ Fortunately we struck hard ground several thousand cubic yards later.

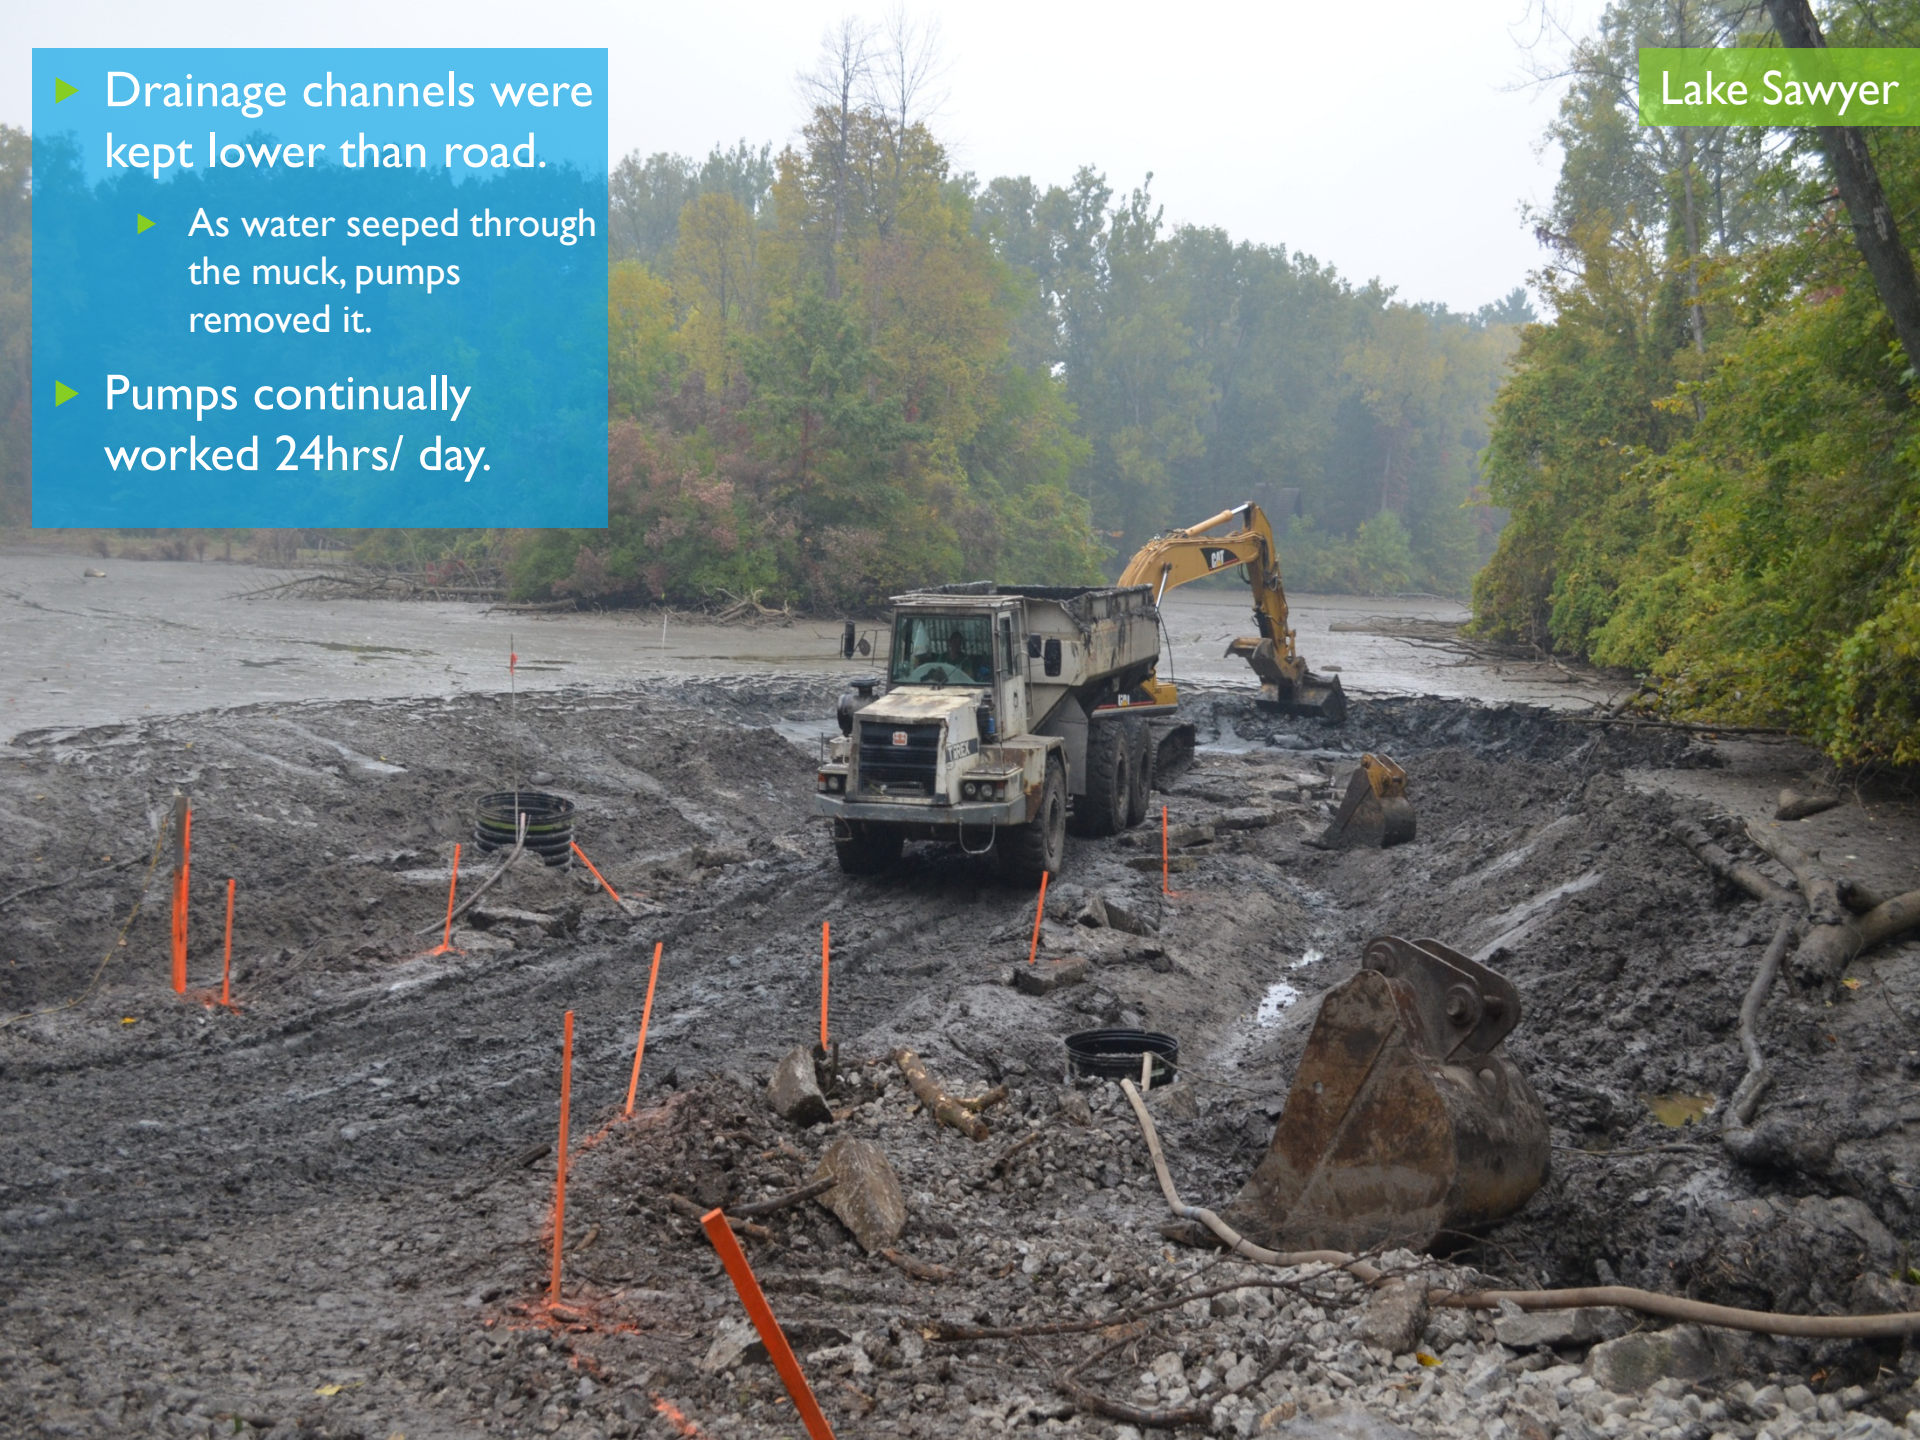
- ▶ Drainage channels were kept lower than road.
  - ▶ As water seeped through the muck, pumps removed it.
- ▶ Pumps continually worked 24hrs/ day.

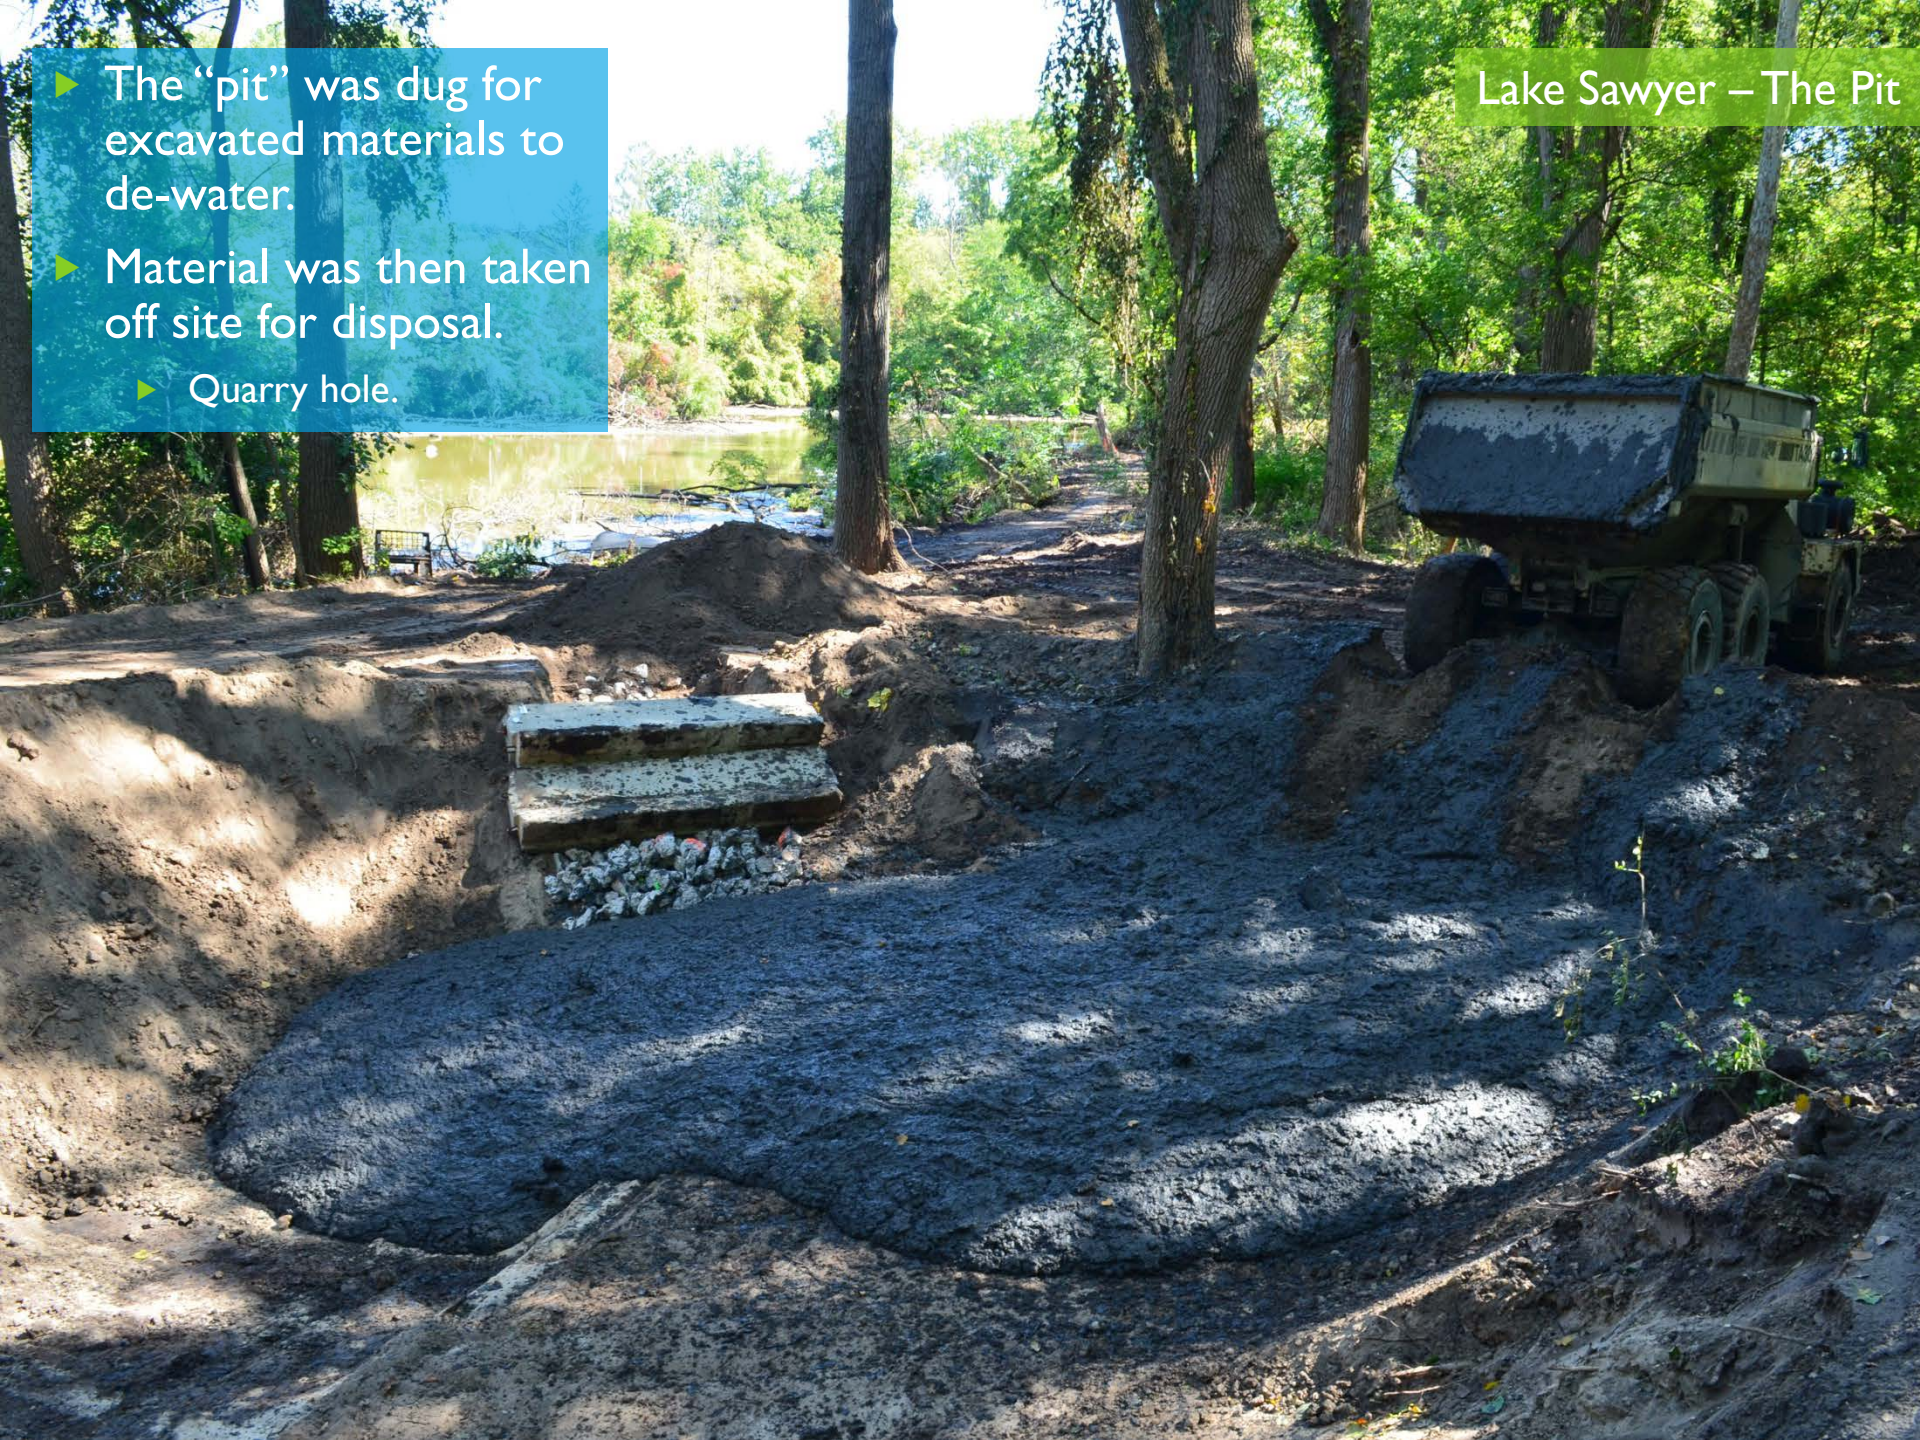
## Lake Sawyer – The Pit

- ▶ The “pit” was dug for excavated materials to de-water.
- ▶ Material was then taken off site for disposal.
  - ▶ Quarry hole.

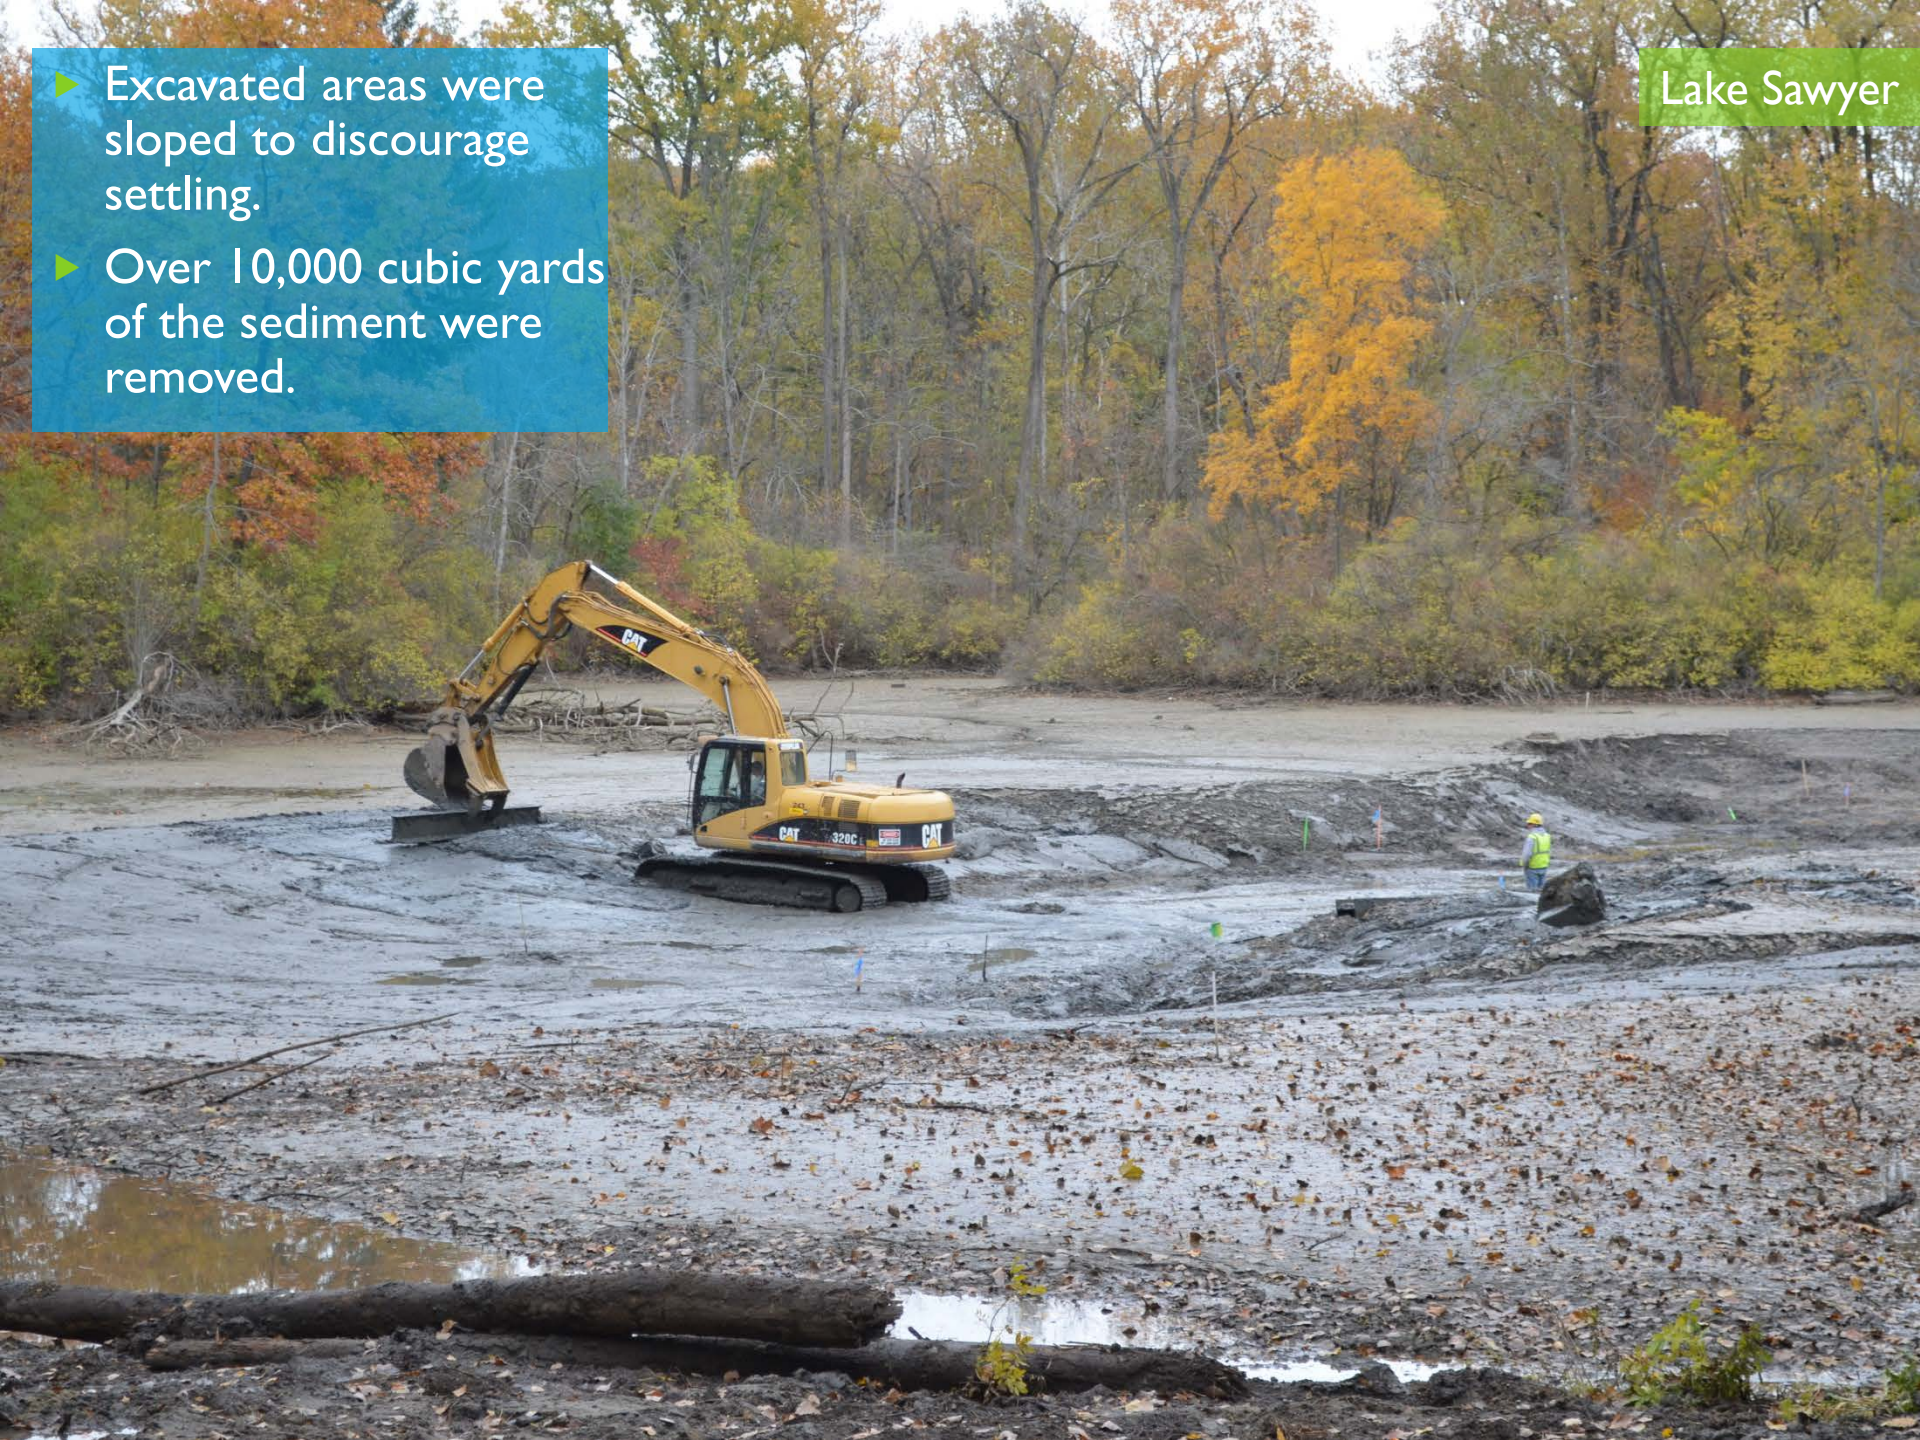
Lake Sawyer

- ▶ Excavated areas were sloped to discourage settling.
- ▶ Over 10,000 cubic yards of the sediment were removed.

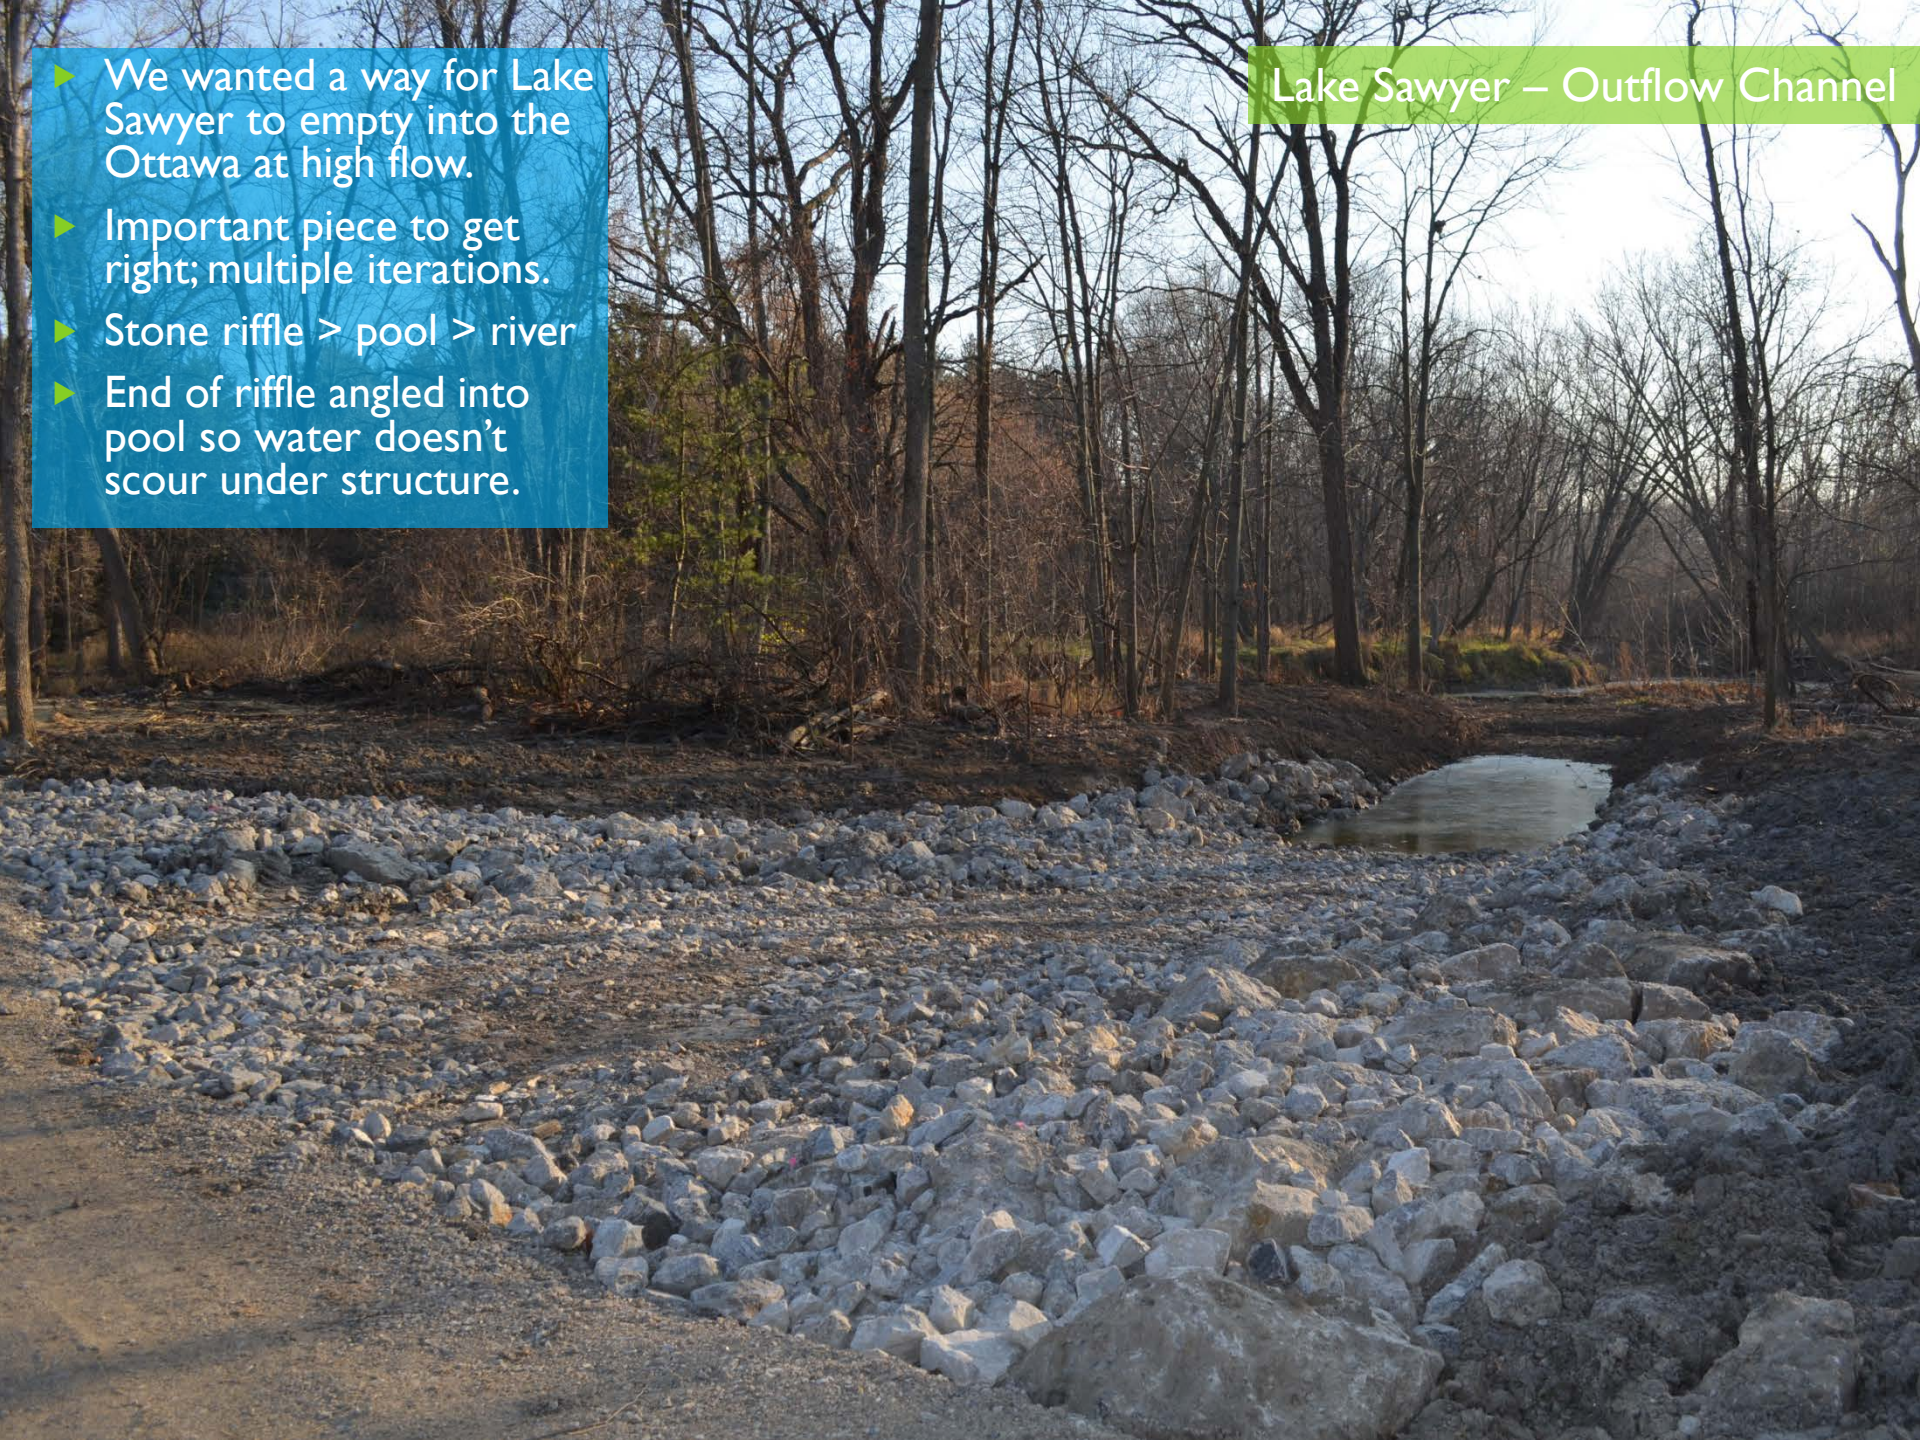
## Lake Sawyer – Outflow Channel

- ▶ We wanted a way for Lake Sawyer to empty into the Ottawa at high flow.
- ▶ Important piece to get right; multiple iterations.
- ▶ Stone riffle > pool > river
- ▶ End of riffle angled into pool so water doesn't scour under structure.
