# CAMP MIAKONDA RESTORATION PROJECT

Partners for Clean Streams

# CAMP MIAKONDA & OTTAWA RIVER RESTORATION

OTTAWA RIVER BEND #1 – CAMP MIAKONDA

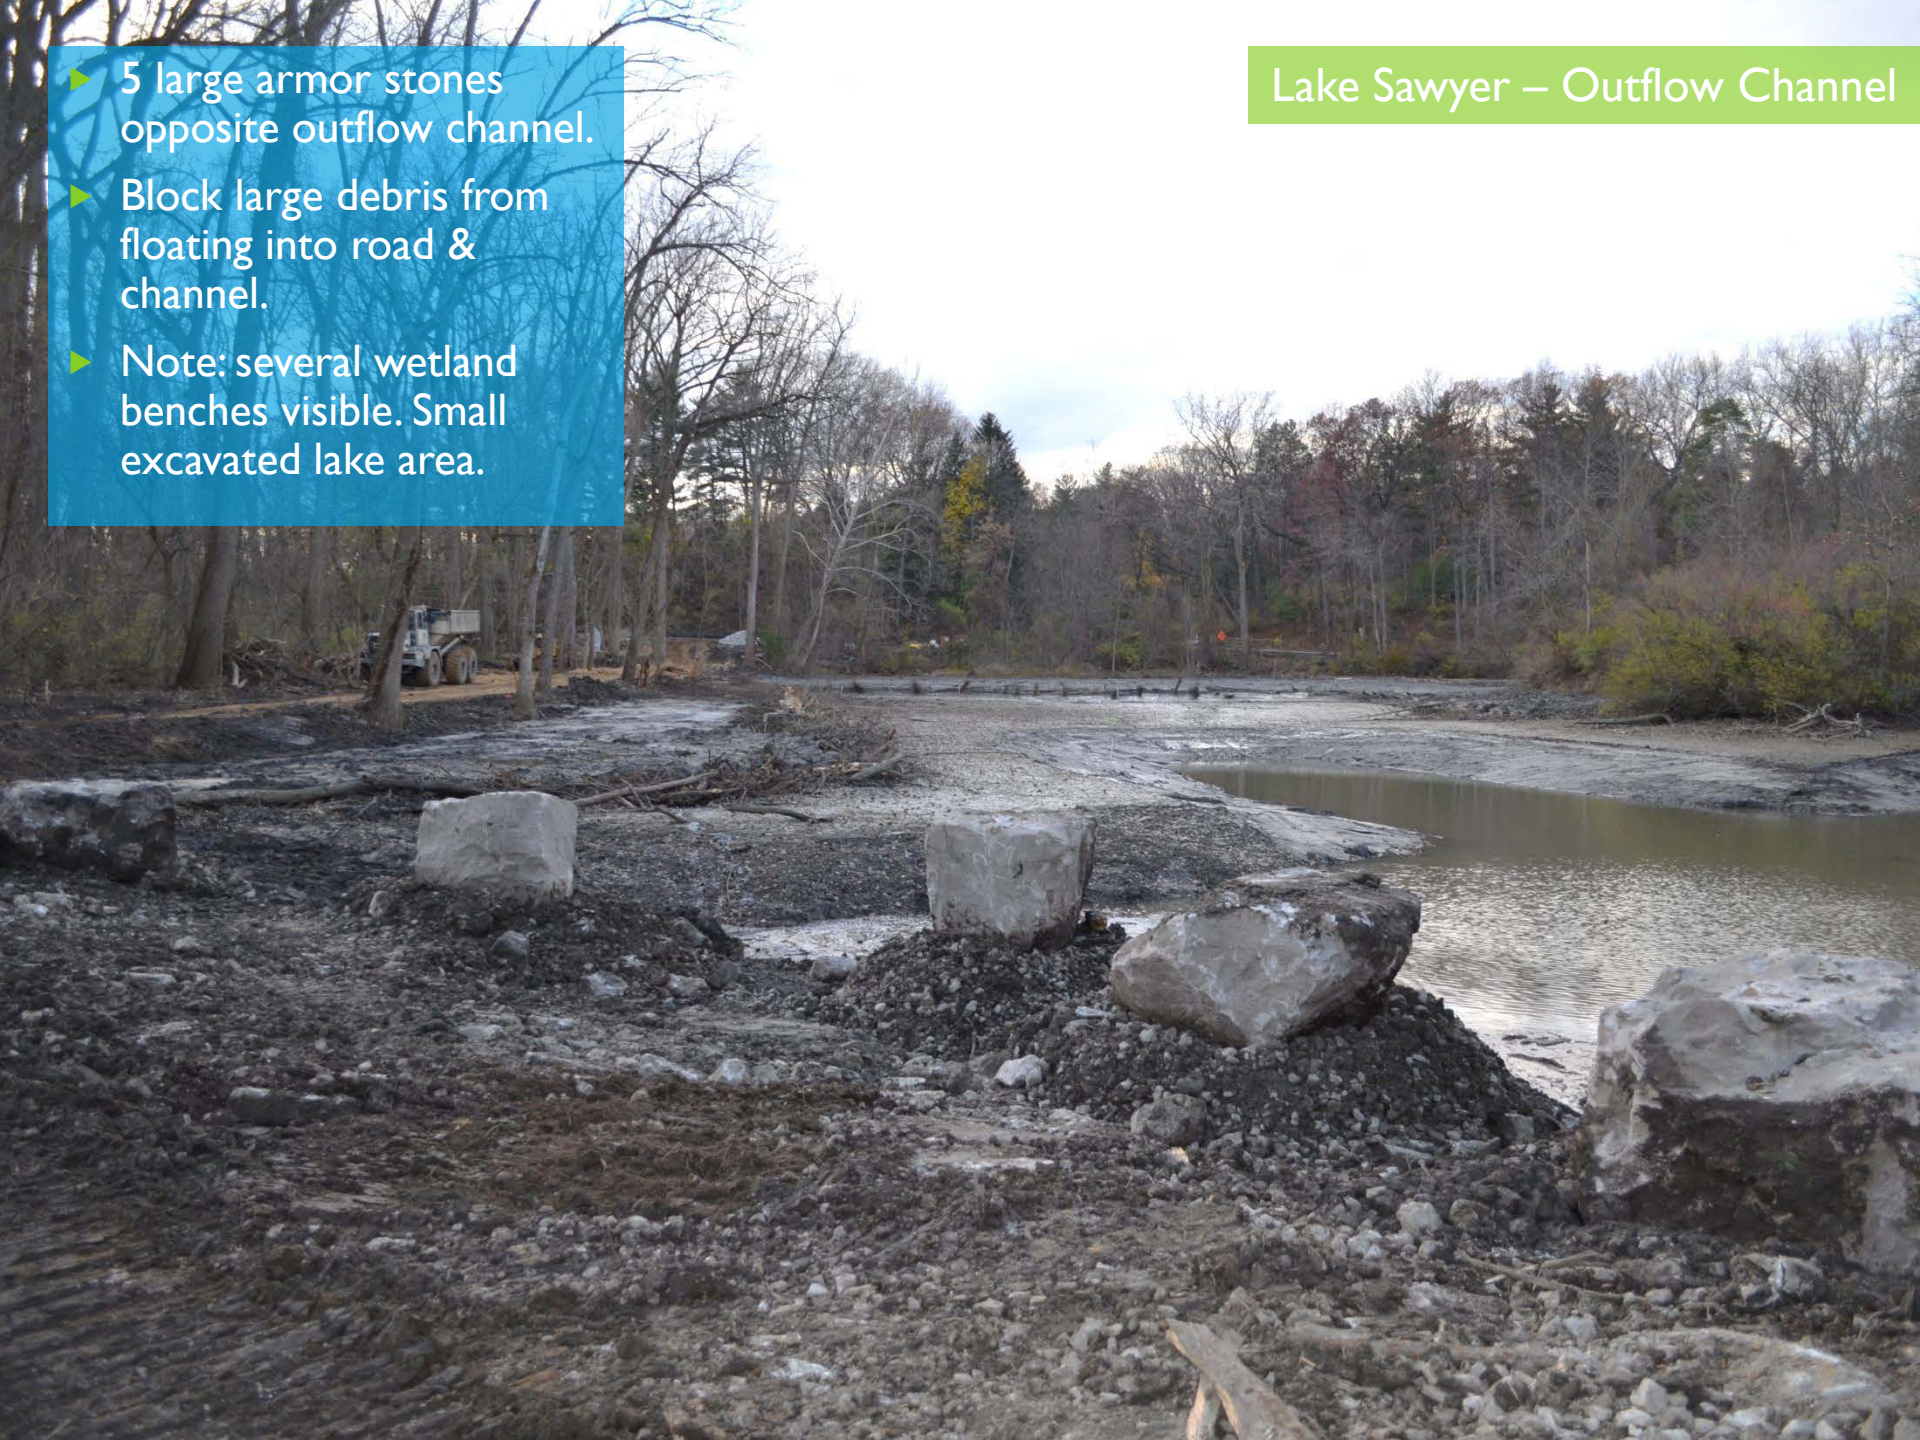
- ▶ 5 large armor stones opposite outflow channel.
- ▶ Block large debris from floating into road & channel.
- ▶ Note: several wetland benches visible. Small excavated lake area.

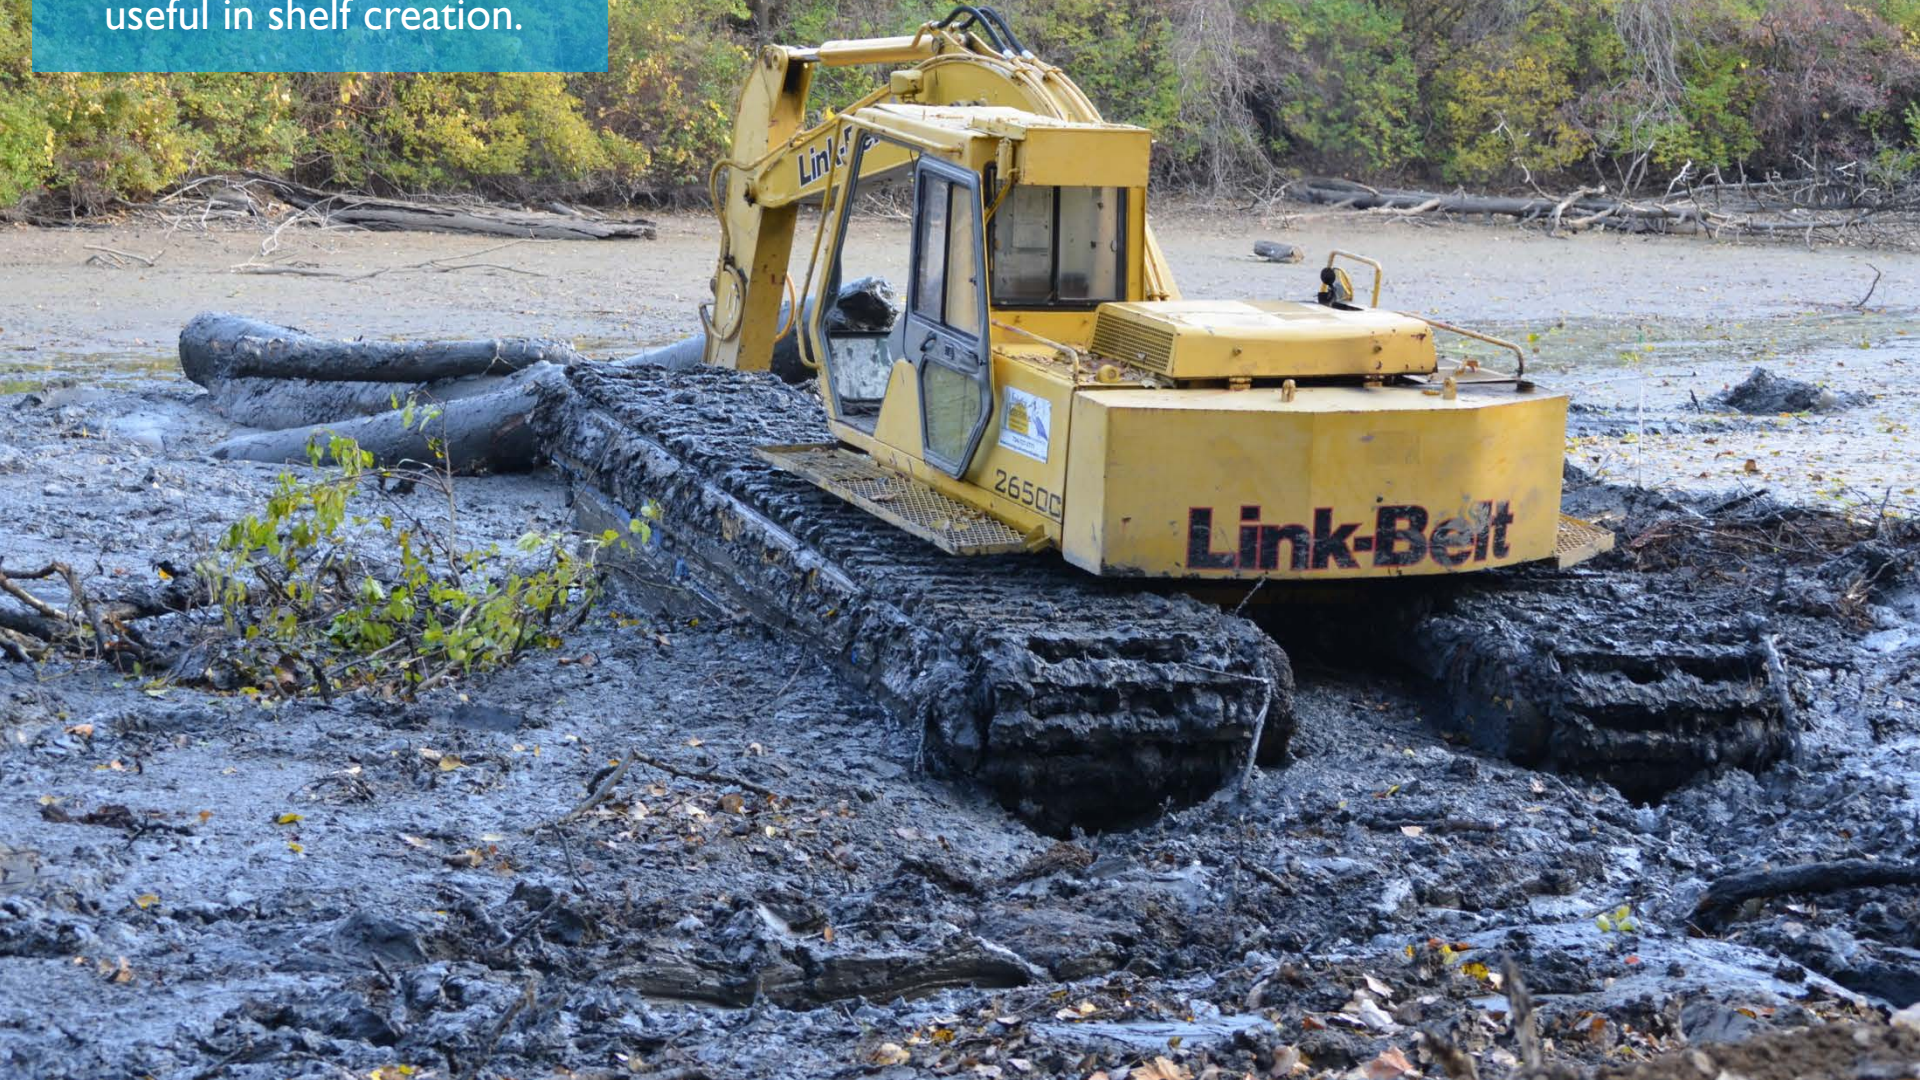
## Lake Sawyer – Wetland Shelf

- ▶ Numerous wetland shelves were created around the lake.
- ▶ Shelves act as filters and sediment controls.
- ▶ The floating excavator was useful in shelf creation.

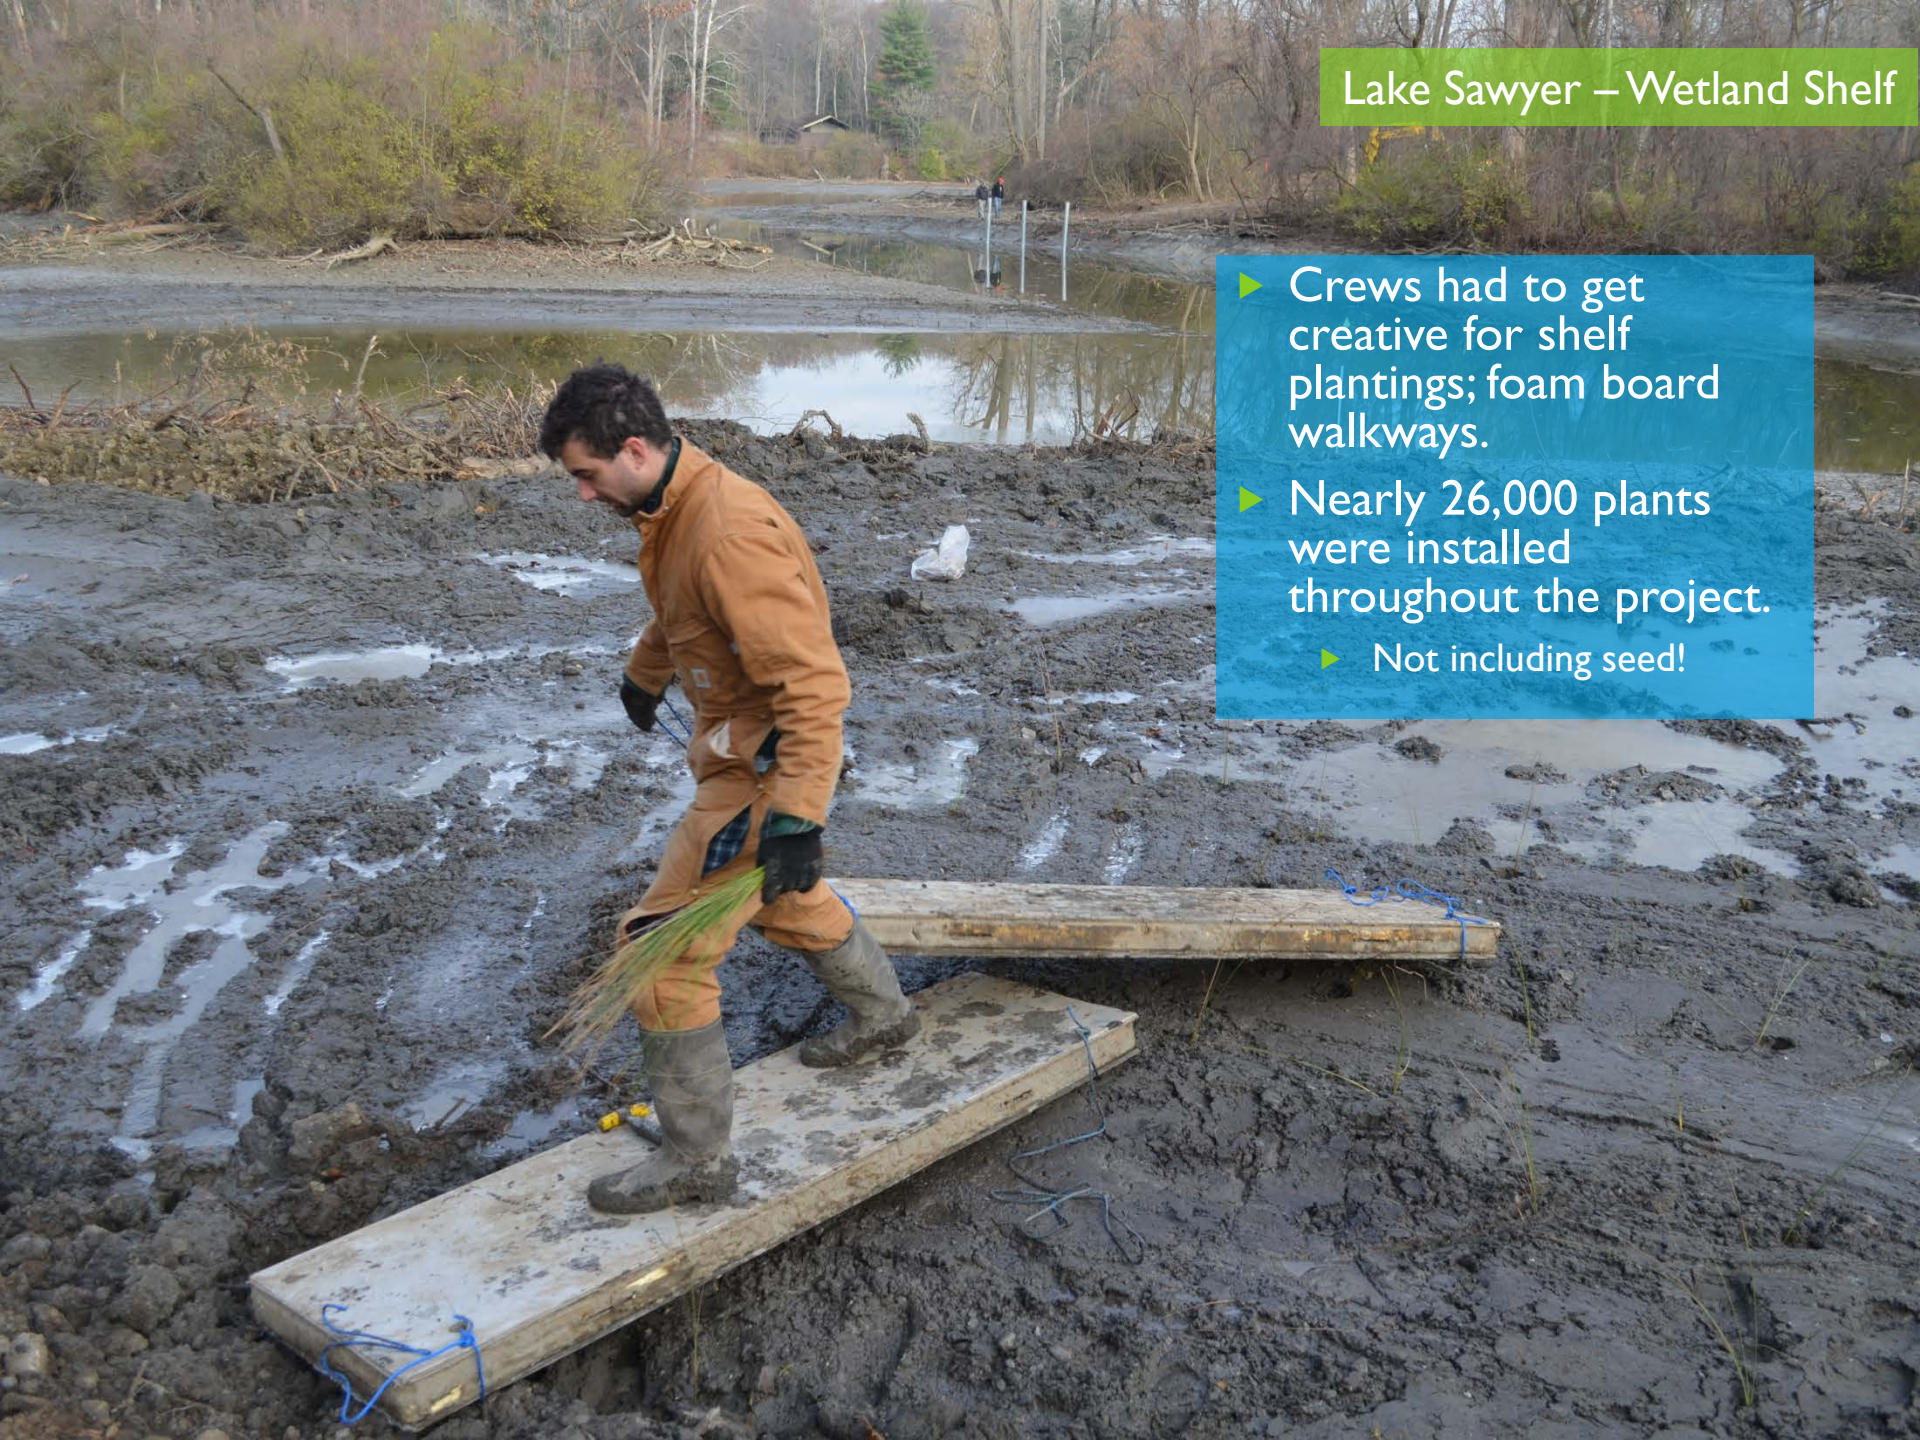
## Lake Sawyer – Wetland Shelf

- ▶ Crews had to get creative for shelf plantings; foam board walkways.
- ▶ Nearly 26,000 plants were installed throughout the project.
  - ▶ Not including seed!
